WIRING DIAGRAM-BACKWALL (WIRE ASM 124158)

97 0-SERIES

TITLE		WIRING DIAGRAM-AUTO LAMPS	
DATE	BY	DATE	BY
11/16	1.6		
SHEET 2 OF 2		124076

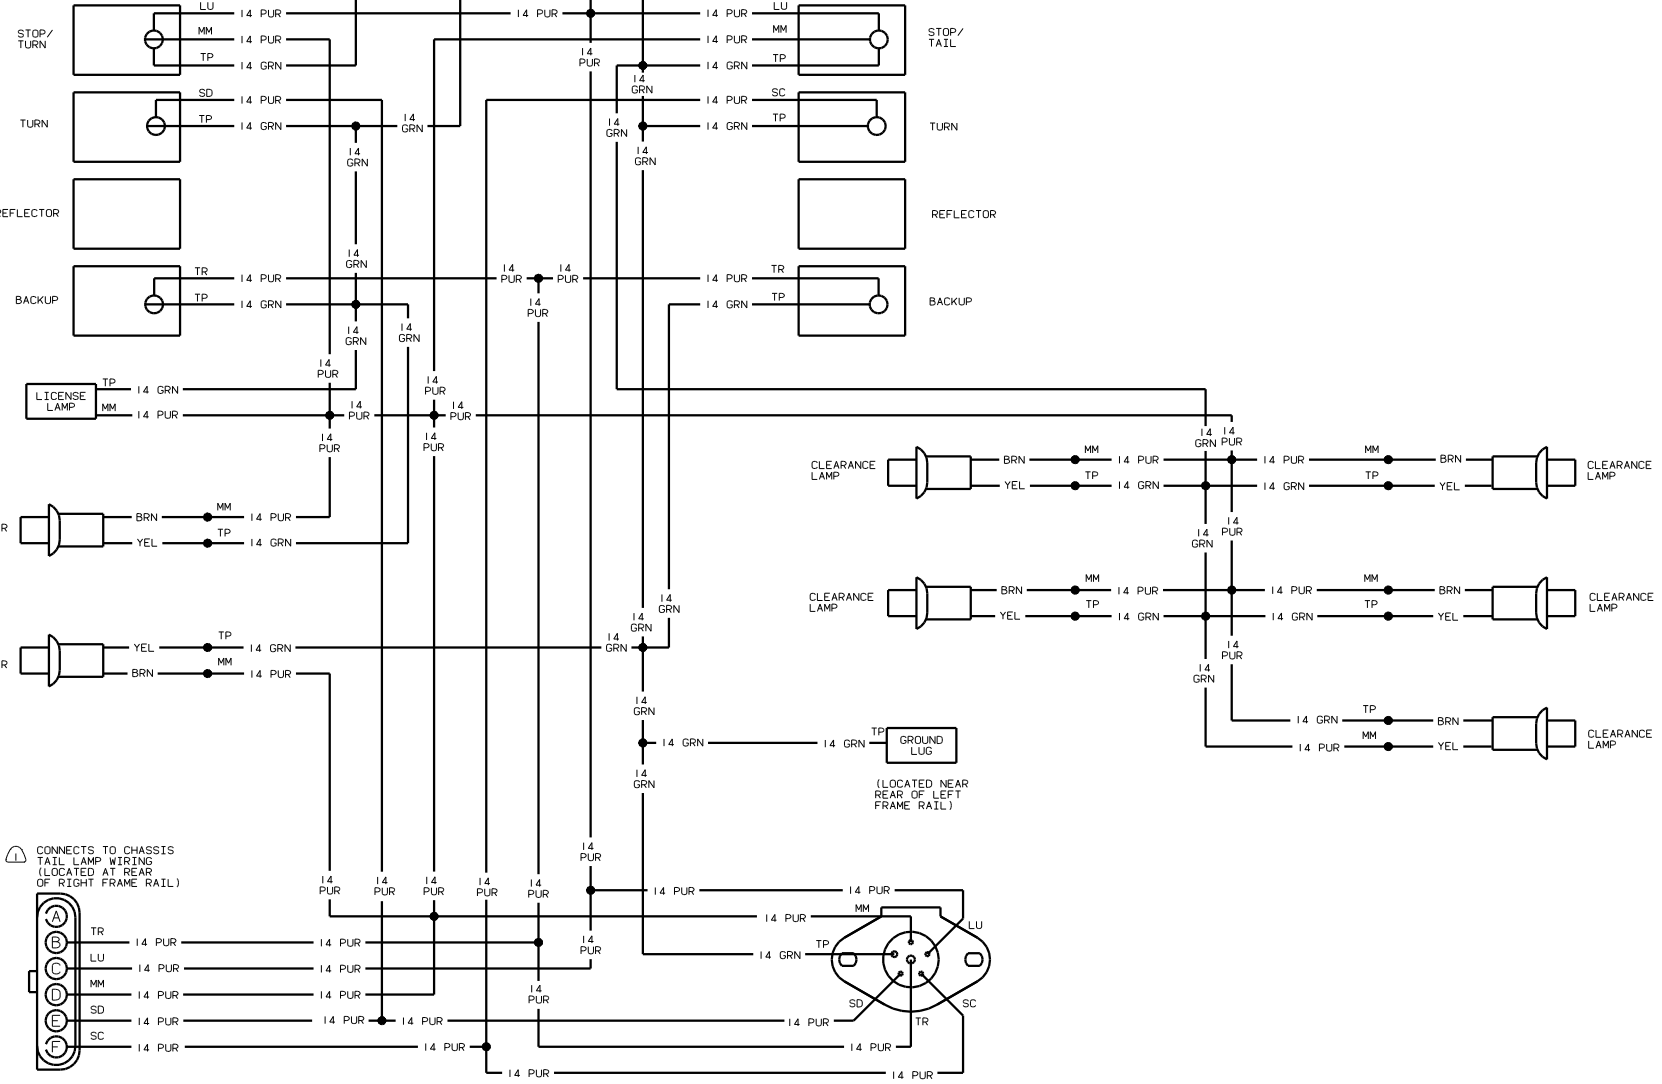
CENTER BRAKE LAMP

LEFT TAILLAMPS

RIGHT TAILLAMPS

CONNECTS TO CHASSIS TAIL LAMP WIRING (LOCATED AT REAR OF RIGHT FRAME RAIL)

(LOCATED NEAR REAR OF LEFT FRAME RAIL)
