98 Q37WP
265 CODE STANDARDS-CSA
78J ELECTRICAL SYS-50 AMP

TITLE: WIRING DIAGRAM-BODY 110V	
NO. OF SHEETS: 2	SHEET NO. 2 OF 2
DATE: 1.6	REV: 1.6
127116

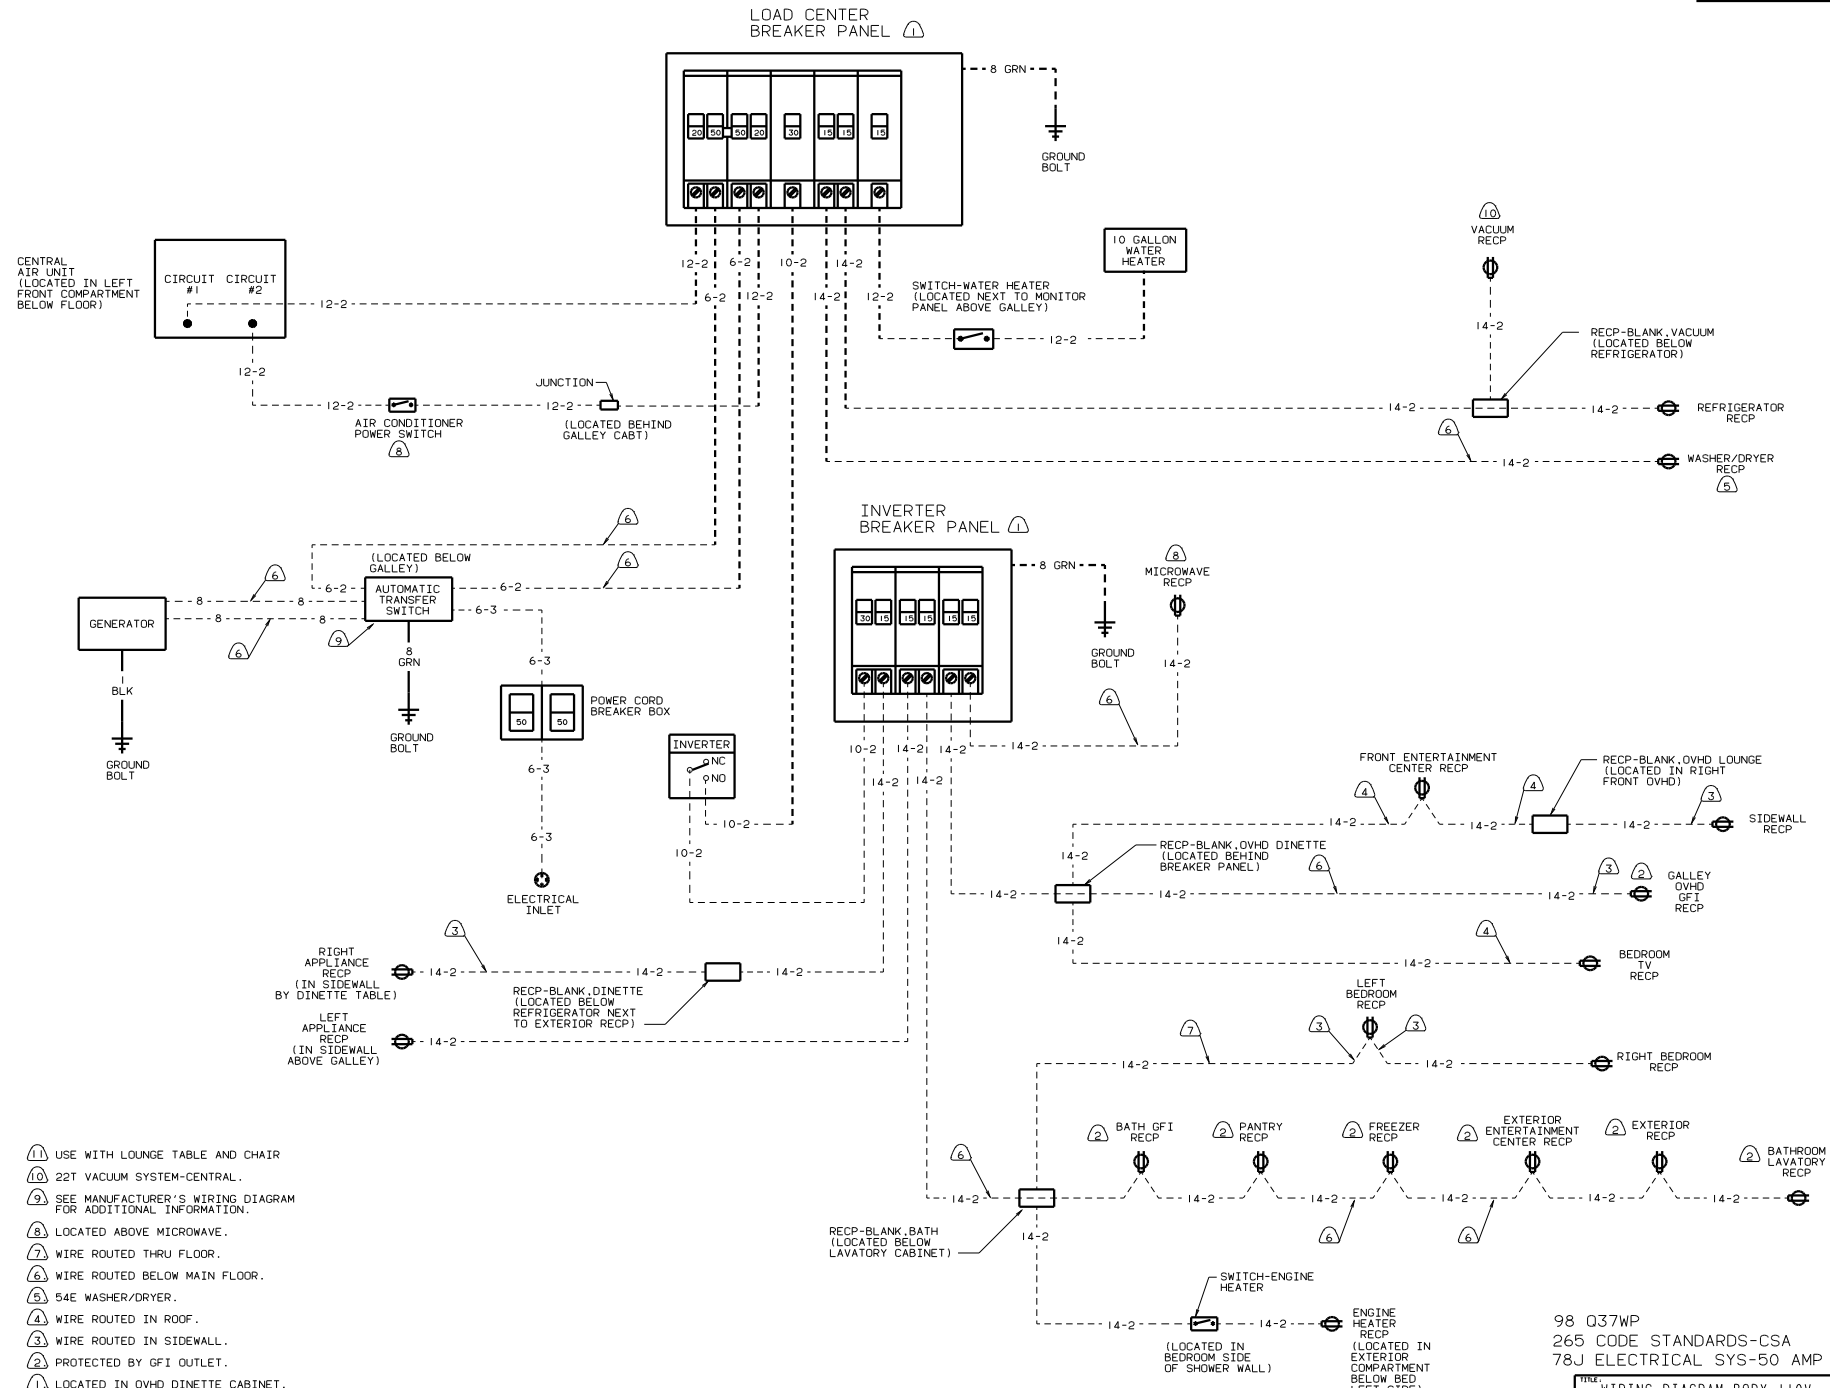
- ① USE WITH LOUNGE TABLE AND CHAIR
- ⑩ 22T VACUUM SYSTEM-CENTRAL.
- ⑨ SEE MANUFACTURER'S WIRING DIAGRAM FOR ADDITIONAL INFORMATION.
- ⑧ LOCATED ABOVE MICROWAVE.
- ⑦ WIRE ROUTED THRU FLOOR.
- ⑥ WIRE ROUTED BELOW MAIN FLOOR.
- ⑤ 54E WASHER/DRYER.
- ④ WIRE ROUTED IN ROOF.
- ③ WIRE ROUTED IN SIDEWALL.
- ② PROTECTED BY GFI OUTLET.
- ① LOCATED IN OVHD DINETTE CABINET.
