WINNEBAGO O1 F31B

WIRING DIAGRAM-BODY 110V

REF: 131920-A 1

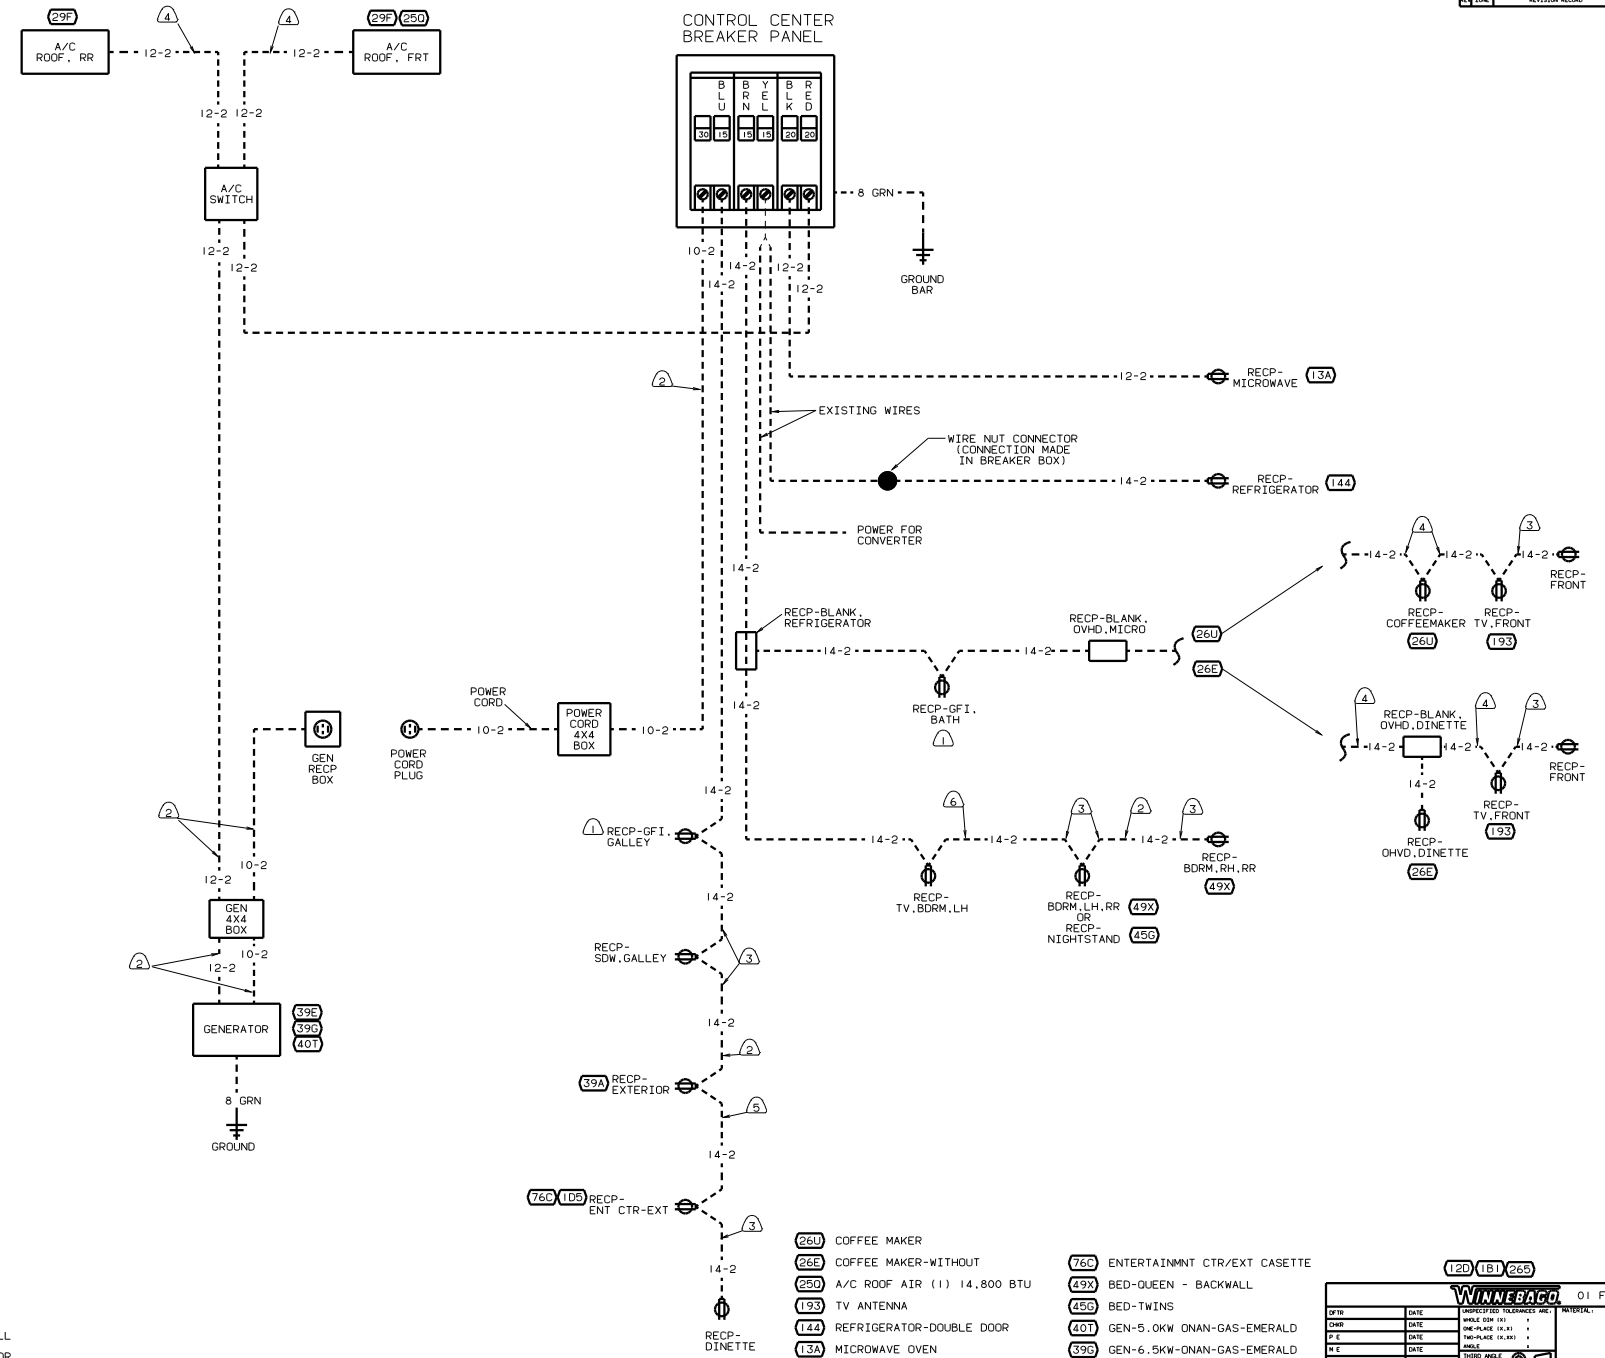
- NOTES:
- (3) WIRE IN FLOOR
 - (4) WIRE IN ROOF
 - (3) WIRE IN SIDEWALL
 - (2) WIRE BELOW FLOOR
 - (1) ALL RECEPTACLES DOWNSTREAM PROTECTED BY GFCI.
