WINNEBAGO 01 F26P

WIRING DIAGRAM-BODY 110V
 REF: 132104-A 135047

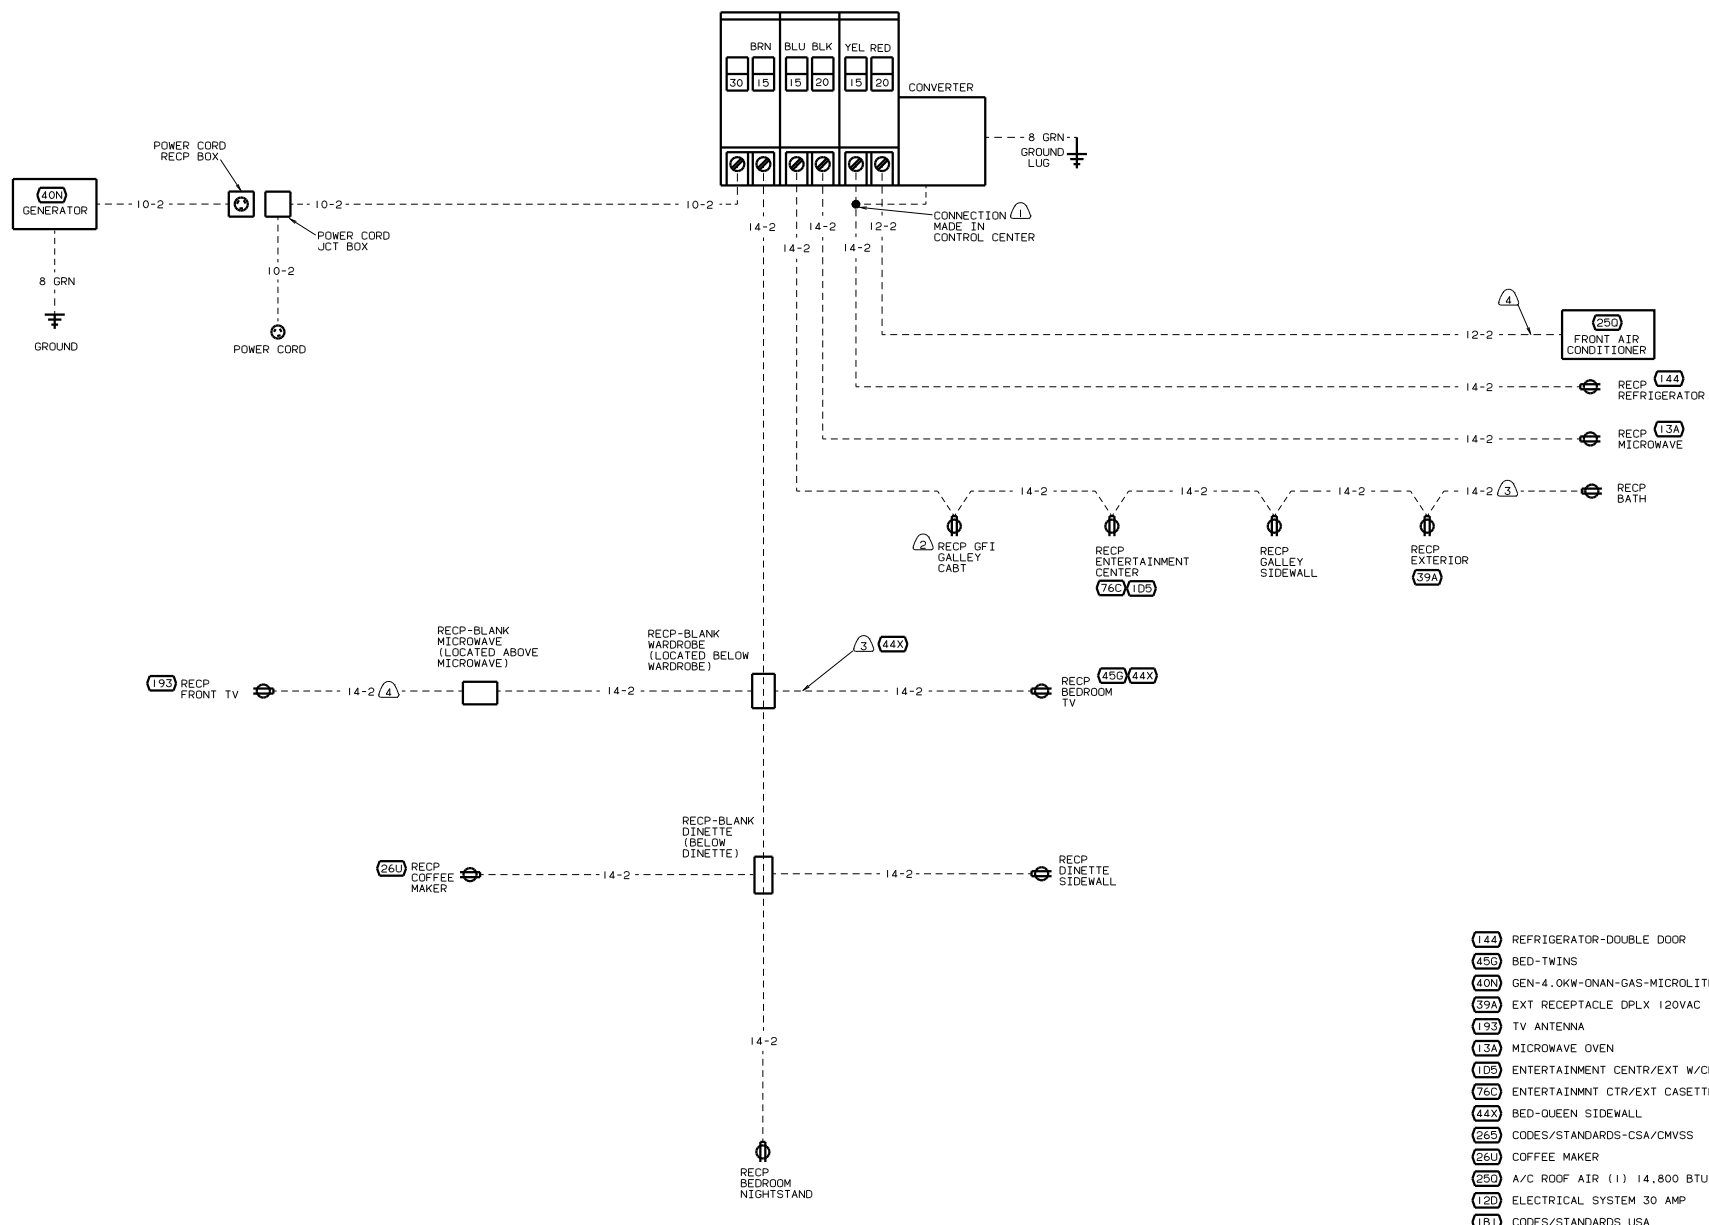
- ④ WIRE ROUTED IN ROOF.
- ③ WIRE ROUTED IN SIDEWALL.
- ② ALL OUTLETS DOWN STREAM AND INCLUDING THIS OUTLET ARE GROUND FAULT INTERRUPT PROTECTED.
- ① LEAD SUPPLIED WITH CONVERTER.
