- (21K) DINING/COMPUTER TABLE/CHAIRS
- (78J) ELECTRICAL SYSTEM - 50 AMP
- (285) CODES/STANDARDS - CSA/CMVSS
- (21N) DISHWASHER/BUILT-IN
- (1B1) CODES/STANDARDS - USA

QTR	ORIG. DATE	09/14/01
DWR	ALL DIMENSIONS ARE IN MILLIMETERS	
P.E.		
V.E.	FIRST USED	
DWR	02 Q40E	
UNSPECIFIED TOLERANCES ARE:		
HOLE DIA. (X) .01		
ONE-PLACE (X) .01		
TWO-PLACE (X) .005		
HOLE .005		
THIRD ANGLE PROJECTION		
DO NOT SCALE DRAWING		
TITLE: WIRING DIAGRAM-BODY, 110V		
SHEET	of	PART NO. 14205

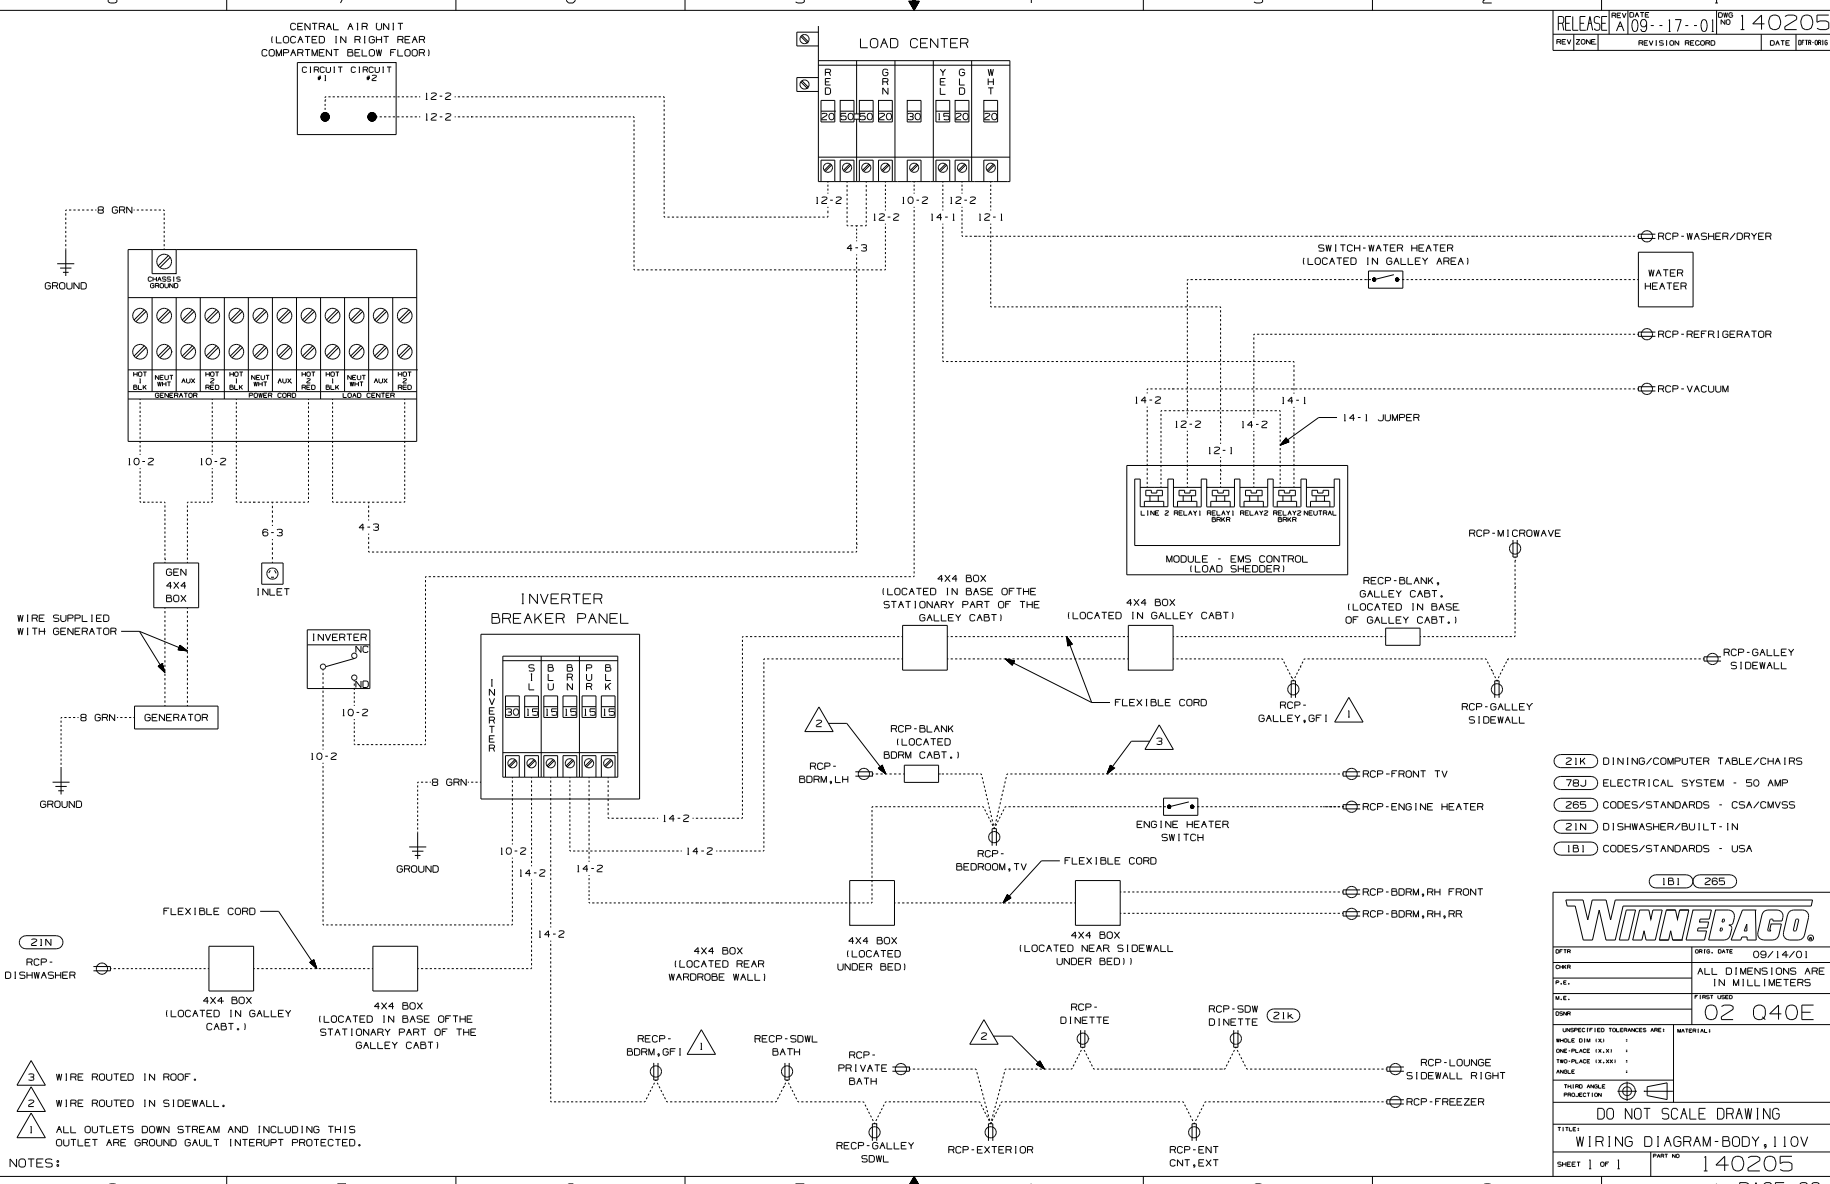
CENTRAL AIR UNIT
 (LOCATED IN RIGHT REAR
 COMPARTMENT BELOW FLOOR)

LOAD CENTER

NOTES:
 3 WIRE ROUTED IN ROOF.
 2 WIRE ROUTED IN SIDEWALL.
 1 ALL OUTLETS DOWN STREAM AND INCLUDING THIS OUTLET ARE GROUND GAULT INTERRUPT PROTECTED.
