TITLE: WIRING DIAGRAM-BODY, 110V  
 SHEET 1 of 1 PART NO 139930

DATE: 05/29/01  
 FIRST USED: 02 Q40WD

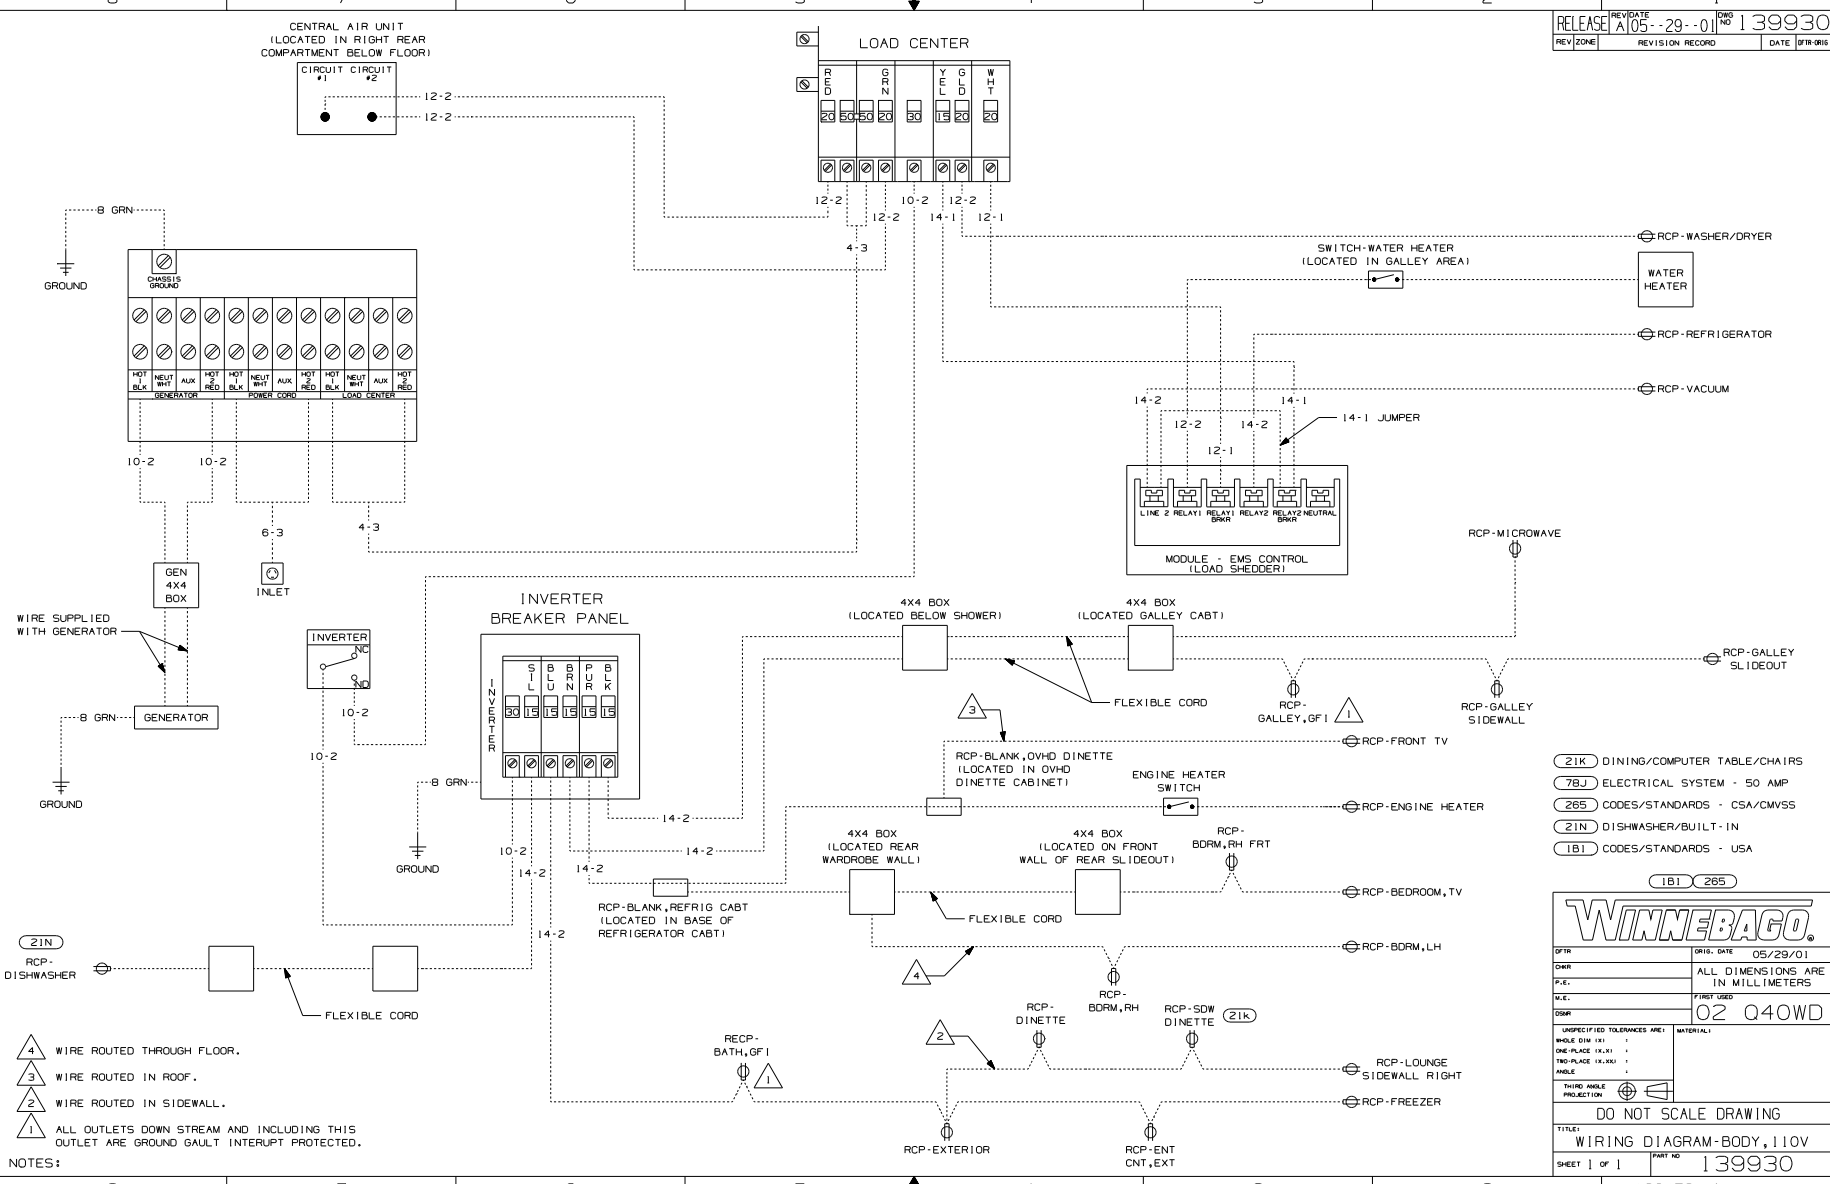
CENTRAL AIR UNIT  
 (LOCATED IN RIGHT REAR  
 COMPARTMENT BELOW FLOOR)

LOAD CENTER

INVERTER BREAKER PANEL

- NOTES:
- 4 WIRE ROUTED THROUGH FLOOR.
  - 3 WIRE ROUTED IN ROOF.
  - 2 WIRE ROUTED IN SIDEWALL.
  - 1 ALL OUTLETS DOWN STREAM AND INCLUDING THIS OUTLET ARE GROUND GAULT INTERRUPT PROTECTED.
