WINNEBAGO		COPYRIGHT 2004 WINNEBAGO INDUSTRIES, INC.	
DFTR	ORIG. DATE	ALL DIMENSIONS ARE IN MILLIMETERS	
CHKR		FIRST USED	
P.E.		93 MOTORHAMES	
M.E.			
DSNR			
UNSPECIFIED TOLERANCES ARE:		MATERIAL:	
WHOLE DIM (X)	:		
ONE-PLACE (X.X)	:		
TWO-PLACE (X.XX)	:		
ANGLE	:		
THIRD ANGLE PROJECTION	⊕		
DO NOT SCALE DRAWING			
TITLE: WIRING DIAGRAM-TV COAX			
SHEET 1 OF 2	PART NO	110138	
REF:	1 07/08/2004

FIRST USED	93 MOTORHAMES
TITLE	DO NOT SCALE DRAWING
TITLE	WIRING DIAGRAM-TV COAX
SHEET 2	PART NO 110138

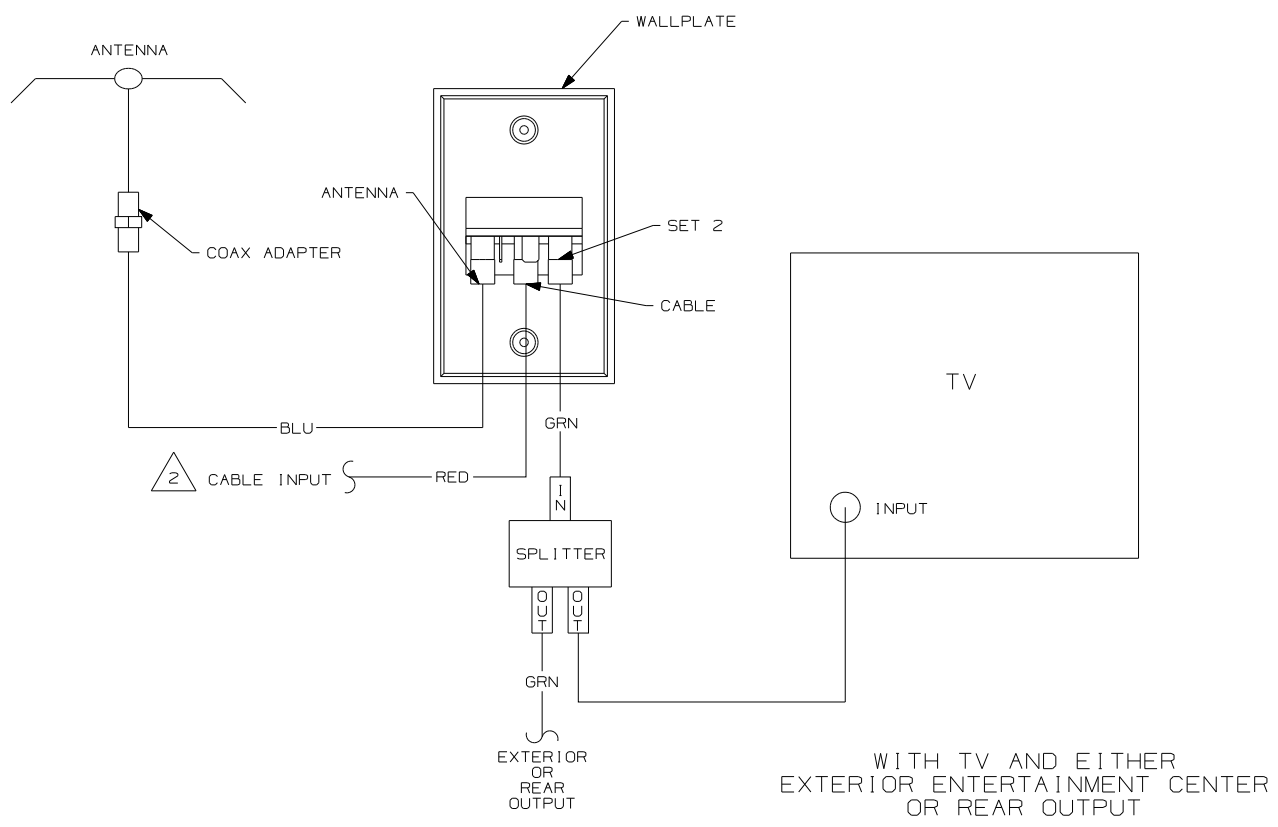
WITH TV AND EITHER EXTERIOR ENTERTAINMENT CENTER OR REAR OUTPUT

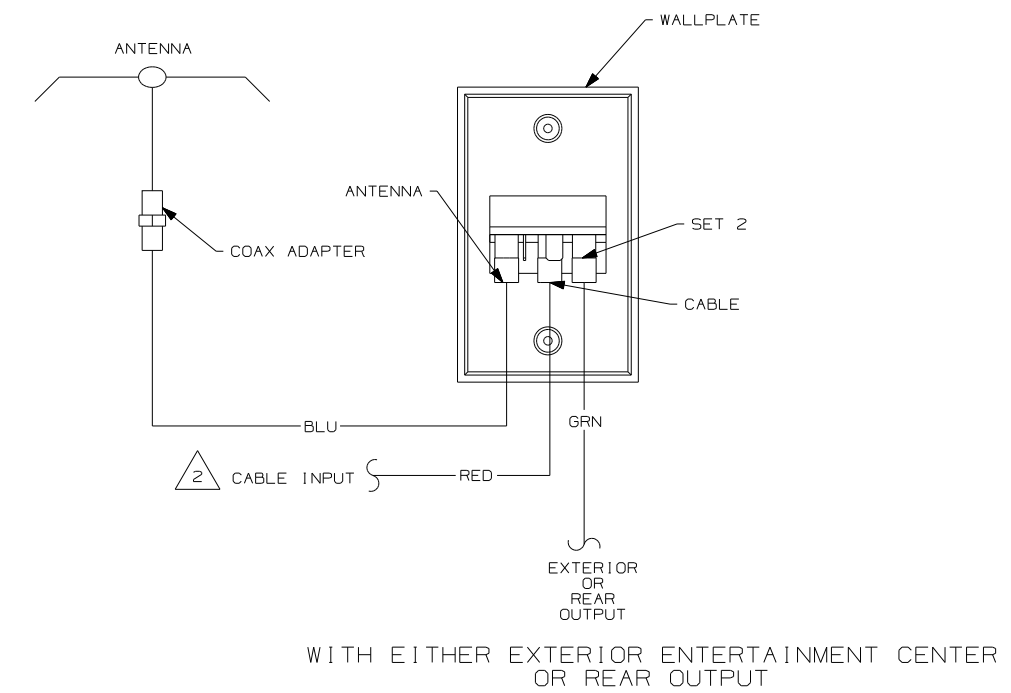
WITH EITHER EXTERIOR ENTERTAINMENT CENTER OR REAR OUTPUT

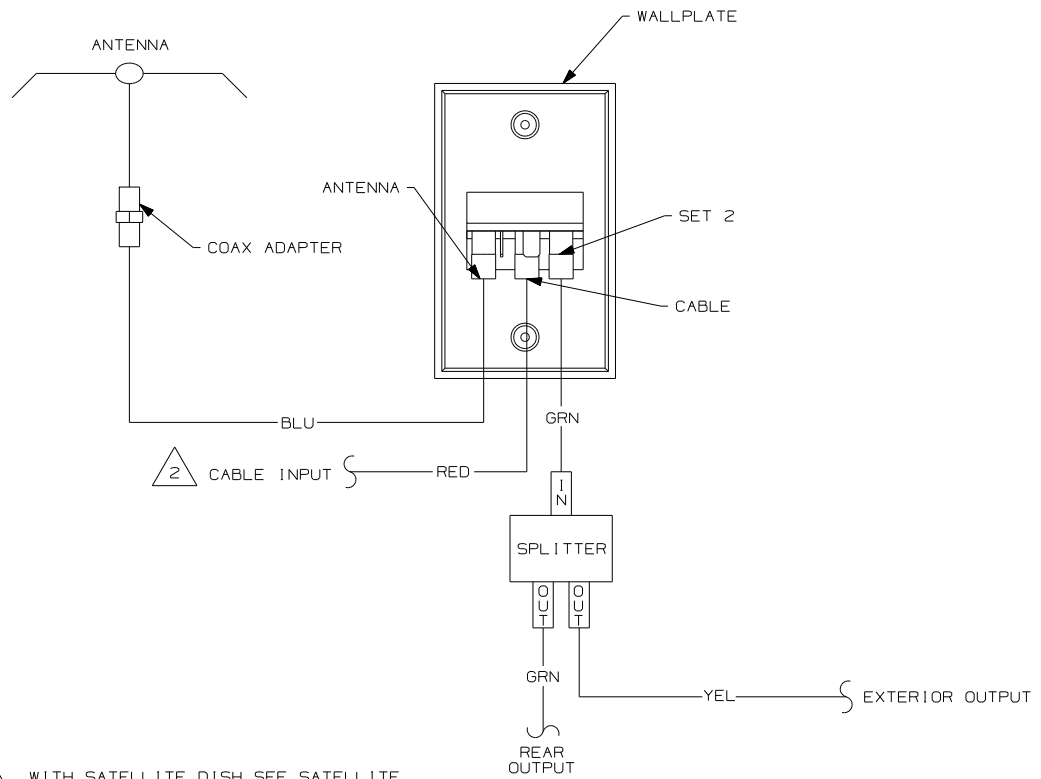
WITH EXTERIOR ENTERTAINMENT CENTER AND REAR OUTPUT

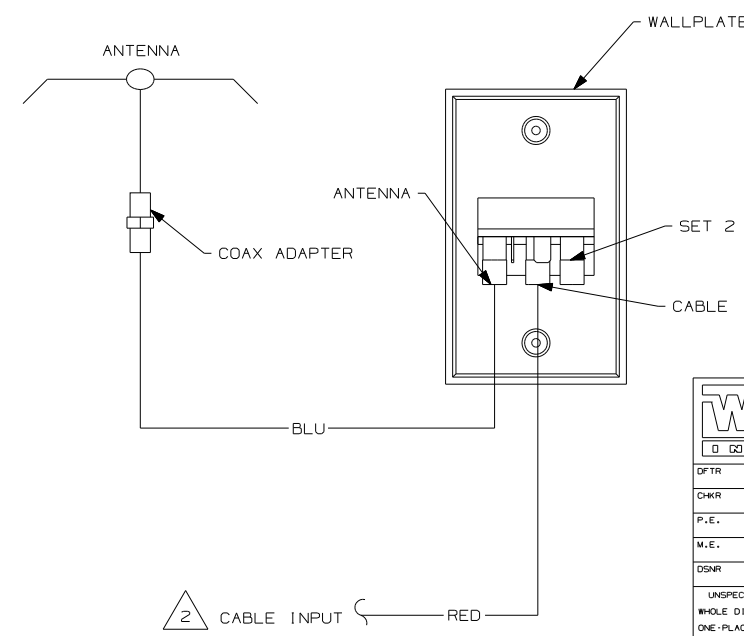
WITHOUT EITHER EXTERIOR ENTERTAINMENT CENTER OR REAR OUTPUT

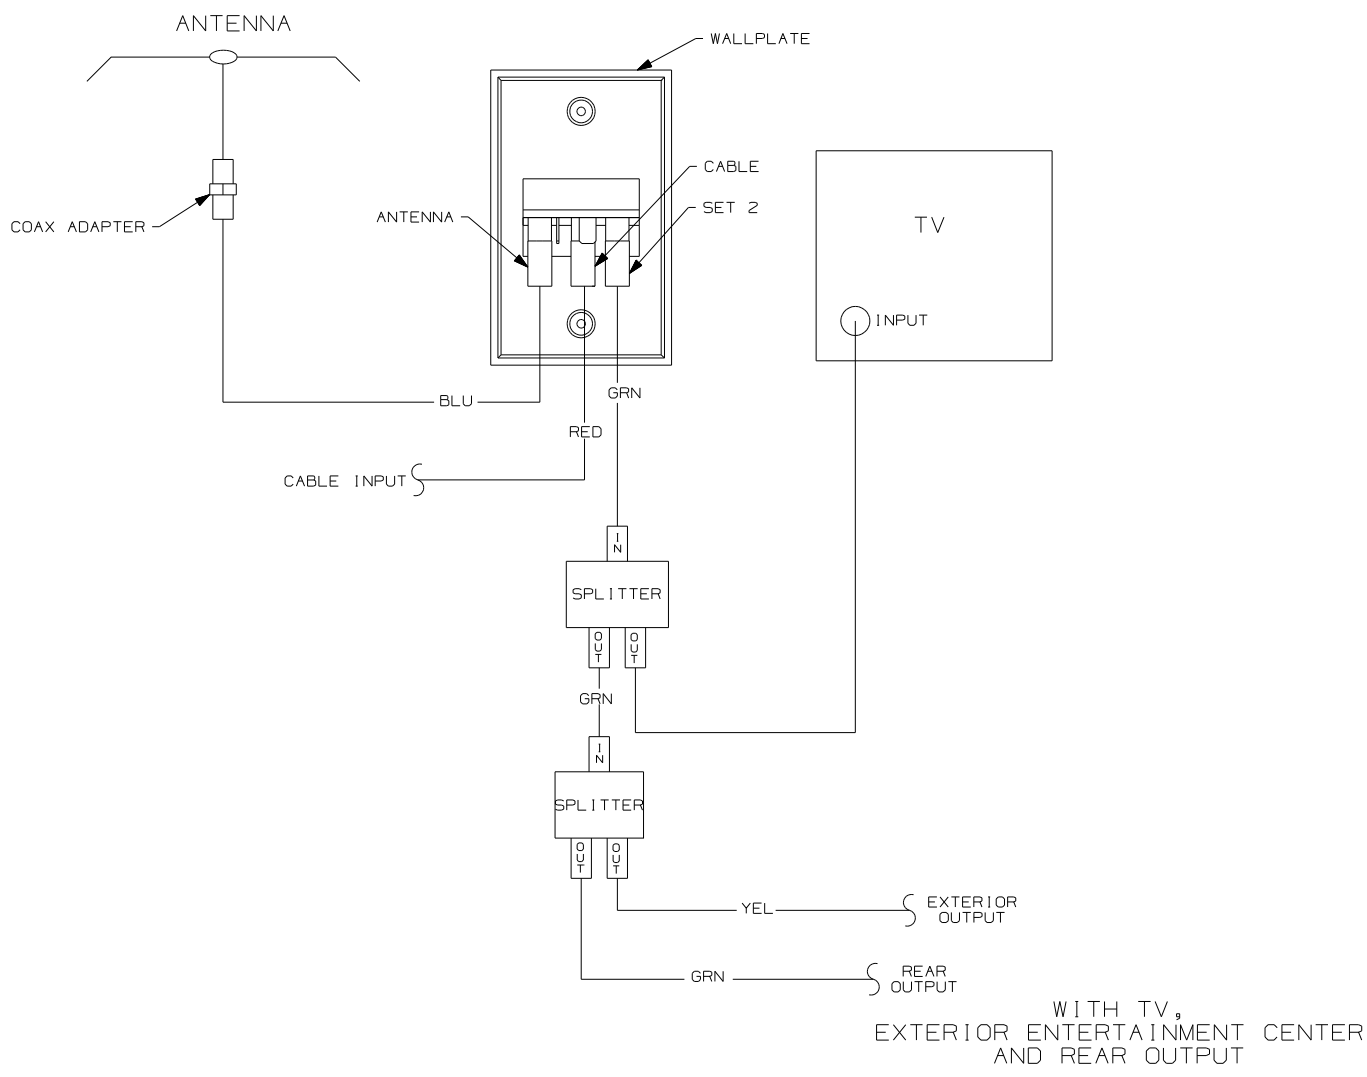
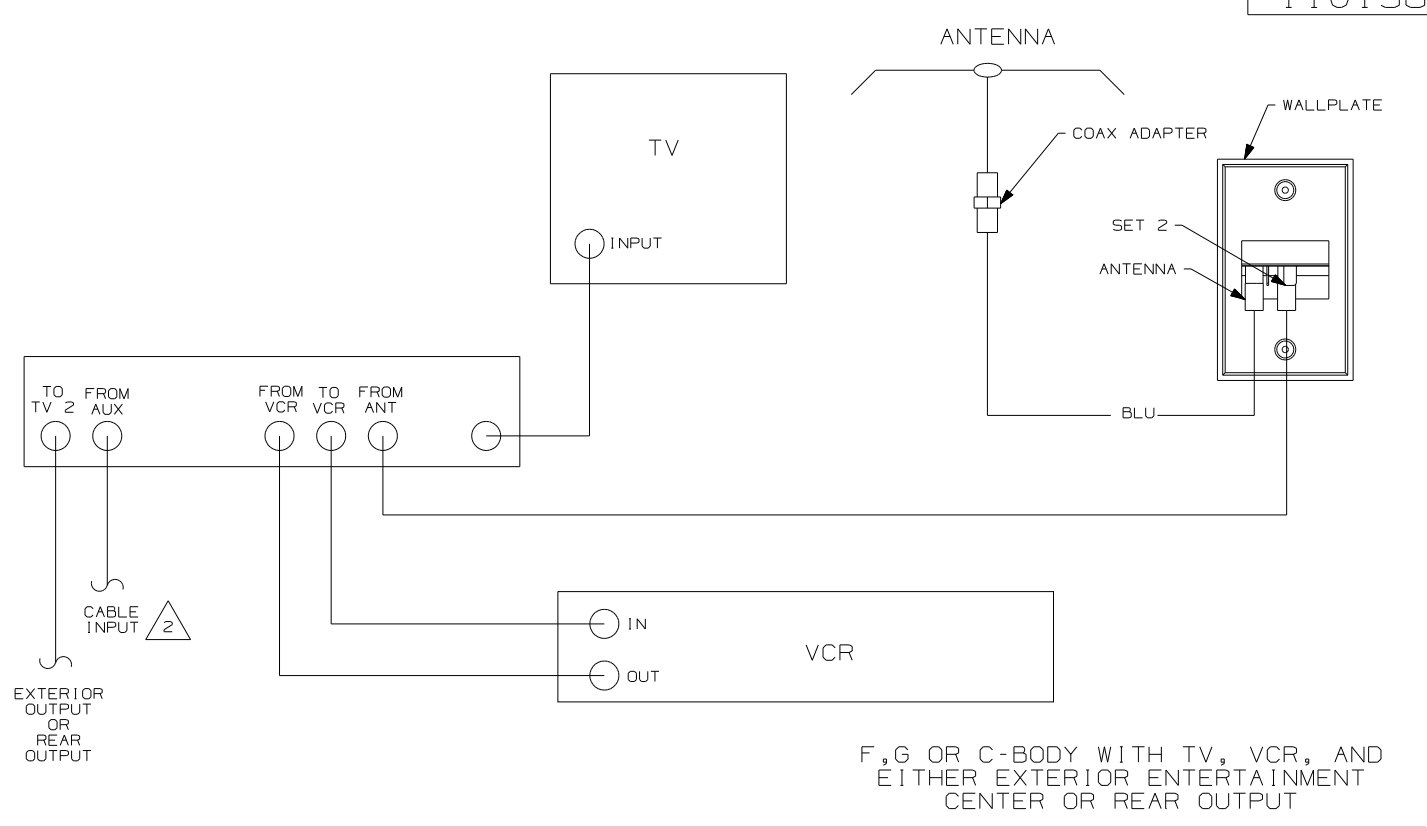
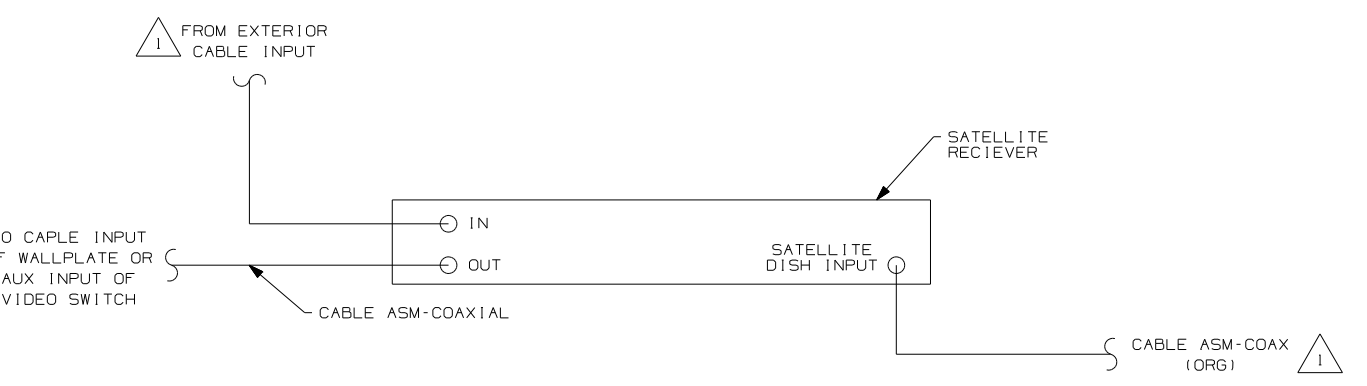
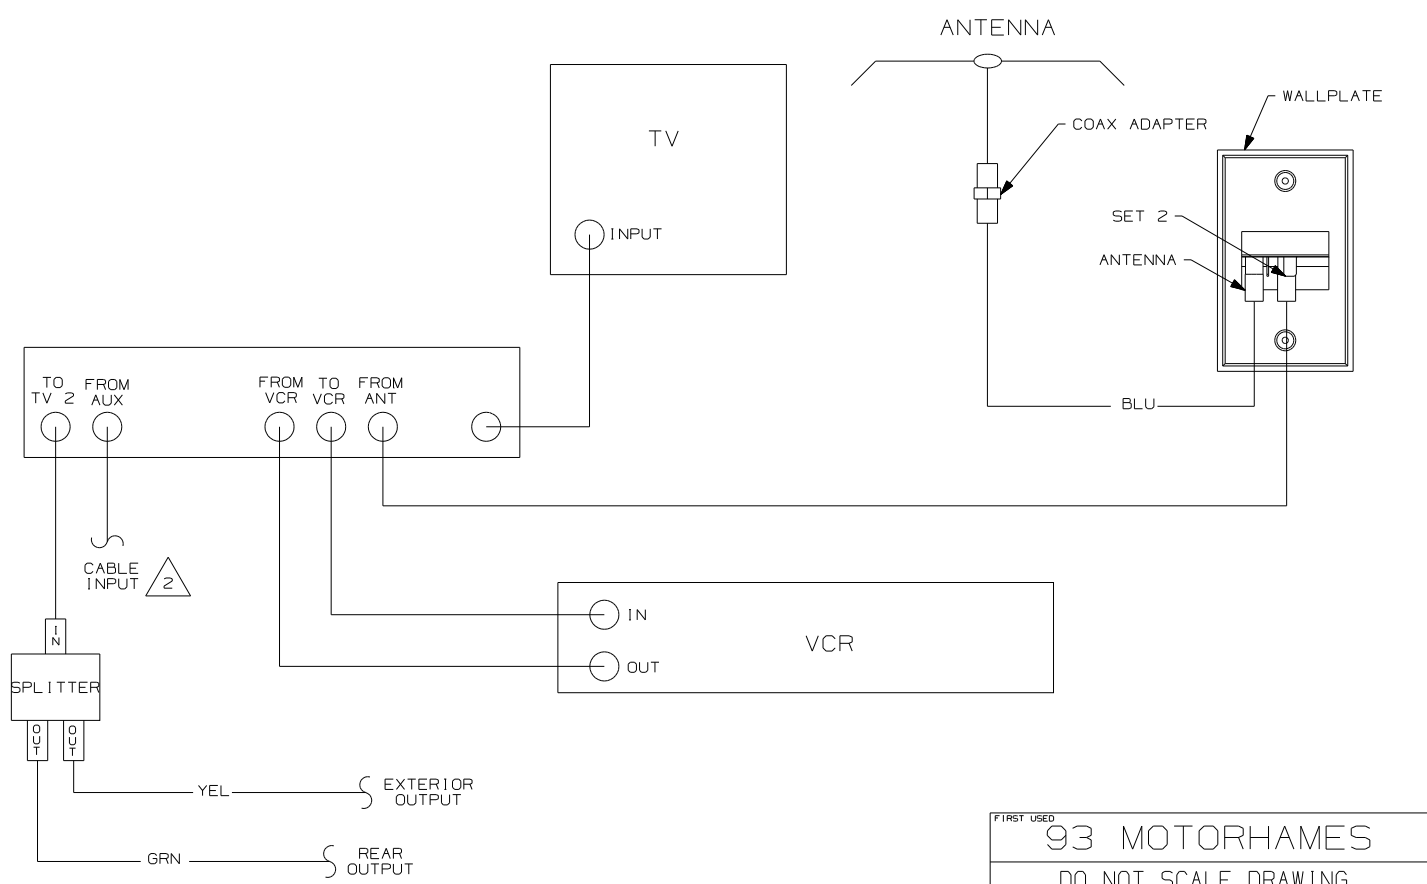
- NOTES:
- 2 WITH SATELLITE DISH SEE SATELLITE DISH VIEW BOTTOM LEFT.
 - 1 CONNECT TV COAX TO JACK ON FRONT OF WALLPLATE.
