- (11C) BREAKFAST BAR
- (265) CODES/STANDARDS - CSA/CMVSS
- (1B1) CODES/STANDARDS - USA

DO NOT SCALE DRAWING	
TITLE: WIRING DIAGRAM-BODY, 110V	
SHEET 1 OF 1	PART NO 159717 REV
REF:	1 2/5/2007

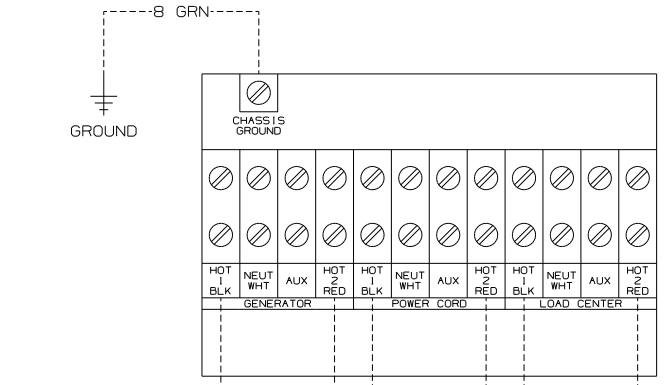
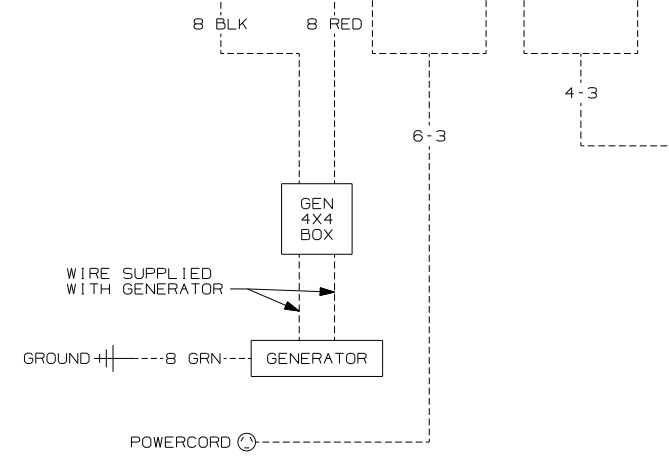
LOAD CENTER

CENTRAL AIR UNIT (LOCATED IN RIGHT REAR COMPARTMENT BELOW FLOOR)

INVERTER BREAKER PANEL
