<b>WINNEBAGO</b>		COPYRIGHT 2006 WINNEBAGO INDUSTRIES, INC.	
DFTR	ORIG. DATE		
CHKR	ALL DIMENSIONS ARE IN MILLIMETERS		
P.E.	FIRST USED	08 R40WD	
M.E.			
DSNR			
UNSPECIFIED TOLERANCES ARE:		MATERIAL:	
WHOLE DIM (X)	:		
ONE-PLACE (X.X)	:		
TWO-PLACE (X.XX)	:		
ANGLE	:		
THIRD ANGLE PROJECTION			
DO NOT SCALE DRAWING			
TITLE: WIRING DIAGRAM-BODY, 110V			
SHEET 1 of 1	PART NO	164479	REV
REF:	1 8/15/2007

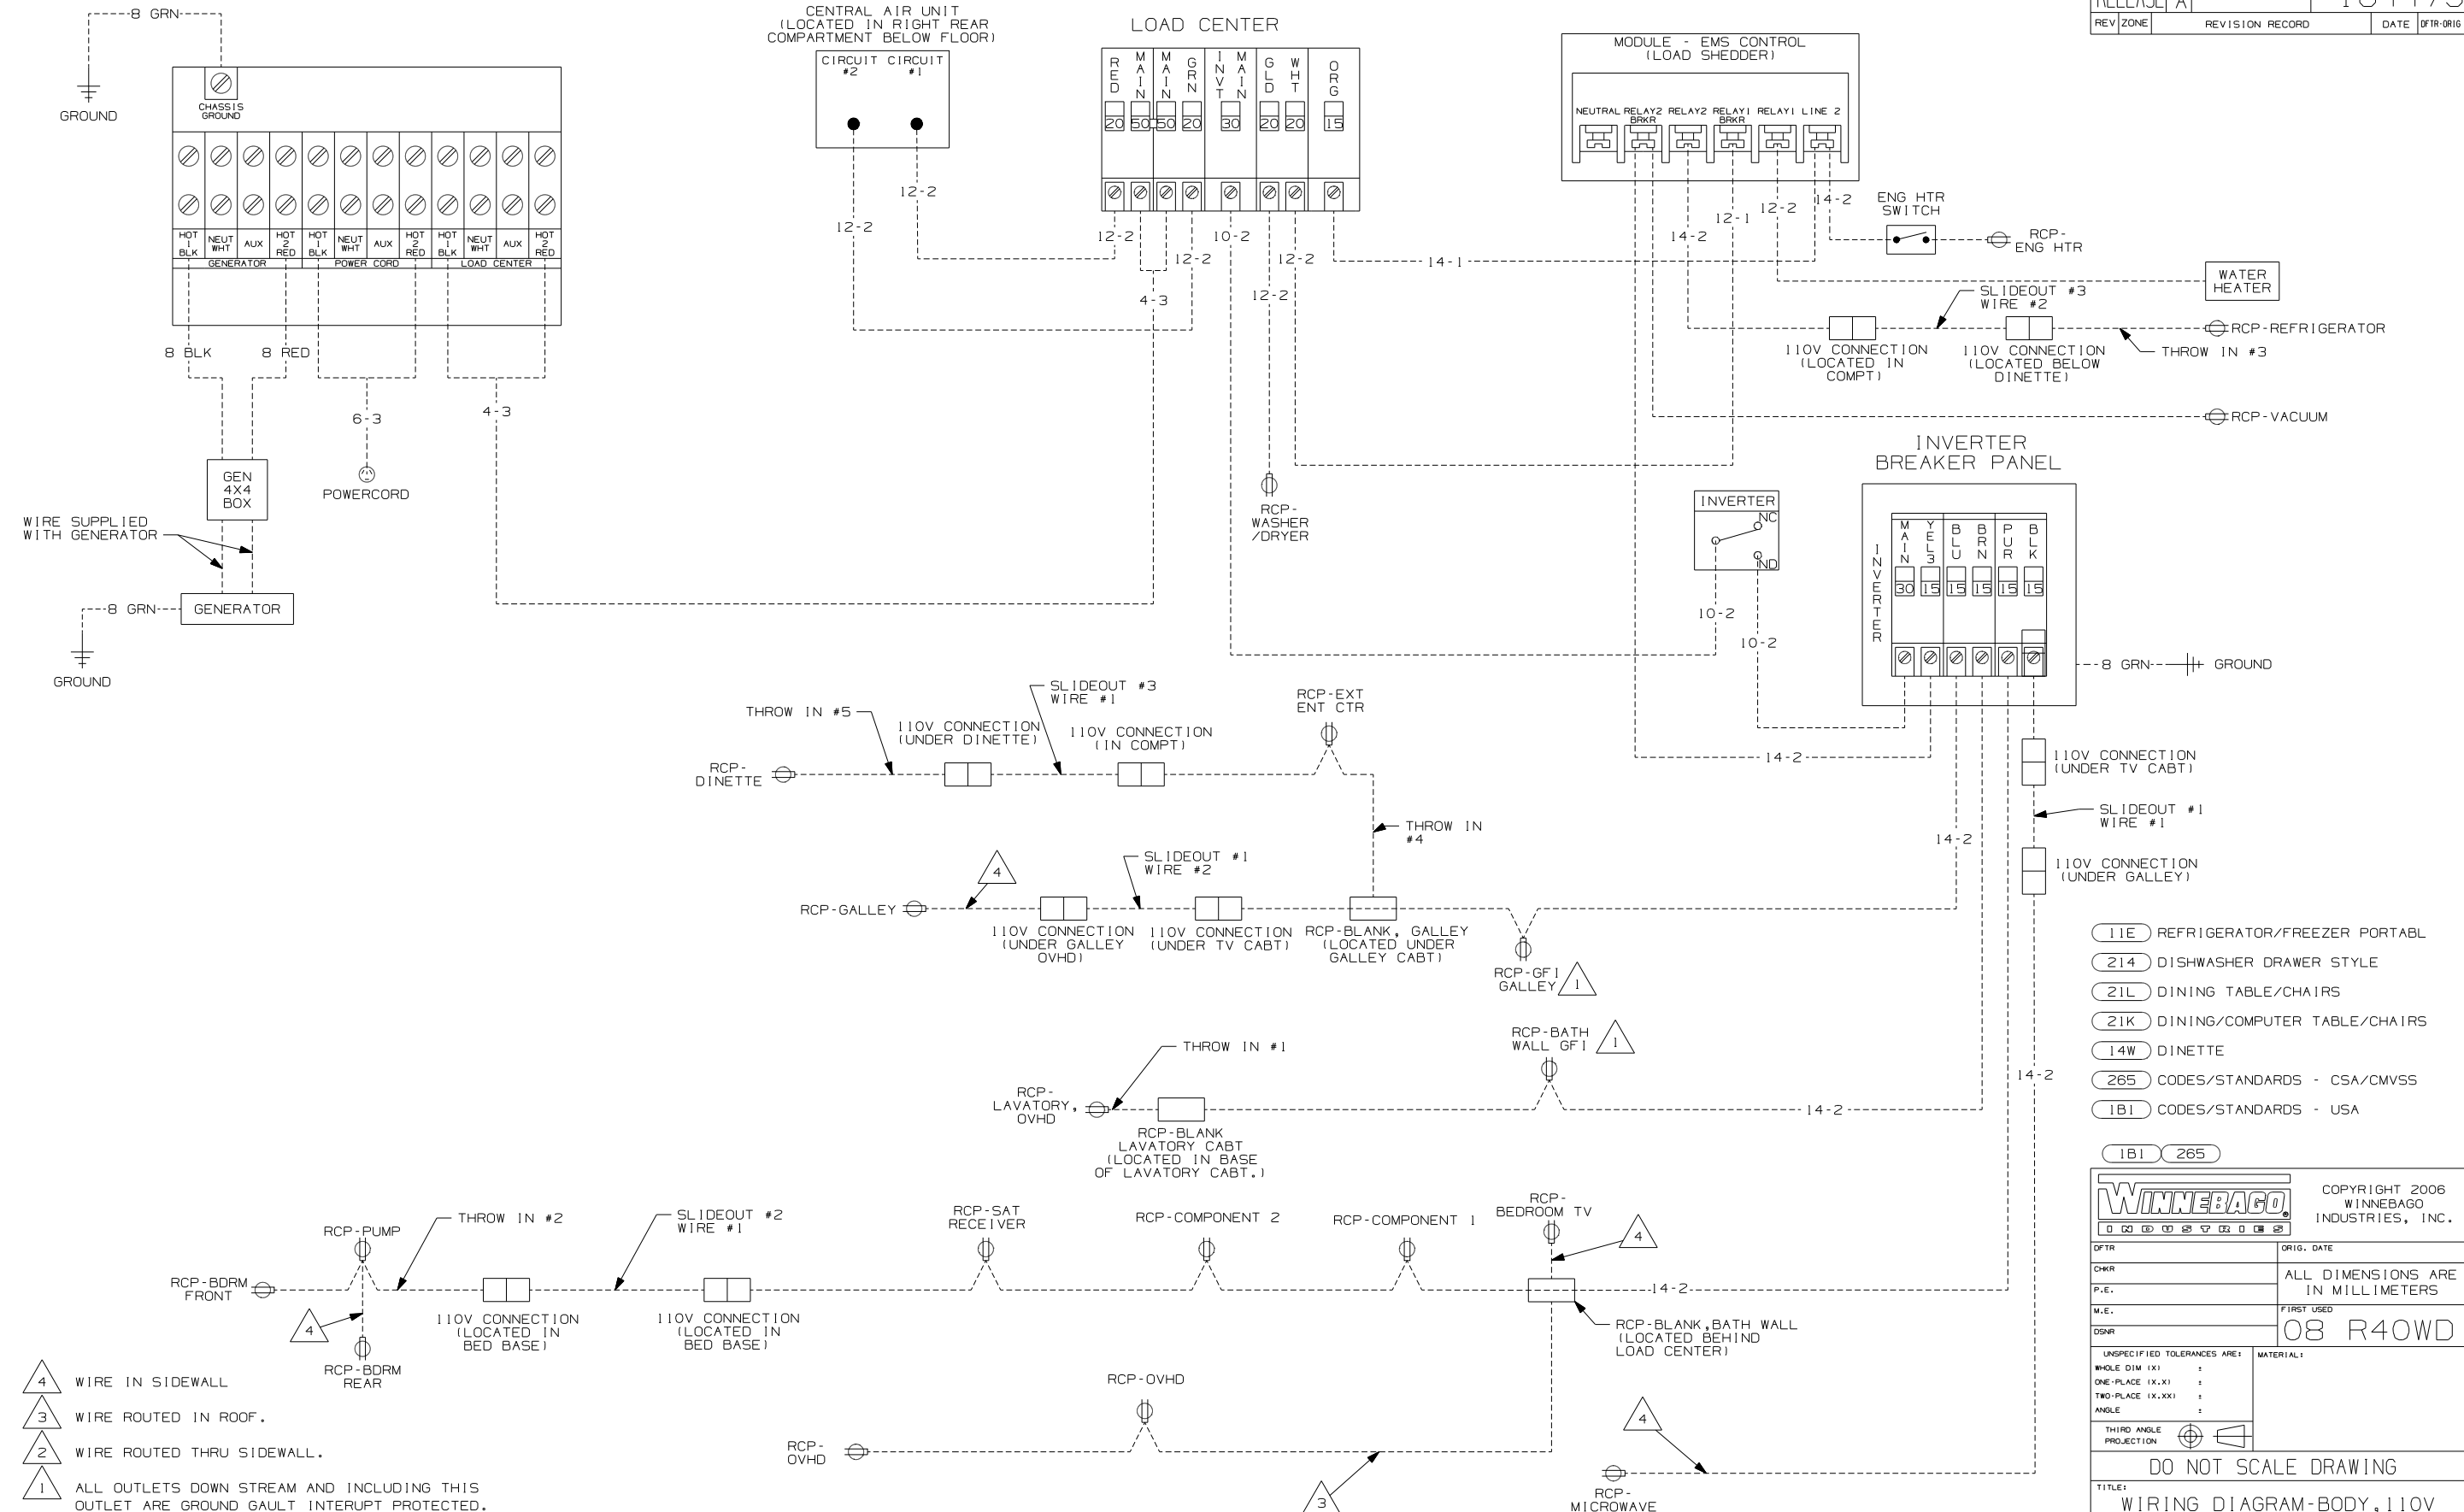
- NOTES:
- 4 WIRE IN SIDEWALL
  - 3 WIRE ROUTED IN ROOF.
  - 2 WIRE ROUTED THRU SIDEWALL.
  - 1 ALL OUTLETS DOWN STREAM AND INCLUDING THIS OUTLET ARE GROUND GAULT INTERRUPT PROTECTED.
