<b>WINNEBAGO</b>		COPYRIGHT 2009 WINNEBAGO INDUSTRIES, INC.	
DTR	ORIG. DATE	ALL DIMENSIONS ARE IN MILLIMETERS	
CHKR		FIRST USED <b>10 730C</b>	
P.E.		UNSPECIFIED TOLERANCES ARE:	
M.E.		MATERIAL:	
DSNR		WHOLE DIM (X) :	
		ONE-PLACE (X.X) :	
		TWO-PLACE (X.XX) :	
		ANGLE :	
		THIRD ANGLE PROJECTION	
<b>DO NOT SCALE DRAWING</b>			
TITLE: <b>WIRING DIAGRAM-BODY, 110V</b>			
SHEET 1 of 1	PART NO	172746	REV
REF:	1 2/5/2009

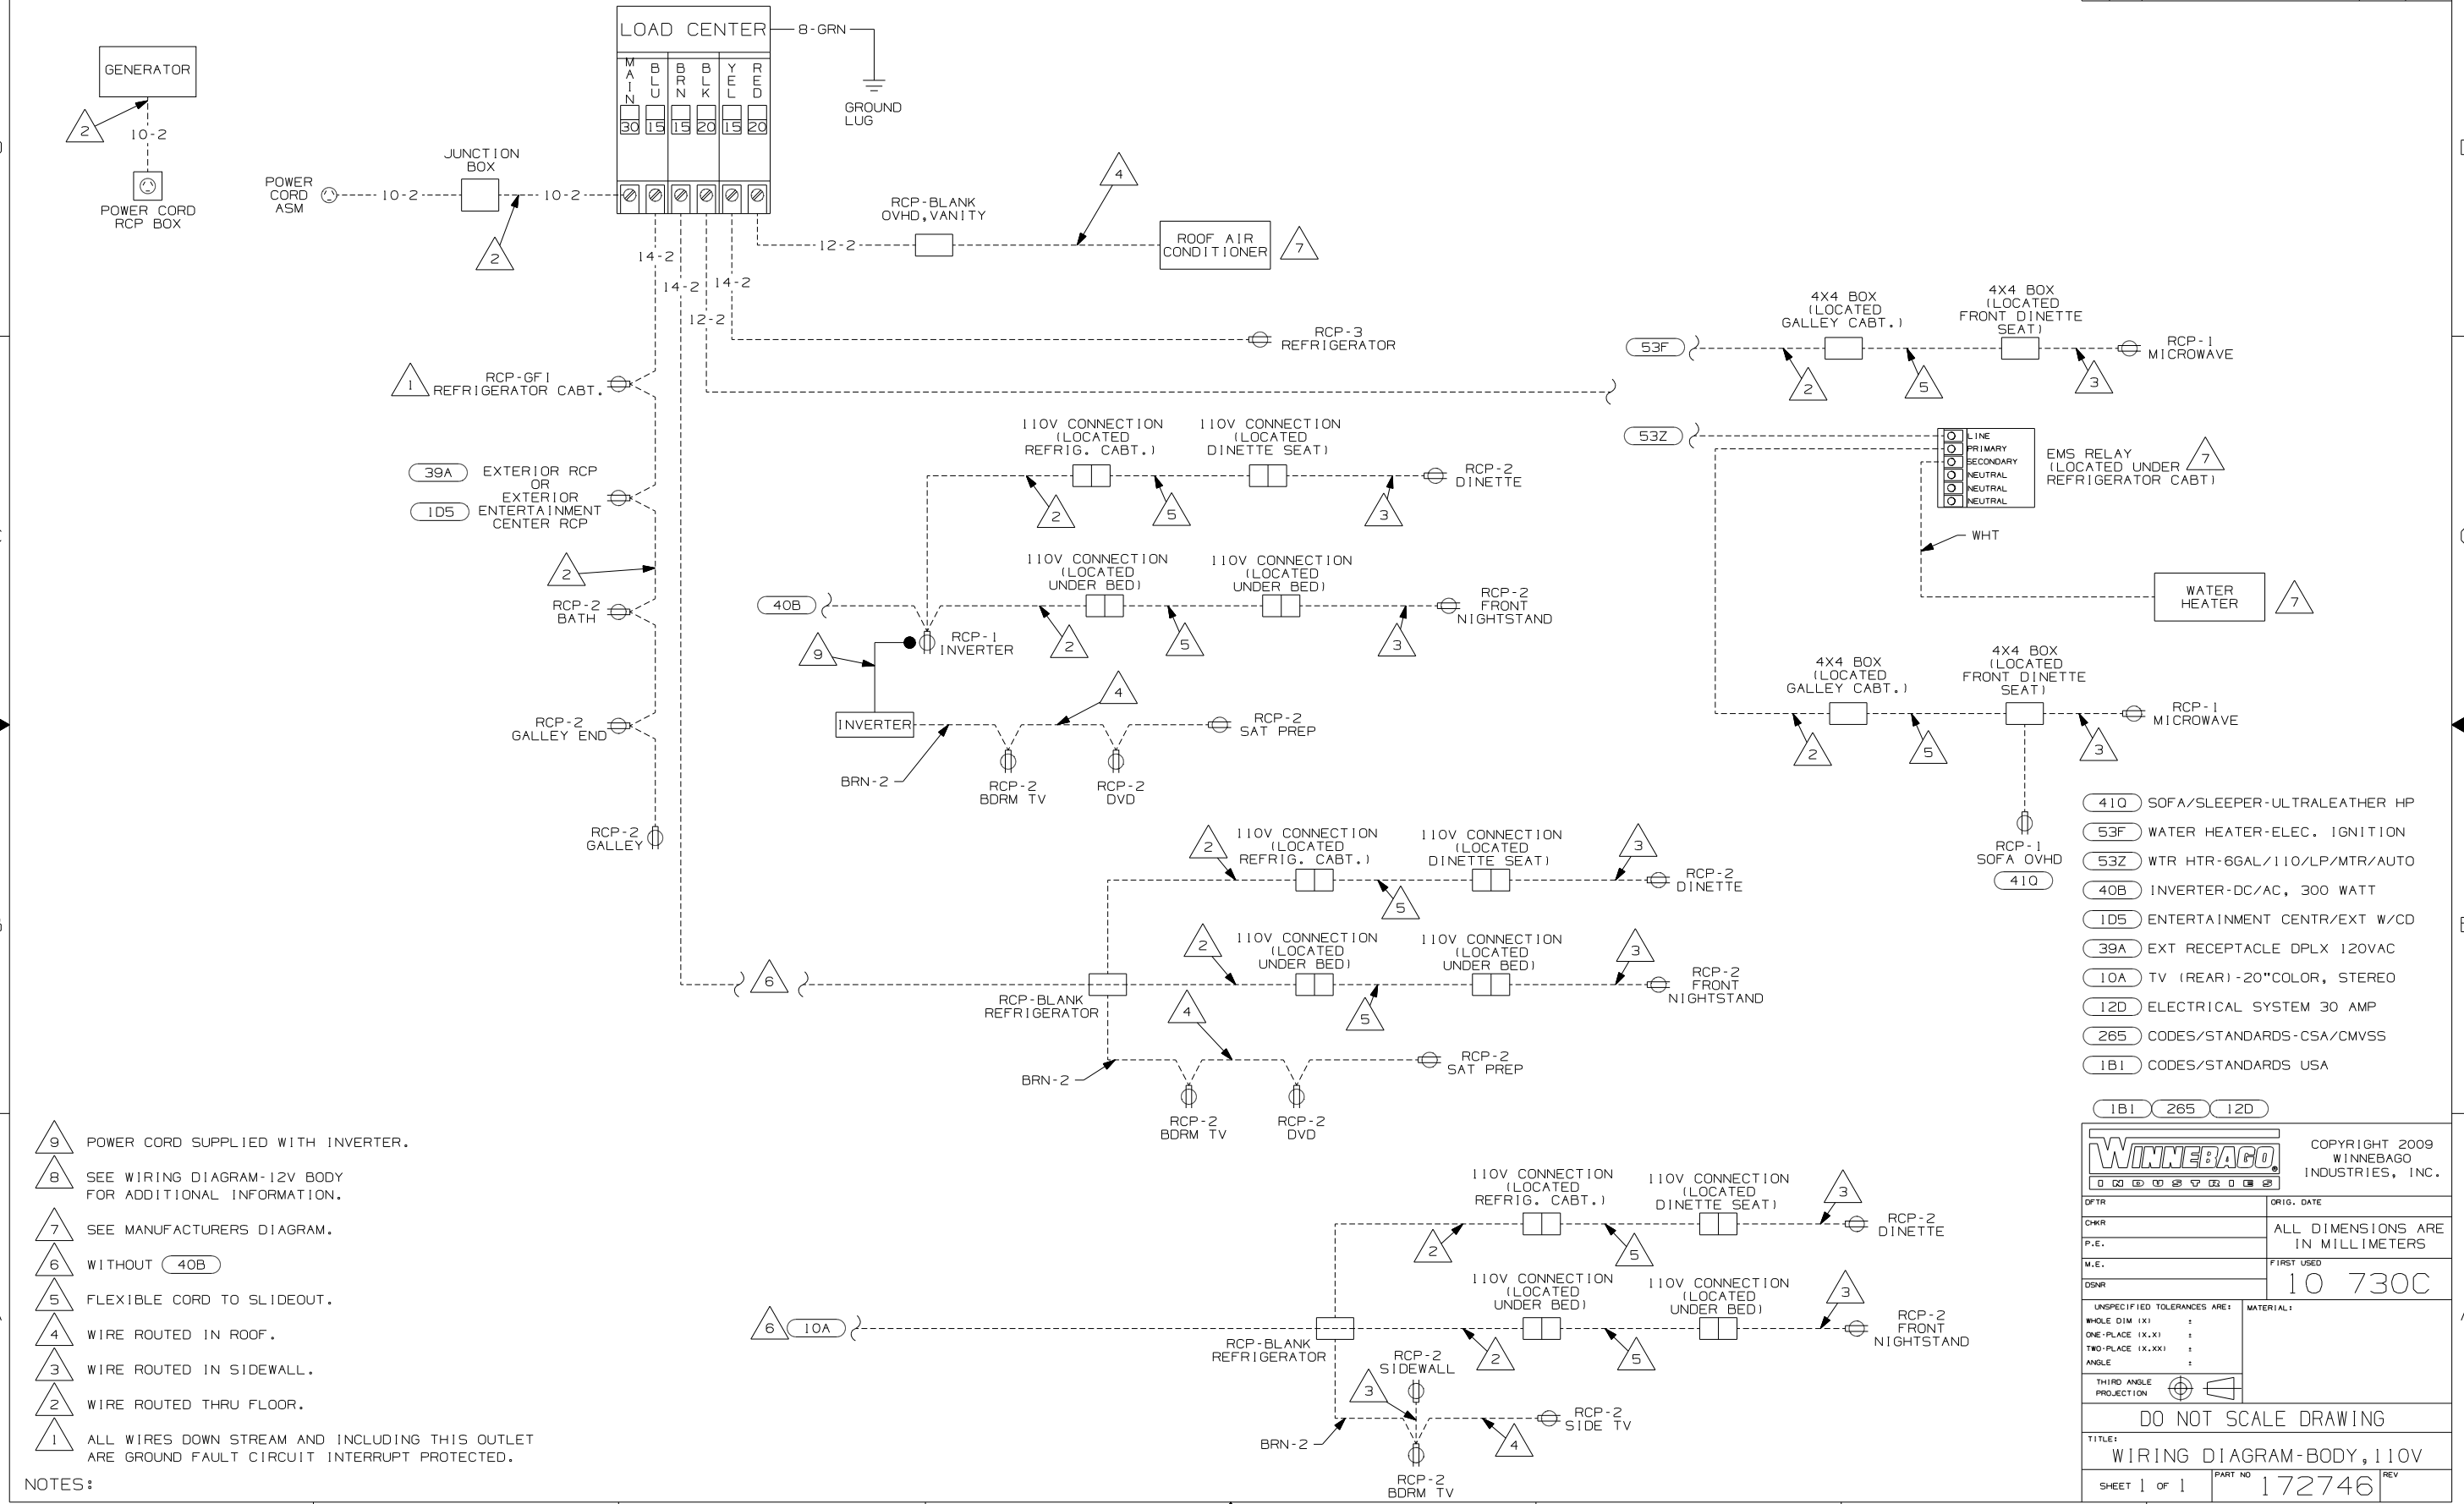
- NOTES:
- 9 POWER CORD SUPPLIED WITH INVERTER.
  - 8 SEE WIRING DIAGRAM-12V BODY FOR ADDITIONAL INFORMATION.
  - 7 SEE MANUFACTURERS DIAGRAM.
  - 6 WITHOUT (40B)
  - 5 FLEXIBLE CORD TO SLIDEOUT.
  - 4 WIRE ROUTED IN ROOF.
  - 3 WIRE ROUTED IN SIDEWALL.
  - 2 WIRE ROUTED THRU FLOOR.
  - 1 ALL WIRES DOWN STREAM AND INCLUDING THIS OUTLET ARE GROUND FAULT CIRCUIT INTERRUPT PROTECTED.

- 410 SOFA/SLEEPER-ULTRALEATHER HP
- 53F WATER HEATER-ELEC. IGNITION
- 53Z WTR HTR-6GAL/110/LP/MTR/AUTO
- 40B INVERTER-DC/AC, 300 WATT
- 1D5 ENTERTAINMENT CENTR/EXT W/CD
- 39A EXT RECEPTACLE DPLX 120VAC
- 10A TV (REAR)-20"COLOR, STEREO
- 12D ELECTRICAL SYSTEM 30 AMP
- 265 CODES/STANDARDS-CSA/CMVSS
- 1B1 CODES/STANDARDS USA
