WINNEBAGO		98 Q37W0
DATE	UNSPECIFIED TOLERANCES ARE:	MATERIAL
DATE	WHOLE OR 1/16"	
DATE	ONE-PLACE (1/32)"	
DATE	TWO-PLACE (1/64)"	
DATE	MILS	
DATE	THIRD ANGLE PROJECTION	
DATE		
LAYOUT		
TITLE		
WIRING DIAGRAM-BODY 110V		
SHEET	1 OF 2	127112

TITLE	WIRING DIAGRAM-BODY
NO. OF SHEETS	16
SHEET	2 OF 2
DATE	1.6
NO.	127112

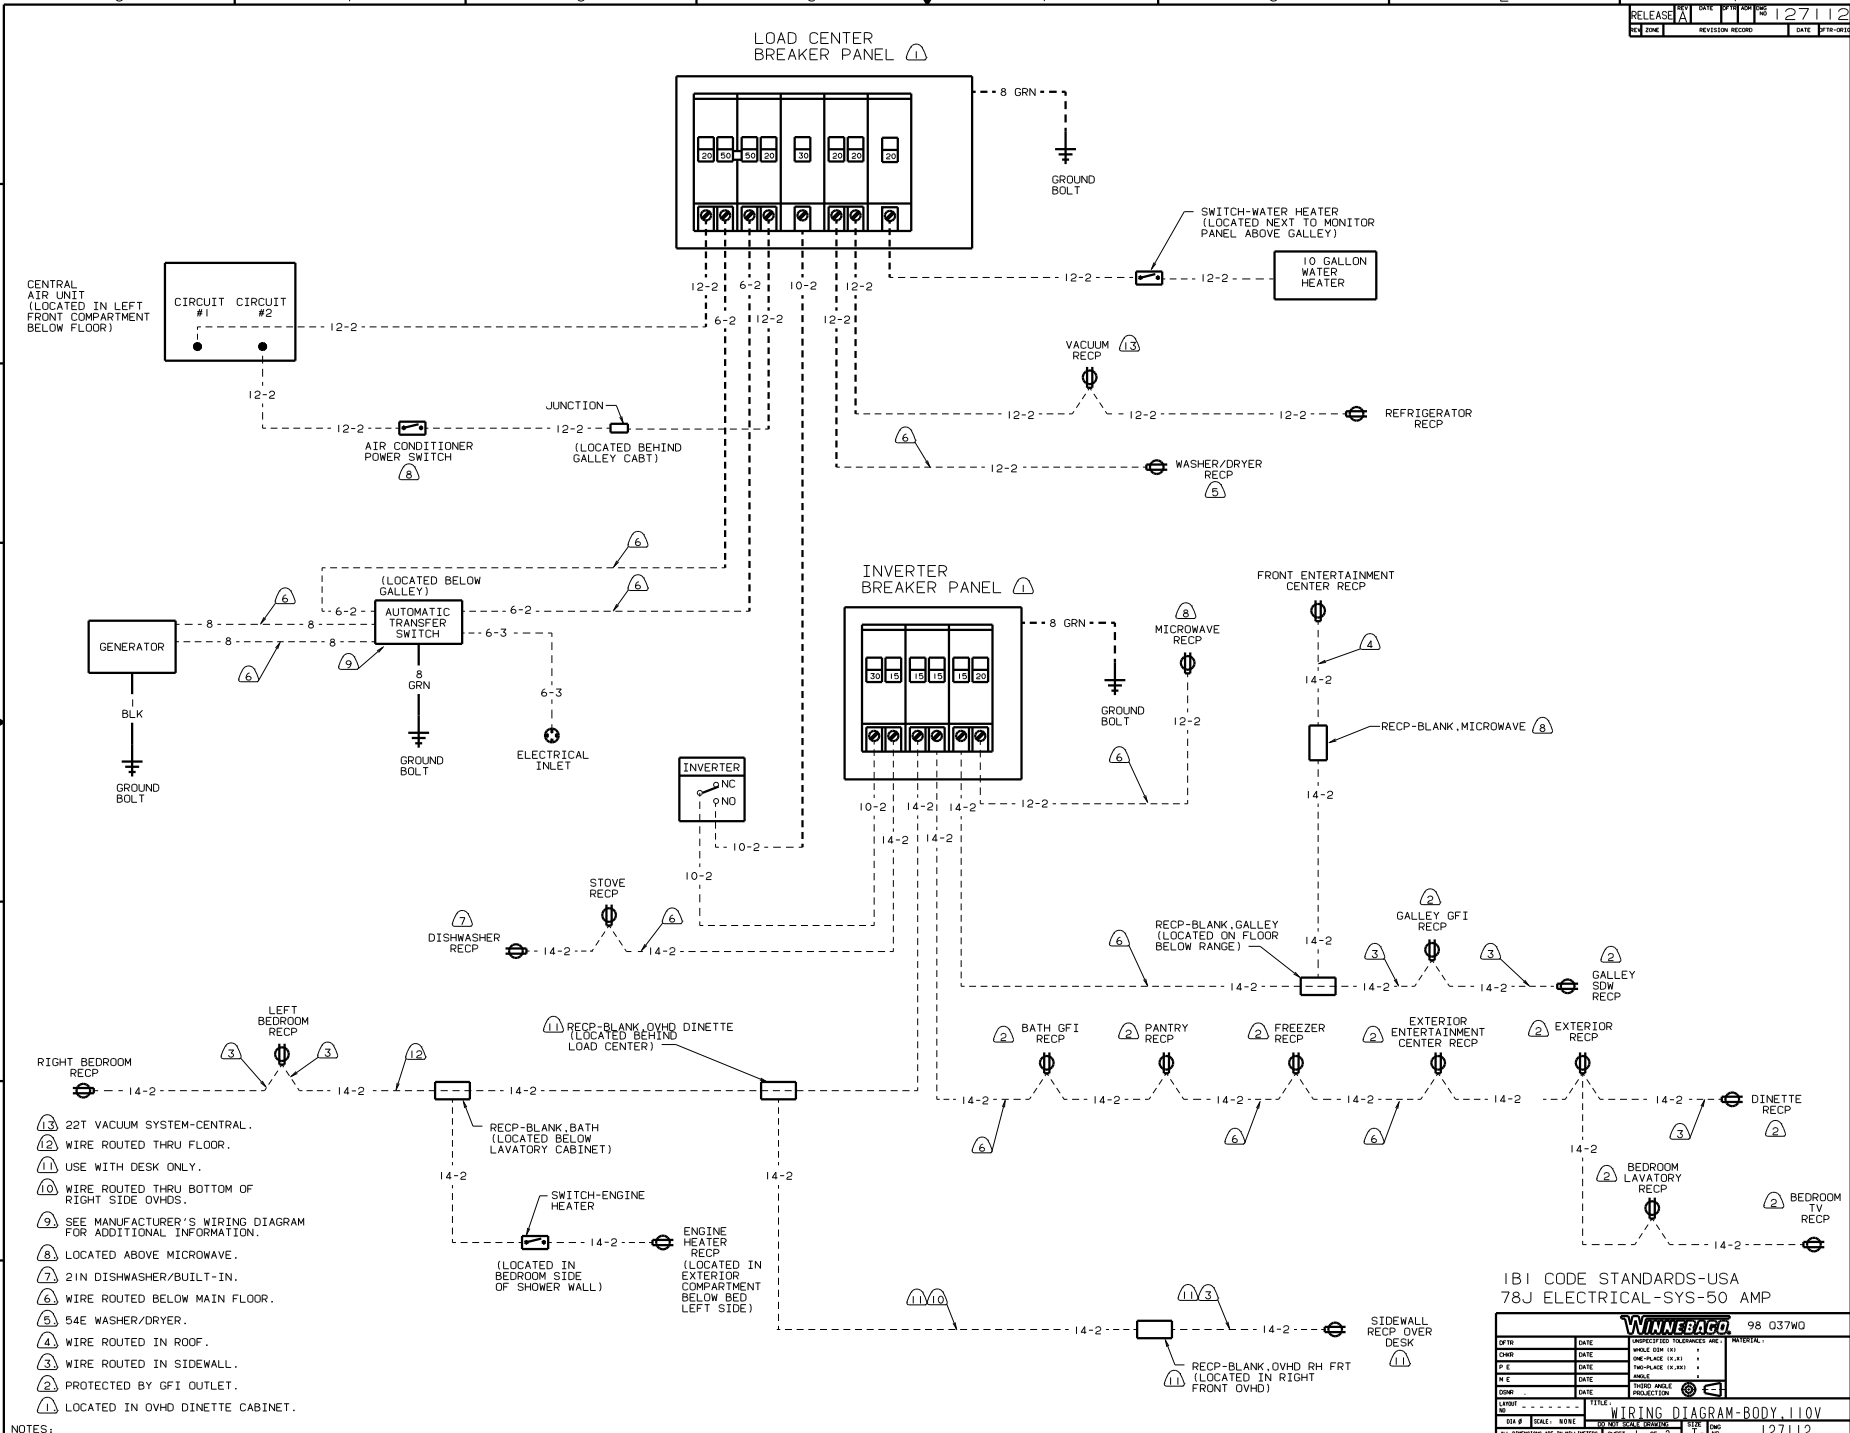
- 13 22T VACUUM SYSTEM-CENTRAL.
- 12 WIRE ROUTED THRU FLOOR.
- 11 USE WITH DESK ONLY.
- 10 WIRE ROUTED THRU BOTTOM OF RIGHT SIDE OVHDS.
- 9 SEE MANUFACTURER'S WIRING DIAGRAM FOR ADDITIONAL INFORMATION.
- 8 LOCATED ABOVE MICROWAVE.
- 7 21N DISHWASHER/BUILT-IN.
- 6 WIRE ROUTED BELOW MAIN FLOOR.
- 5 54E WASHER/DRYER.
- 4 WIRE ROUTED IN ROOF.
- 3 WIRE ROUTED IN SIDEWALL.
- 2 PROTECTED BY GFI OUTLET.
- 1 LOCATED IN OVHD DINETTE CABINET.

81 CODE STANDARDS-USA
 78J ELECTRICAL-SYS-50 AMP

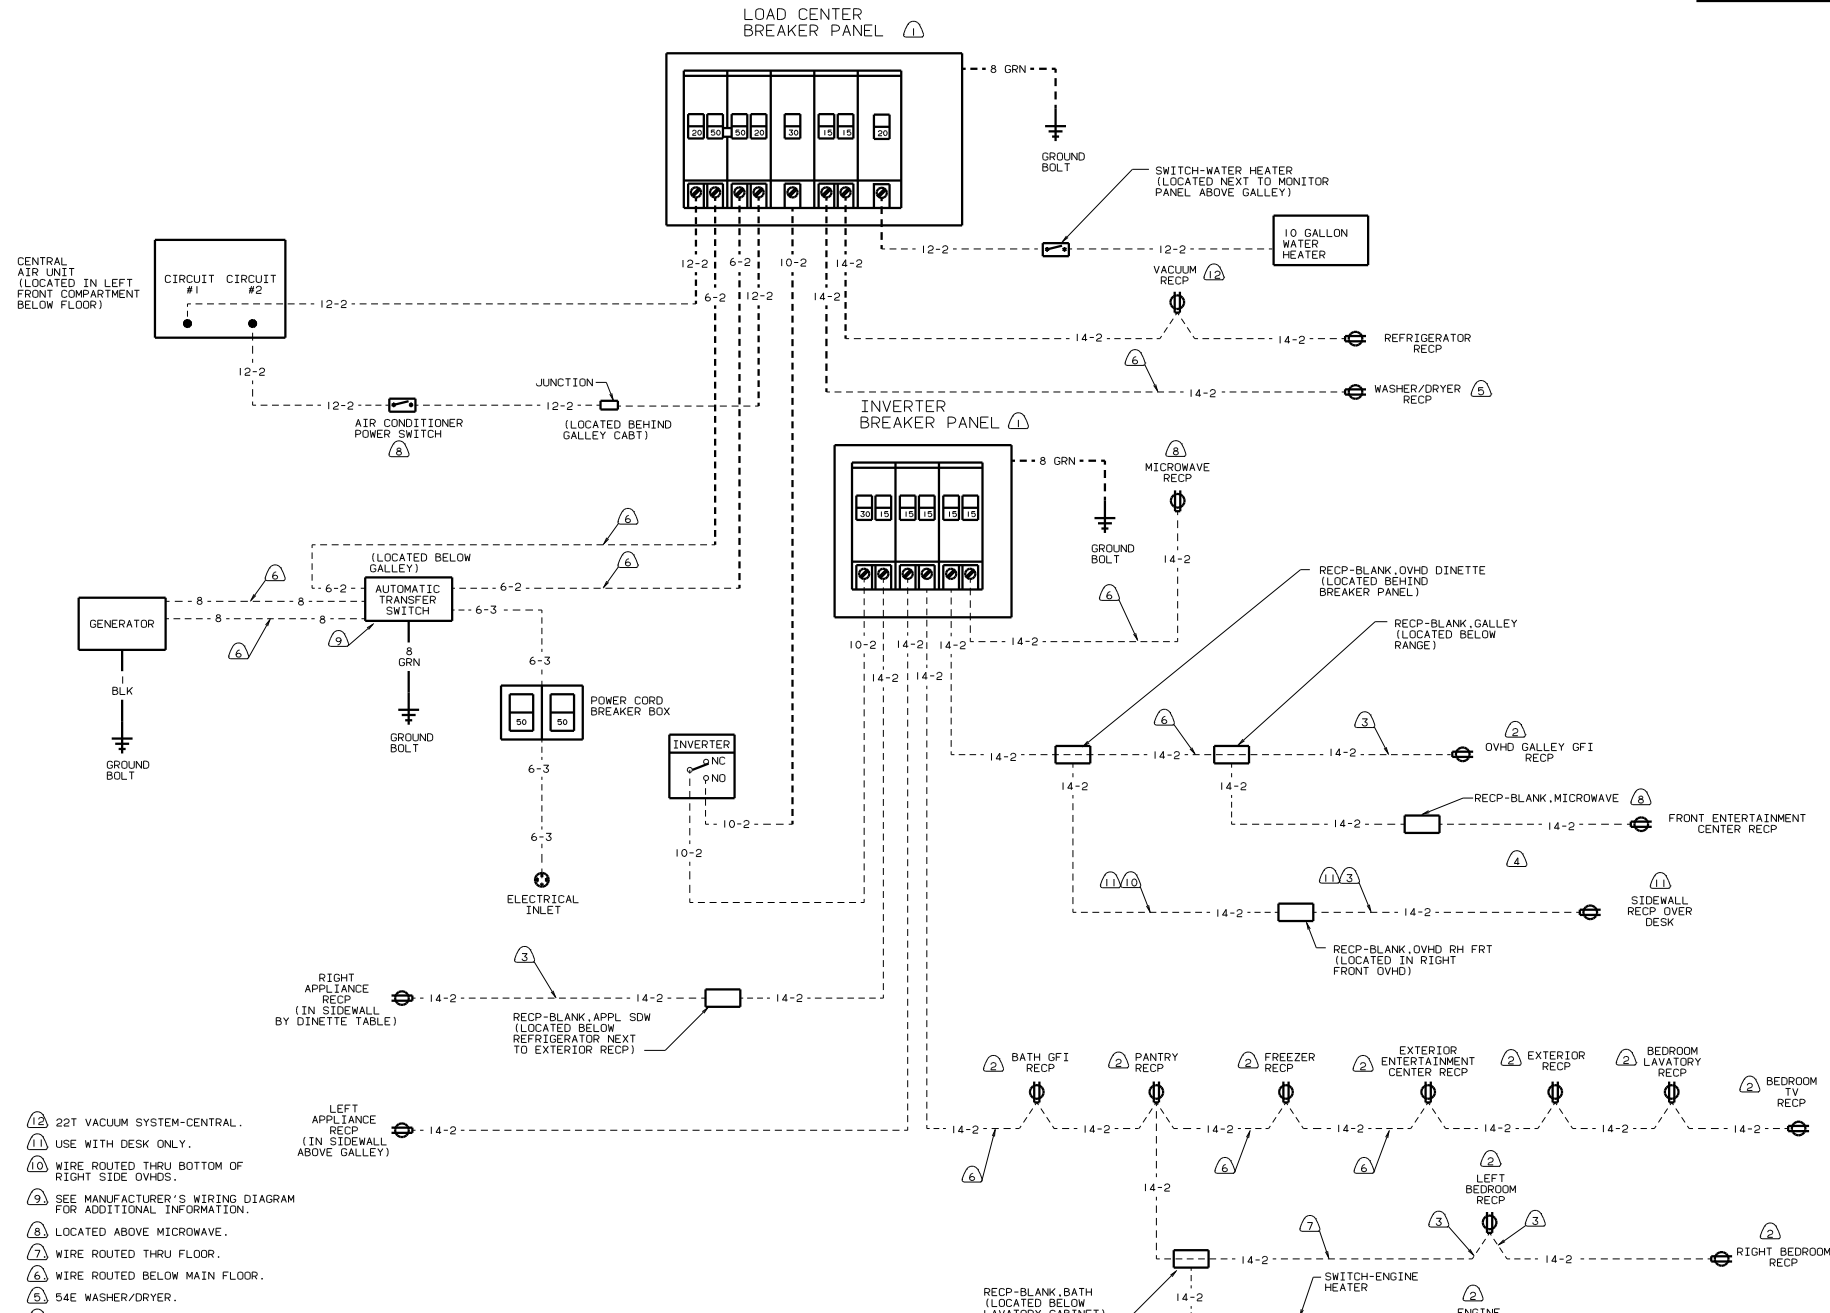
- 12 22T VACUUM SYSTEM-CENTRAL.
- 11 USE WITH DESK ONLY.
- 10 WIRE ROUTED THRU BOTTOM OF RIGHT SIDE OVHDS.
- 9 SEE MANUFACTURER'S WIRING DIAGRAM FOR ADDITIONAL INFORMATION.
- 8 LOCATED ABOVE MICROWAVE.
- 7 WIRE ROUTED THRU FLOOR.
- 6 WIRE ROUTED BELOW MAIN FLOOR.
- 5 54E WASHER/DRYER.
- 4 WIRE ROUTED IN ROOF.
- 3 WIRE ROUTED IN SIDEWALL.
- 2 PROTECTED BY GFI OUTLET.
- 1 LOCATED IN OVHD DINETTE CABINET.

98 Q37W0
 265 CODE STANDARDS-CSA
 78J ELECTRICAL-SYS 50 AMP
