**WINNEBAGO** 01 331C

LANE # \_\_\_\_\_ TITLE: **WIRING DIAGRAM-BODY 110V**

REF: 132250 134799

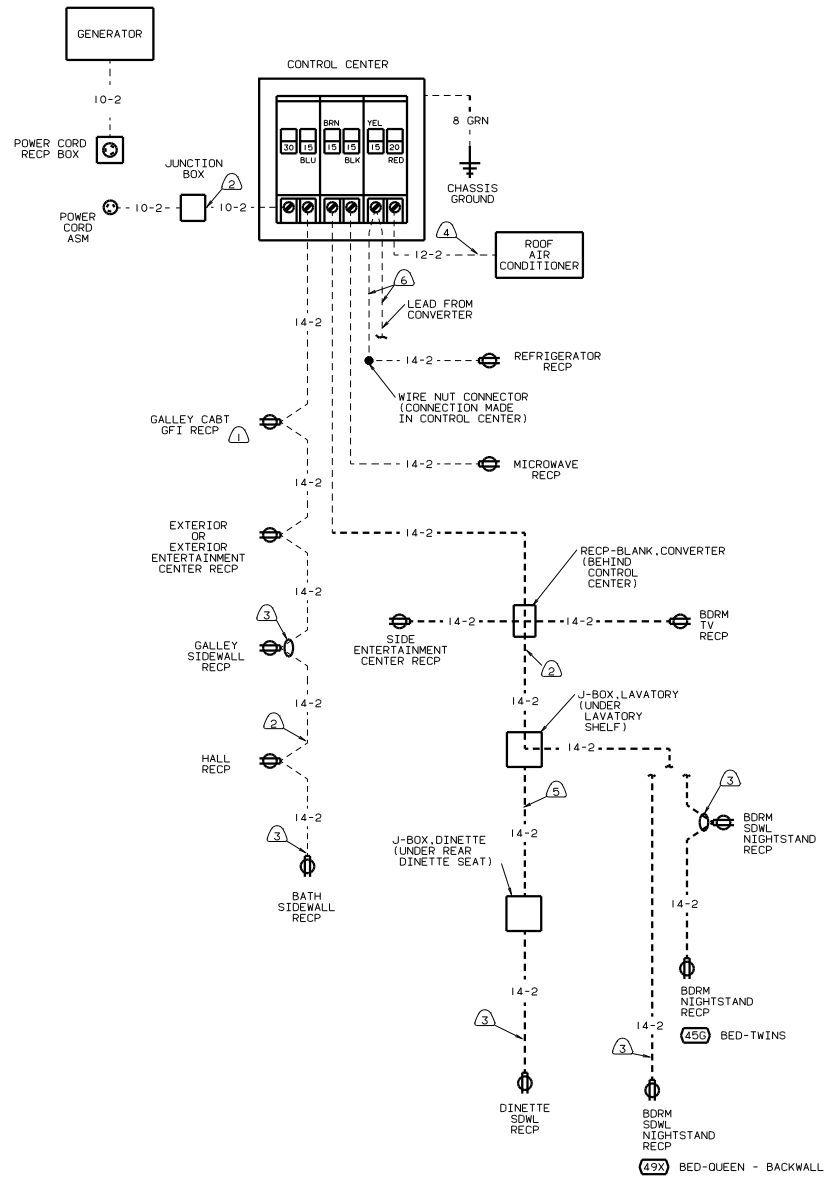
- NOTES:
- ③ LEAD SUPPLIED WITH CONVERTER.
  - ⑤ FLEXIBLE CORD FOR SLIDEOUT.
  - ④ WIRE ROUTED THRU ROOF.
  - ③ WIRE ROUTED THRU SIDEWALL.
  - ② WIRE ROUTED THRU FLOOR.
  - ① ALL OUTLETS DOWN STREAM AND INCLUDING THIS OUTLET ARE GROUND FAULT INTERRUPT PROTECTED.
