WINNEBAGO 01 331T

DRAWN BY: _____ TITLE: **WIRING DIAGRAM-BODY 110V**
 CHECKED BY: _____ DATE: _____
 ALL DIMENSIONS ARE IN MILLIMETERS SHEET 1 OF 1 FILE NO. 134802

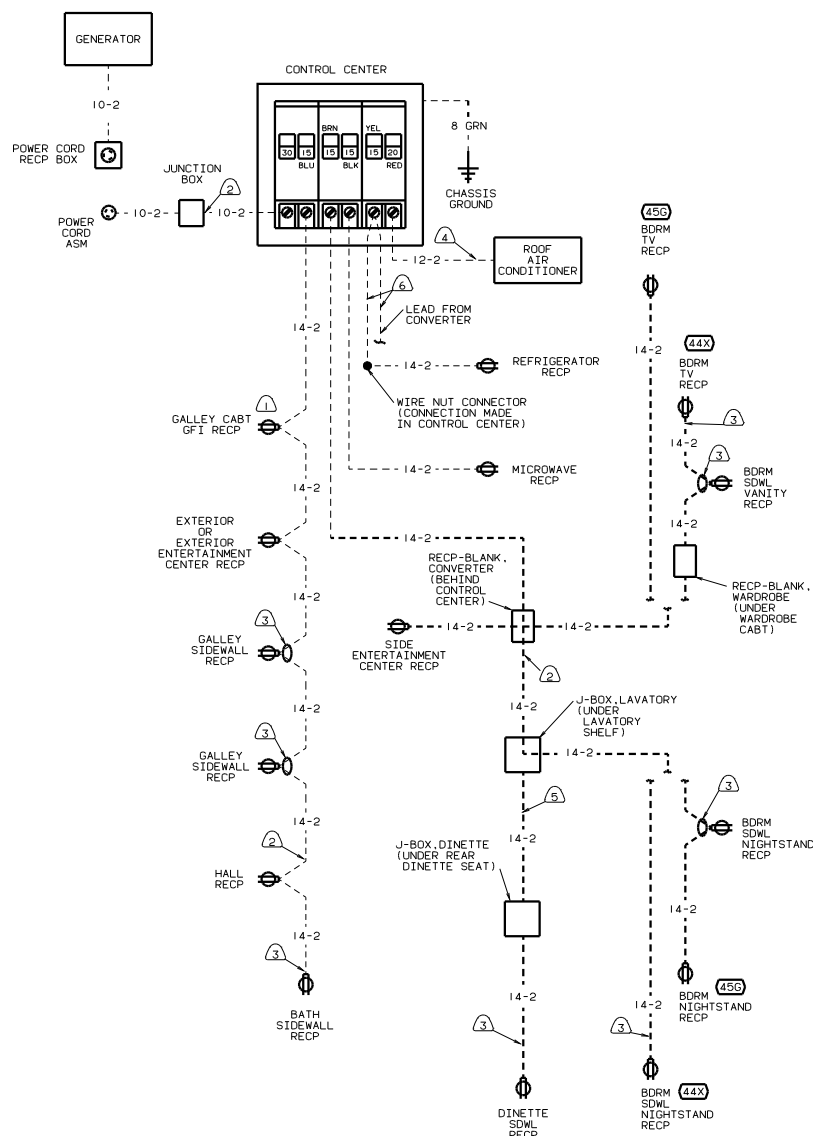
- ⑥ LEAD SUPPLIED WITH CONVERTER.
- ⑤ FLEXIBLE CORD FOR SLIDEOUT.
- ④ WIRE ROUTED THRU ROOF.
- ③ WIRE ROUTED THRU SIDEWALL.
- ② WIRE ROUTED THRU FLOOR.
- ① ALL OUTLETS DOWN STREAM AND INCLUDING THIS OUTLET ARE GROUND FAULT INTERRUPT PROTECTED.

- ④5G BED-TWINS
- ④4X BED-QUEEN SIDEWALL
- ②6S CODES/STANDARDS-CSA/CMVSS
- ①2D ELECTRICAL SYSTEM 30 AMP
- ①B1 CODES/STANDARDS USA
