WINNEBAGO 01 430V

LAYOUT: - - - TITLE: WIRING DIAGRAM-BODY 110V
 DIA # SCALE: NONE TO THE SCALE SHOWN FILE NO: 134903
 ALL DIMENSIONS ARE IN MILLIMETERS SHEET 1 OF 1

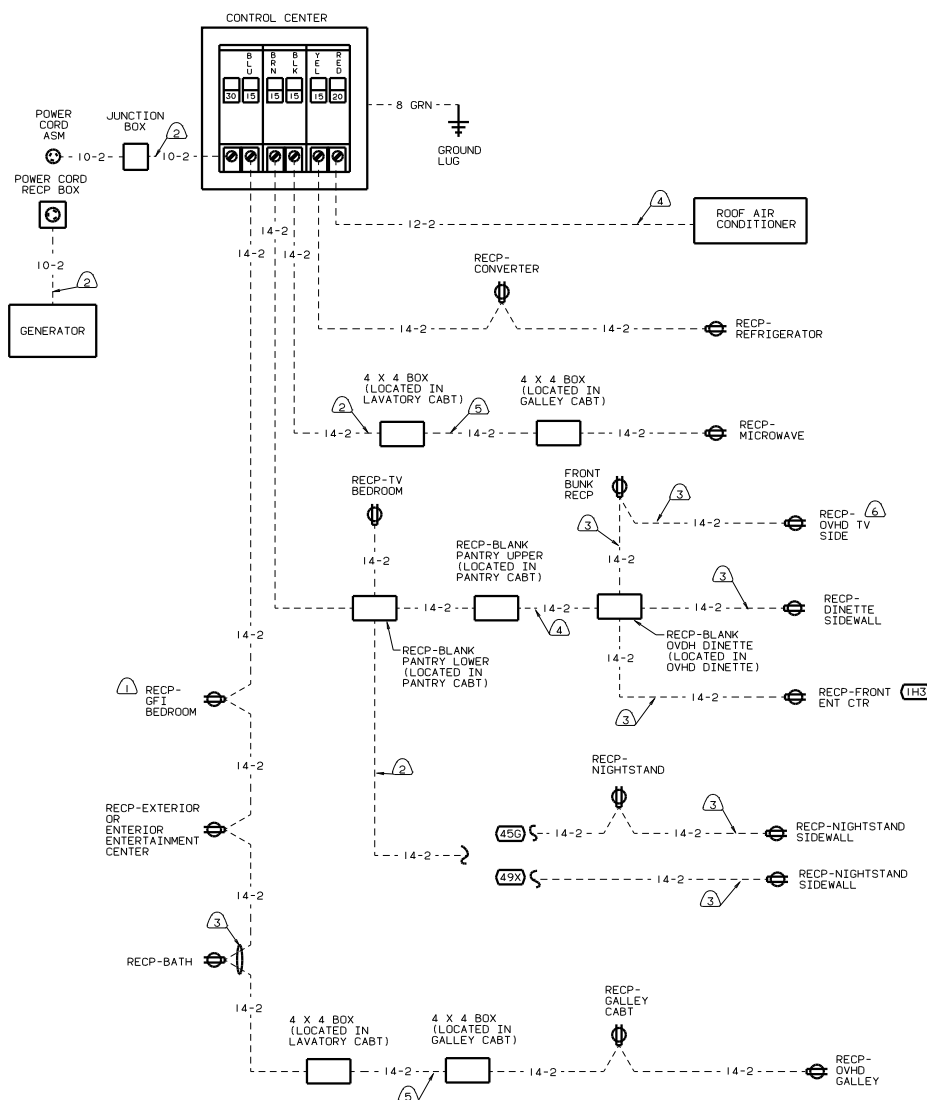
- (78A) TV-13" W/VCP-12V
- (49X) BED-QUEEN - BACKWALL
- (45G) BED-TWINS
- (265) CODES/STANDARDS-CSA/CMVSS
- (1H3) TV-25"/VIDEO SEL/SGL BUNK
- (1B1) CODES/STANDARDS USA
- (12D) ELECTRICAL SYSTEM 30 AMP

- (6) NOT USED WITH (1H3) OR (78A)
- (5) FLEXIBLE CORD TO SLIDEOUT.
- (4) WIRE ROUTED IN ROOF.
- (3) WIRE ROUTED IN SIDEWALL
- (2) WIRE ROUTED THRU FLOOR
- (1) ALL OUTLETS DOWN STREAM AND INCLUDING THIS OUTLET ARE GROUND FAULT CIRCUIT INTERRUPT PROTECTED.
