WINNEBAGO		01 427P
OF IN	DATE	UNDESIGNED TOLERANCES ARE:
CHP	DATE	WHOLE DIM (IN)
D/E	DATE	ONE-PLACE (IN.X1)
D/E	DATE	TWO-PLACE (IN.XXX)
D/E	DATE	THREE-PLACE (IN.XXXX)
CONP	DATE	INDIC. W/ANGLE PROJECTION
TITLE: WIRING DIAGRAM-BODY 110V		FIG. NO. 136617
SHEET 1 OF 1	DATE	BY

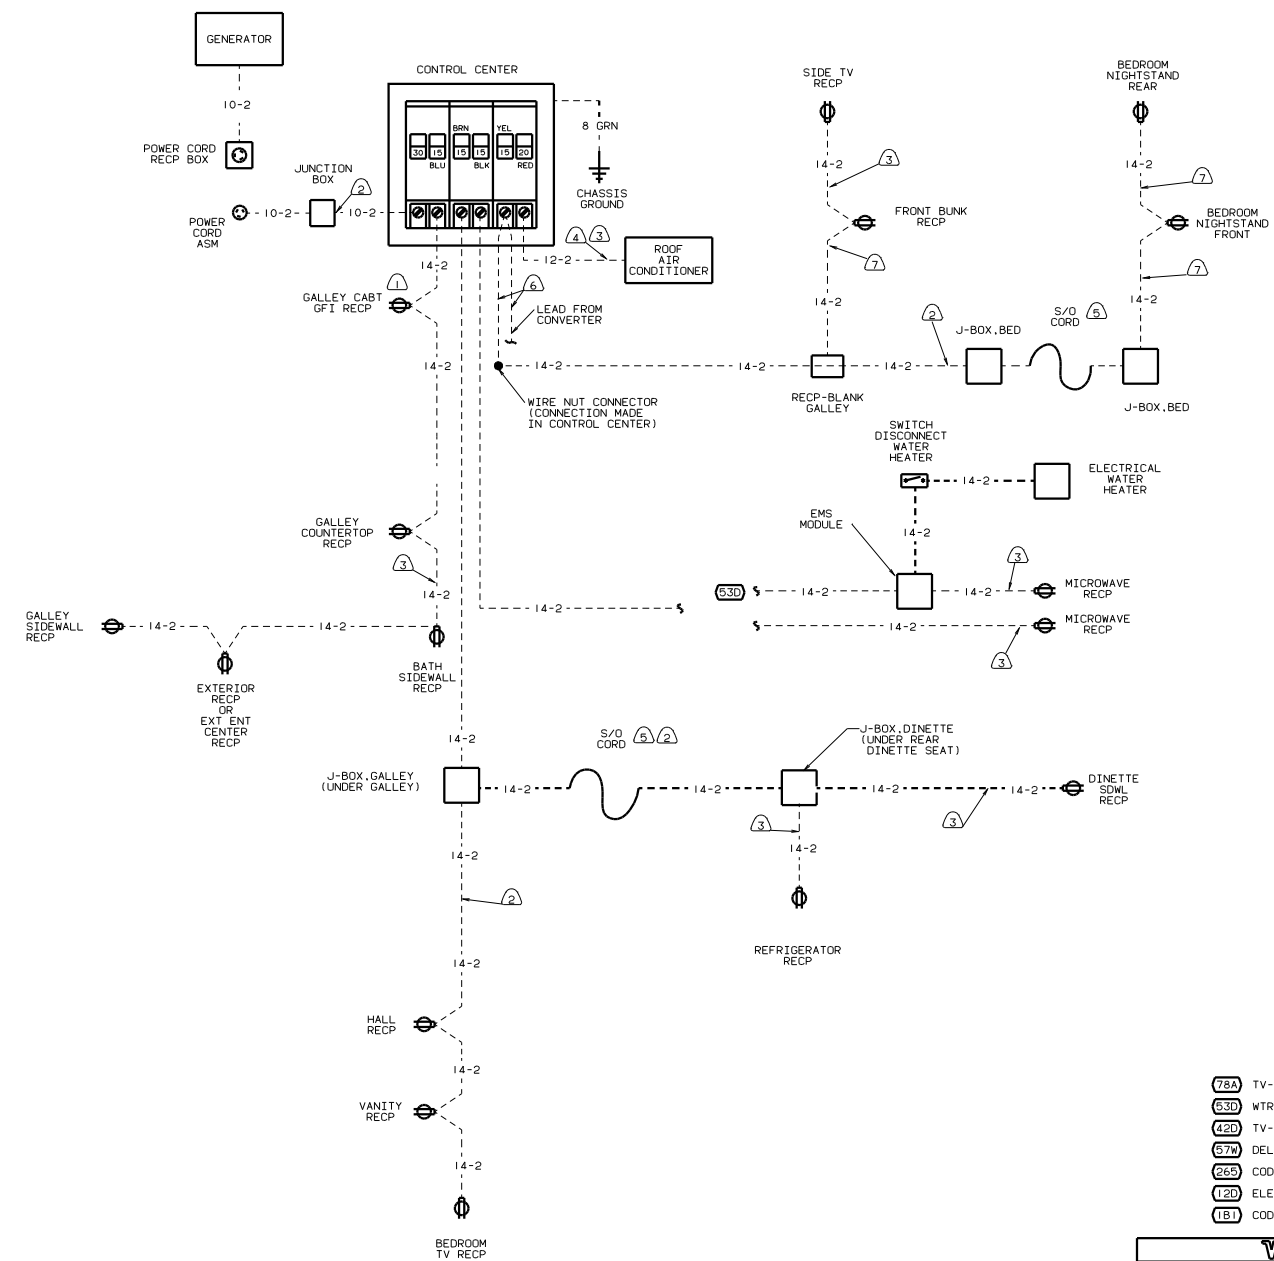
- NOTES:
- ⑦ WIRE ROUTED IN SIDEWALL
 - ⑥ LEAD SUPPLIED WITH CONVERTER.
 - ⑤ FLEXIBLE CORD FOR SLIDEOUT.
 - ④ WIRE ROUTED THRU ROOF.
 - ③ WIRE ROUTED THRU SIDEWALL.
 - ② WIRE ROUTED BELOW FLOOR.
 - ① ALL OUTLETS DOWN STREAM AND INCLUDING THIS OUTLET ARE GROUND FAULT INTERRUPT PROTECTED.
