WIRING DIAGRAM COACH
 (WIRE ASM 135687)

WIRING DIAGRAM-BODY_12V

SHEET 1 OF 2

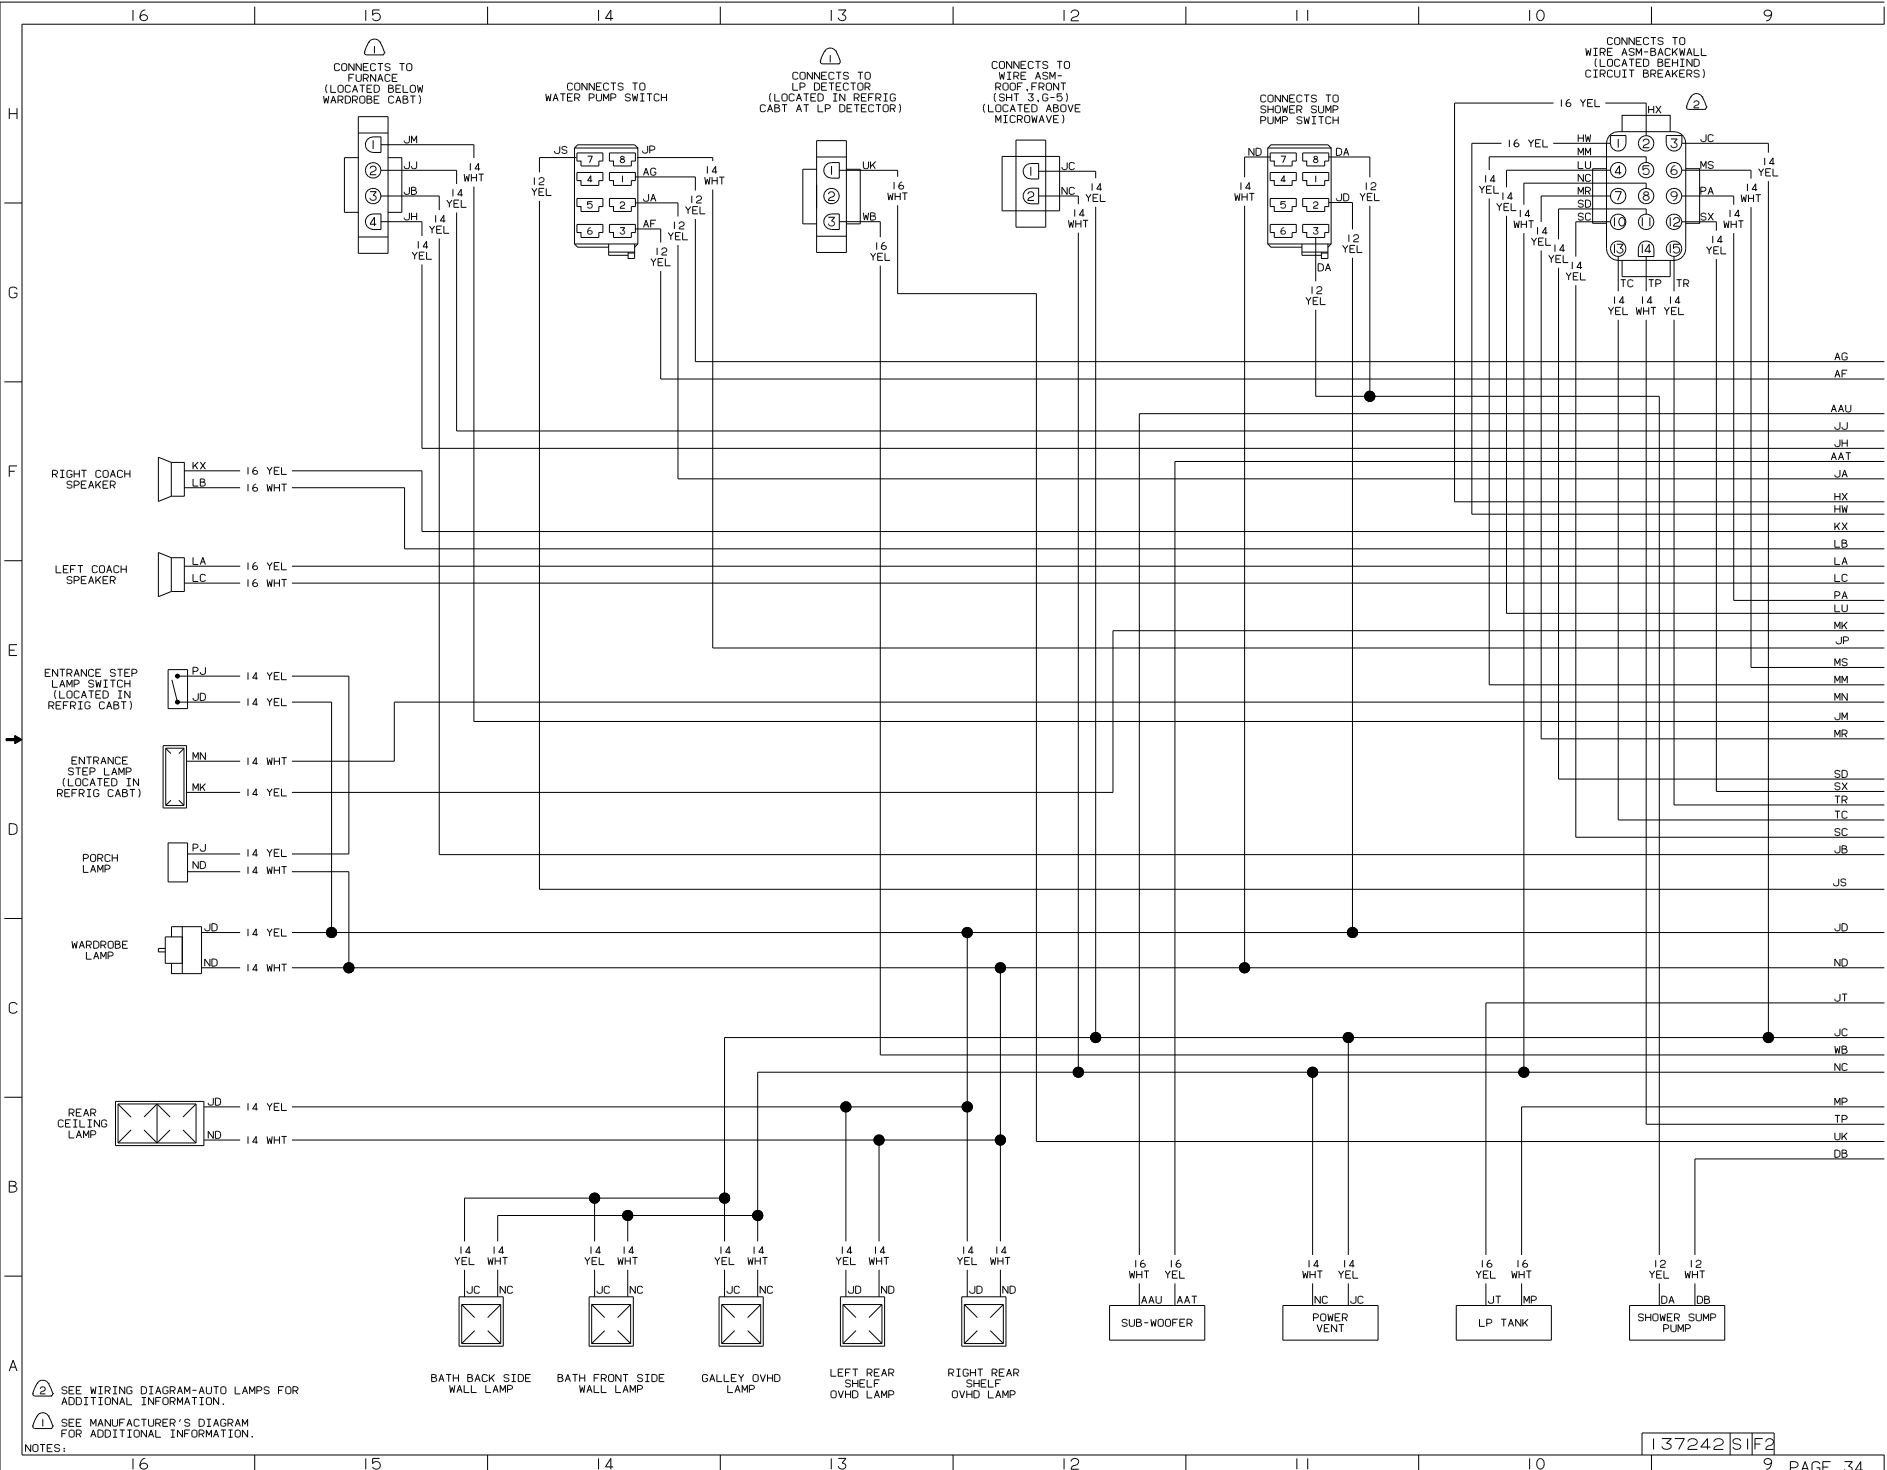
WIRING DIAGRAM-ROOF, FRONT
(WIRE ASM 119112)

WIRING DIAGRAM-SIDEWALL
(WIRE ASM 111451-03)
