WITH HEAT PUMP

WIRING DIAGRAM-THERMOSTAT, EXT
(WIRE ASM 138131)
(WITH HEAT PUMP)

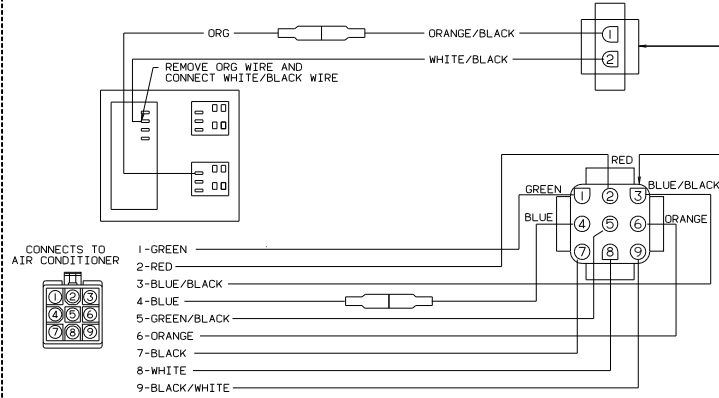
VENDOR SUPPLIED HARNESS

ORG WIRE IS REMOVED FROM TERMINAL AND CONNECTED TO ORG/BLK WIRE THEN WHT/BLK WIRE IS CONNECTED TO THE TERMINAL WHERE TH ORG WIRE WAS.

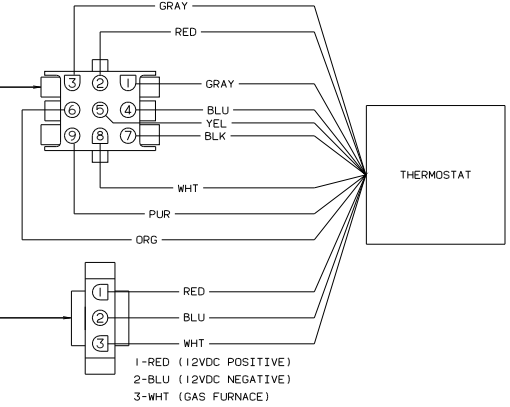
THERMOSTAT

- 1-GRY (FREEZE SWITCH & EXCLUSION RELAY)
- 2-RED (+12VDC)
- 3-GRY (FREEZE SWITCH & EXCLUSION RELAY)
- 4-BLU (-12VDC)
- 5-YEL (COOLING COMPRESSOR #1)
- 6-ORG (COOLING COMPRESSOR #2)
- 7-BLK (FAN HIGH)
- 8-WHT (HEAT PUMP)
- 9-PUR (FAN LOW)
