- 78J ELECTRICAL SYSTEM - 50 AMP
- 285 CODES/STANDARDS - CSA/CMVSS
- 2IN DISHWASHER/BUILT-IN
- 1B1 CODES/STANDARDS - USA

WINNEBAGO

TITLE: WIRING DIAGRAM-BODY, 110V
 SHEET 1 of 1 PART NO. 139710

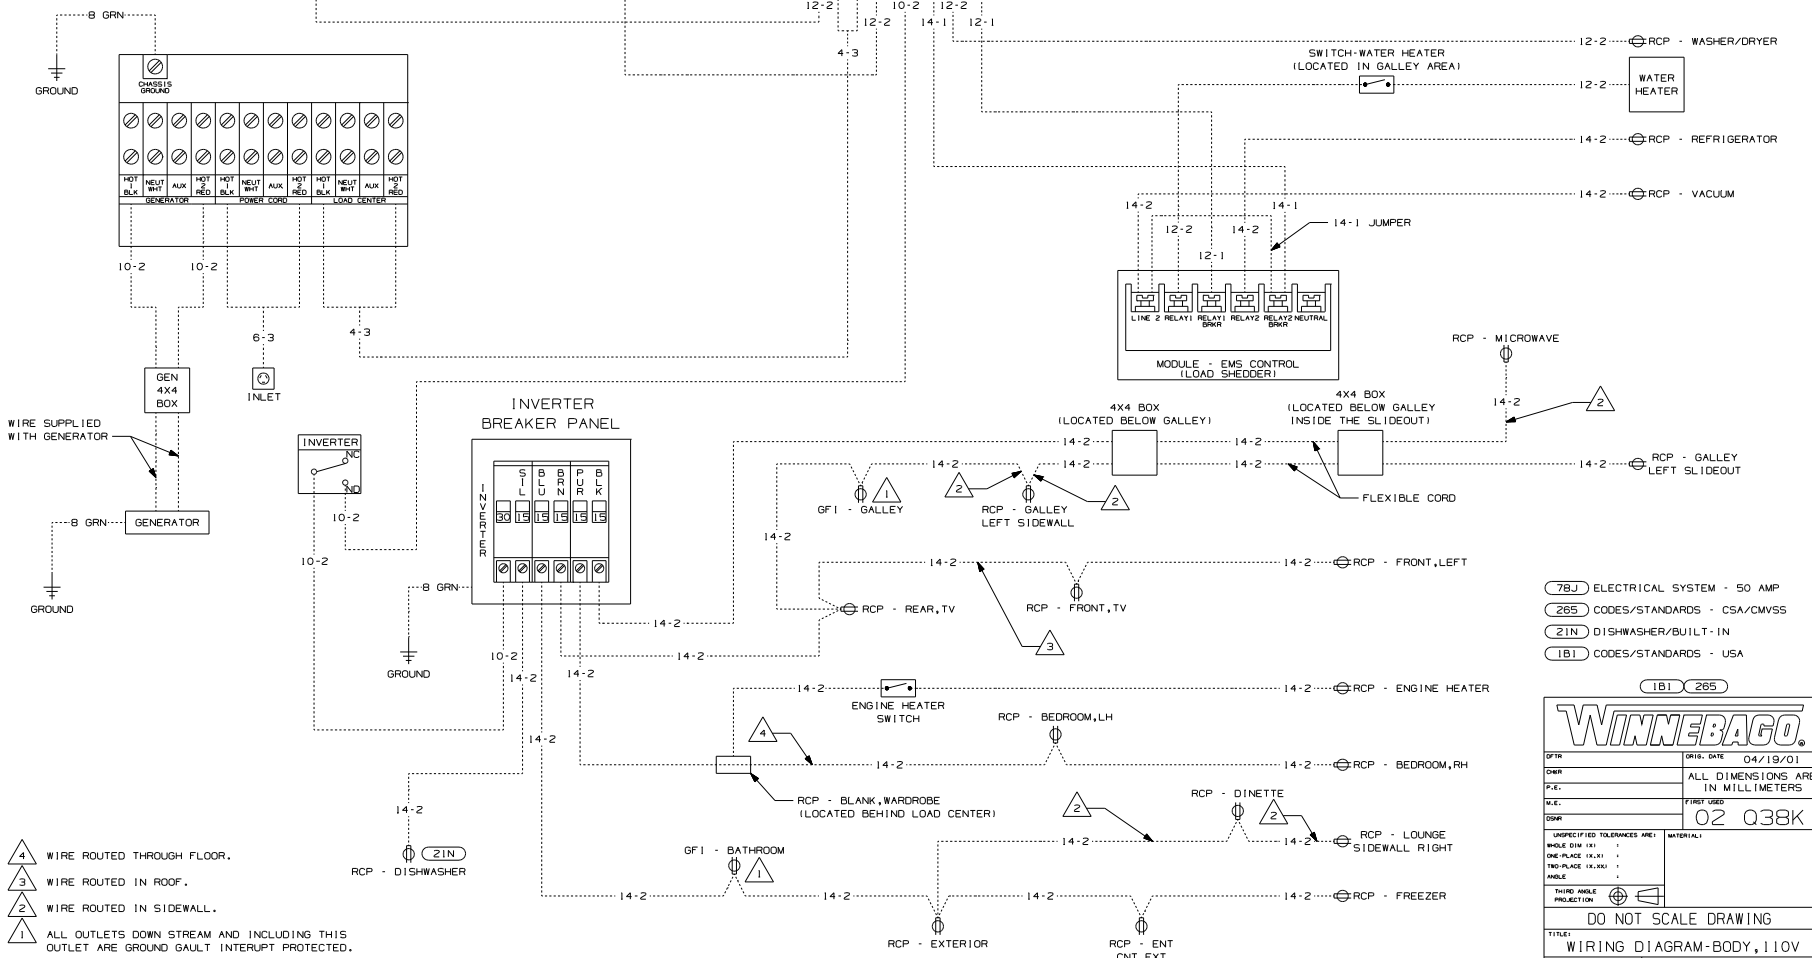
CENTRAL AIR UNIT
 (LOCATED IN RIGHT REAR
 COMPARTMENT BELOW FLOOR)

LOAD CENTER

INVERTER BREAKER PANEL

- NOTES:
- 4 WIRE ROUTED THROUGH FLOOR.
 - 3 WIRE ROUTED IN ROOF.
 - 2 WIRE ROUTED IN SIDEWALL.
 - 1 ALL OUTLETS DOWN STREAM AND INCLUDING THIS OUTLET ARE GROUND FAULT INTERRUPT PROTECTED.
