WINNEBAGO

TITLE: WIRING DIAGRAM-BODY, 110V

SHEET 1 of 1 PART NO 142760

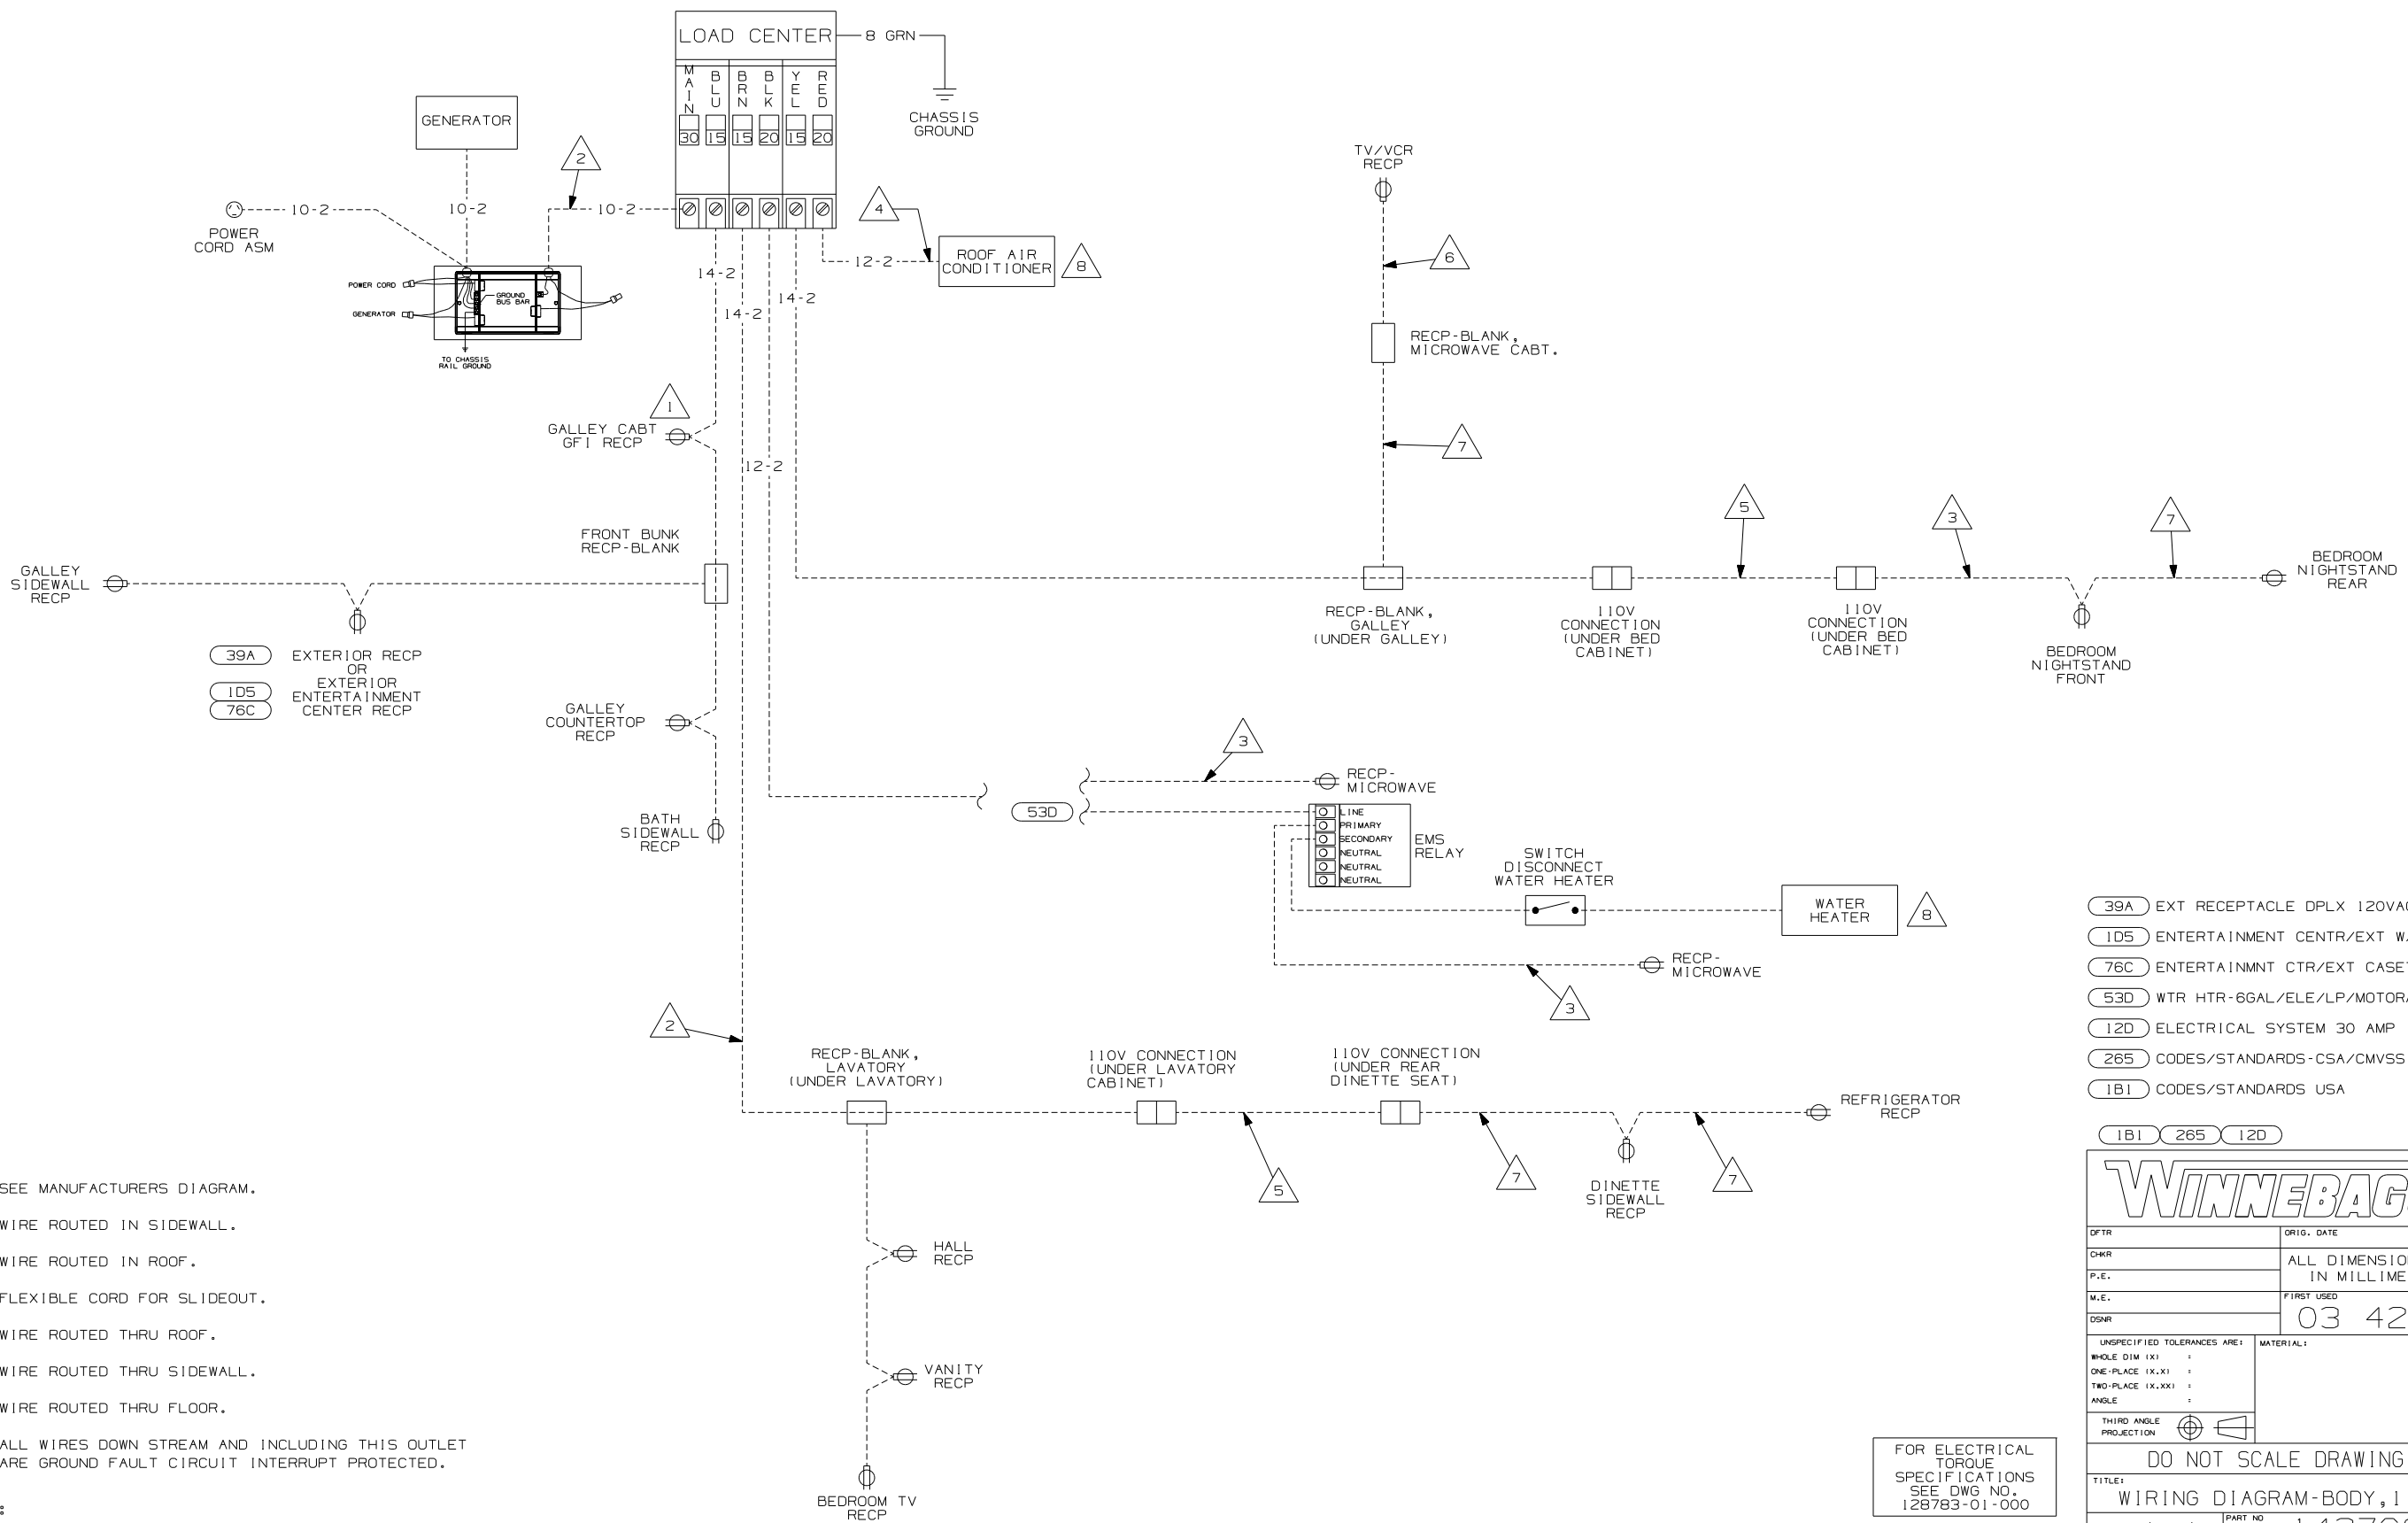
39A EXTERIOR RECP OR EXTERIOR ENTERTAINMENT CENTER RECP
 1D5 ENTERTAINMENT CENTER RECP
 76C ENTERTAINMENT CENTER RECP

53D

- 39A EXT RECEPTACLE DPLX 120VAC
- 1D5 ENTERTAINMENT CENTR/EXT W/CD
- 76C ENTERTAINMENT CTR/EXT CASSETTE
- 53D WTR HTR-6GAL/ELE/LP/MOTORAID
- 12D ELECTRICAL SYSTEM 30 AMP
- 265 CODES/STANDARDS-CSA/CMVSS
- 1B1 CODES/STANDARDS USA
