WINNEBAGO	
DFTR	ORIG. DATE
CHKR	ALL DIMENSIONS ARE IN MILLIMETERS
P.E.	
M.E.	FIRST USED
DSNR	03 L39T
UNSPECIFIED TOLERANCES ARE:	MATERIAL:
WHOLE DIM (X)	
ONE-PLACE (X.X)	
TWO-PLACE (X.XX)	
ANGLE	
THIRD ANGLE PROJECTION	
DO NOT SCALE DRAWING	
TITLE:	
WIRING DIAGRAM-BODY, 110V	
SHEET 1 OF 1	PART NO
	142387
REF: NONE	1 03/03/03

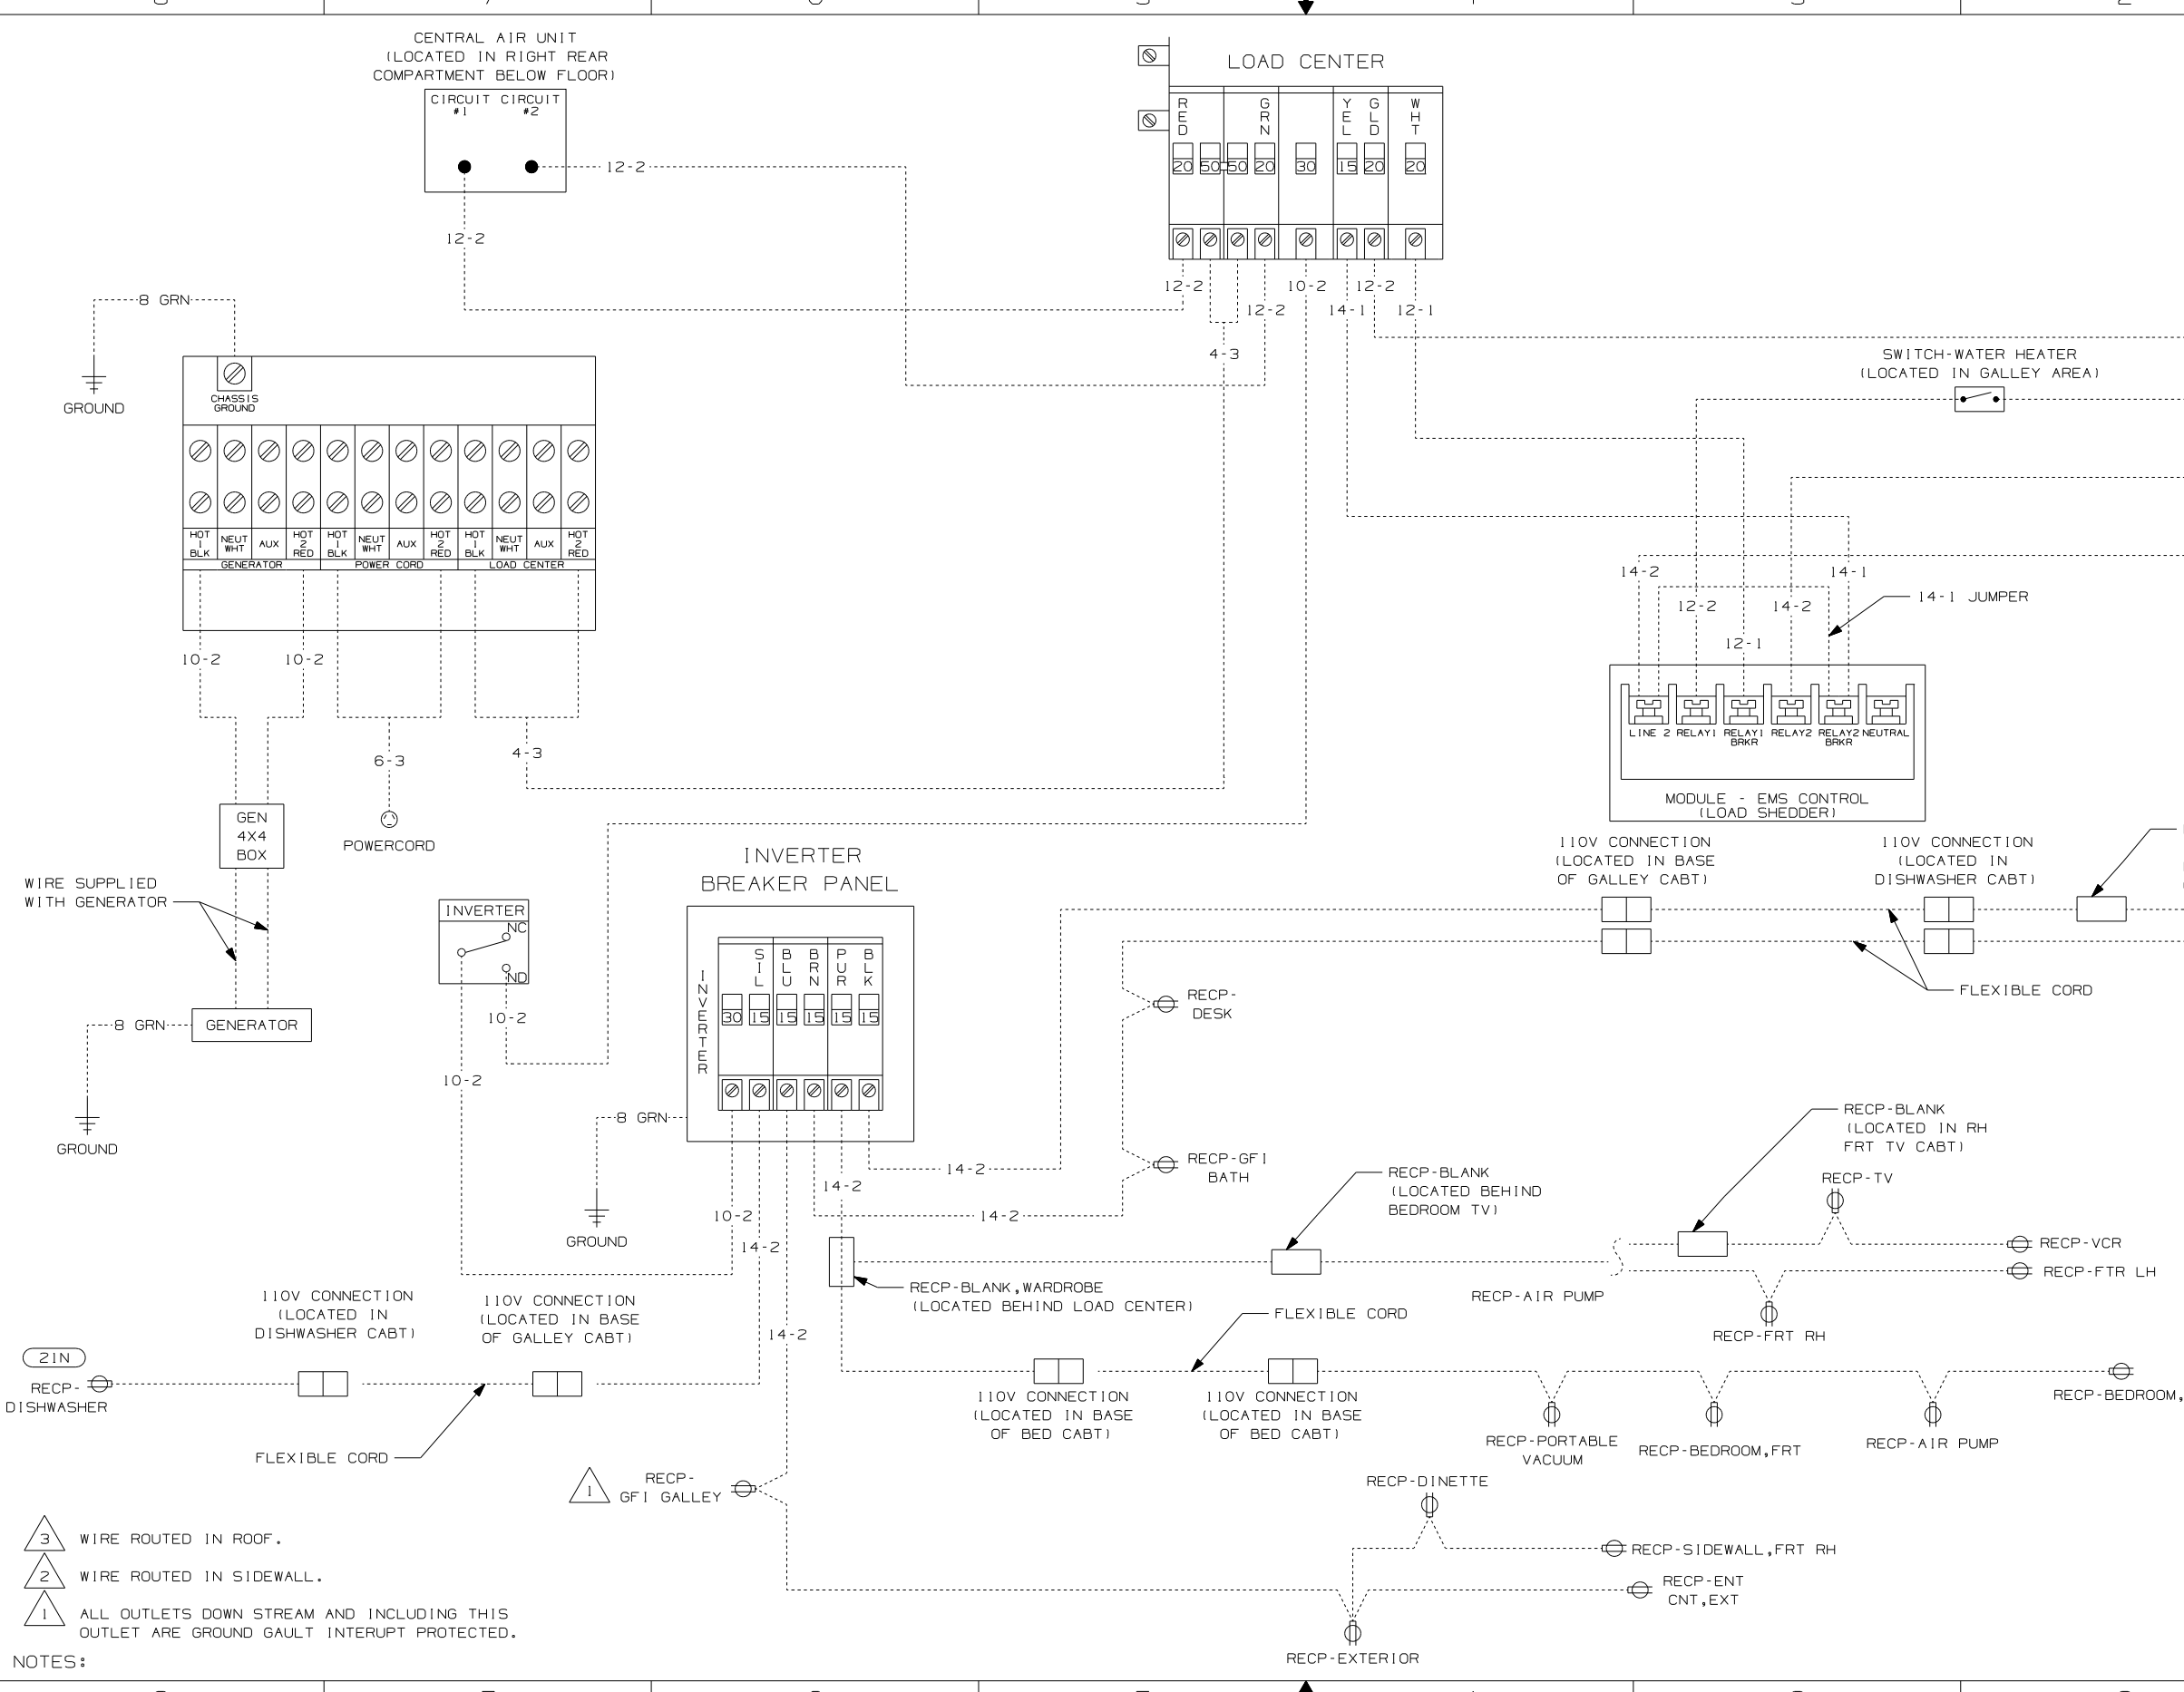
- NOTES:
- 3 WIRE ROUTED IN ROOF.
 - 2 WIRE ROUTED IN SIDEWALL.
 - 1 ALL OUTLETS DOWN STREAM AND INCLUDING THIS OUTLET ARE GROUND FAULT INTERRUPT PROTECTED.

- 13X INVERTER/CHARGER 2.0 KW
- 265 CODES/STANDARDS - CSA/CMVSS
- 21N DISHWASHER/BUILT-IN
- 1B1 CODES/STANDARDS - USA
