- (21L) DINING TABLE/CHAIRS
- (21K) DINING/COMPUTER TABLE/CHAIRS
- (78J) ELECTRICAL SYSTEM - 50 AMP
- (265) CODES/STANDARDS - CSA/CMVSS
- (21N) DISHWASHER/BUILT-IN
- (1B1) CODES/STANDARDS - USA

WINNEBAGO		COPYRIGHT 2002 WINNEBAGO INDUSTRIES, INC.	
DFTR	ORIG. DATE		
CHKR	ALL DIMENSIONS ARE IN MILLIMETERS		
P.E.	FIRST USED	03 Q40K	
M.E.			
DSNR			
UNSPECIFIED TOLERANCES ARE:		MATERIAL:	
WHOLE DIM (X)	:	X	
ONE-PLACE (X.X)	:	X	
TWO-PLACE (X.XX)	:	X	
ANGLE	:	X	
THIRD ANGLE PROJECTION		X	
DO NOT SCALE DRAWING			
TITLE: WIRING DIAGRAM-BODY, 110V			
SHEET 01	PART NO	143168	
REF: X	1 03/03/03

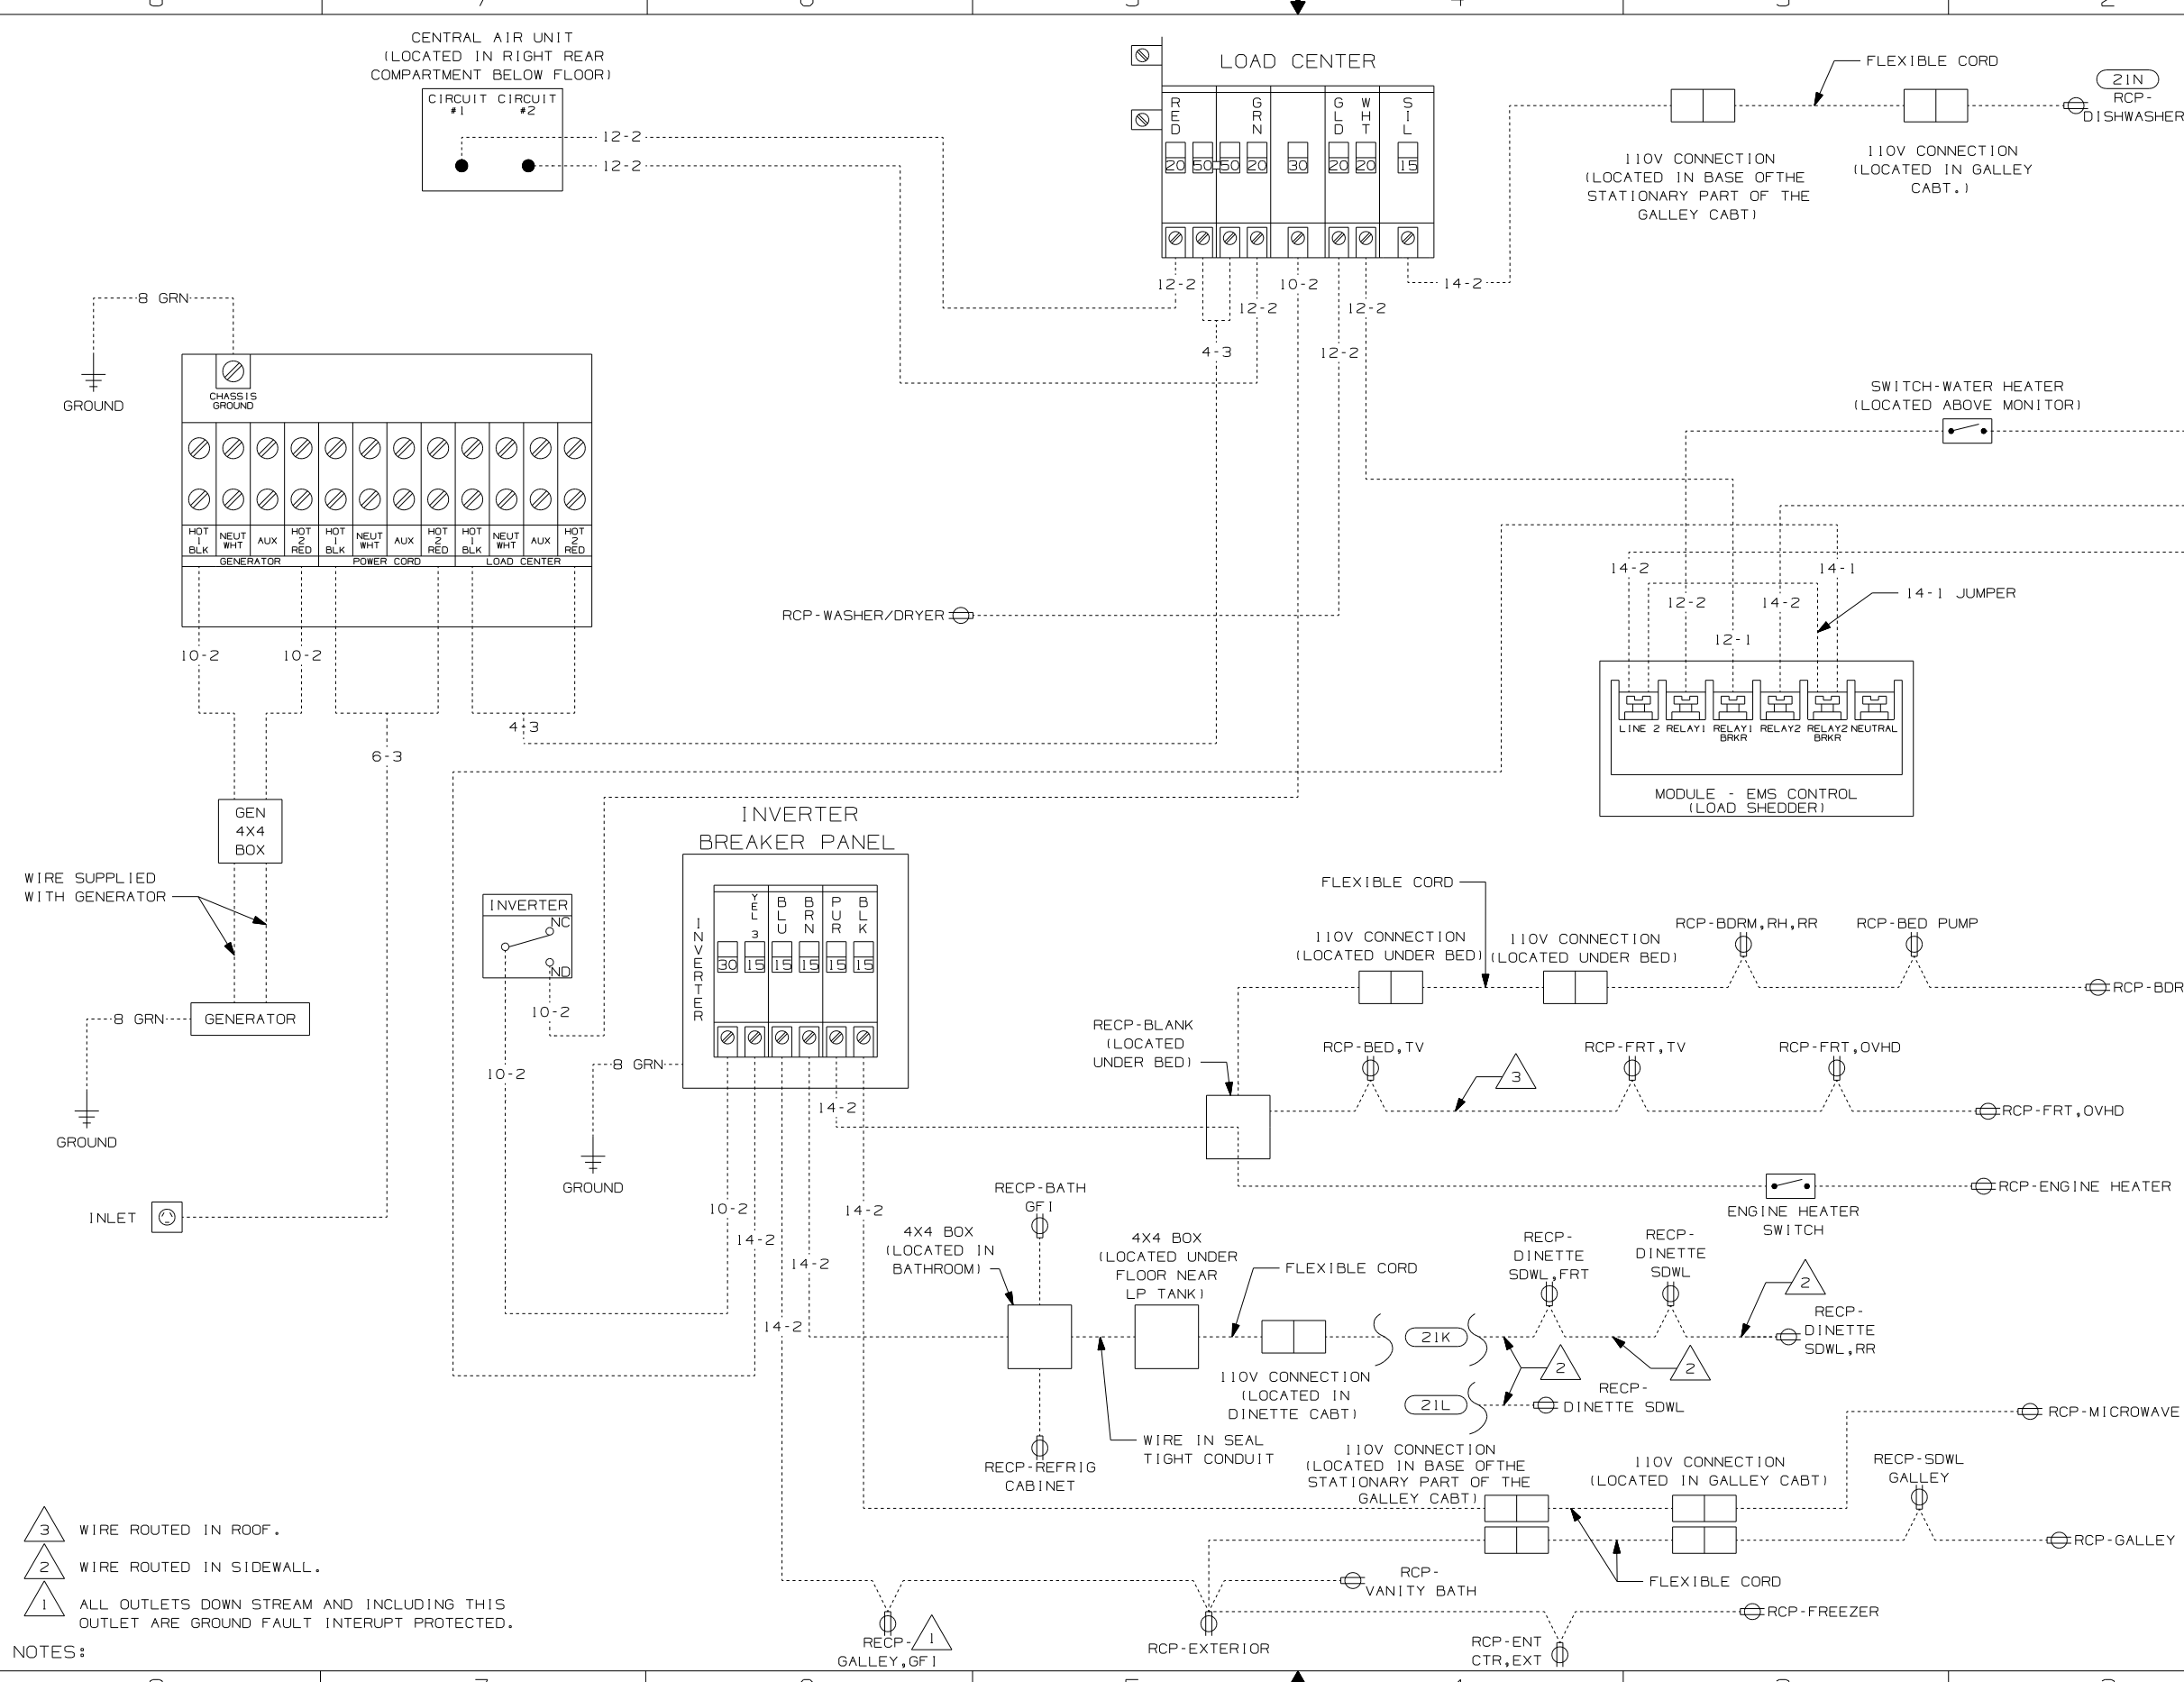
- 3 WIRE ROUTED IN ROOF.
- 2 WIRE ROUTED IN SIDEWALL.
- 1 ALL OUTLETS DOWN STREAM AND INCLUDING THIS OUTLET ARE GROUND FAULT INTERRUPT PROTECTED.
