WINNEBAGO		COPYRIGHT 2002 WINNEBAGO INDUSTRIES, INC.	
DFTR	ORIG. DATE		
CHKR	P.E.	ALL DIMENSIONS ARE IN MILLIMETERS	
M.E.	DSNR	FIRST USED 04 329B	
UNSPECIFIED TOLERANCES ARE:		MATERIAL:	
WHOLE DIM (X)	:		
ONE-PLACE (X.X)	:		
TWO-PLACE (X.XX)	:		
ANGLE	:		
THIRD ANGLE PROJECTION			
DO NOT SCALE DRAWING			
TITLE: WIRING DIAGRAM-BODY, 110V			
SHEET 1 OF 1	PART NO	146363	
REF:142310 1 05/23/03

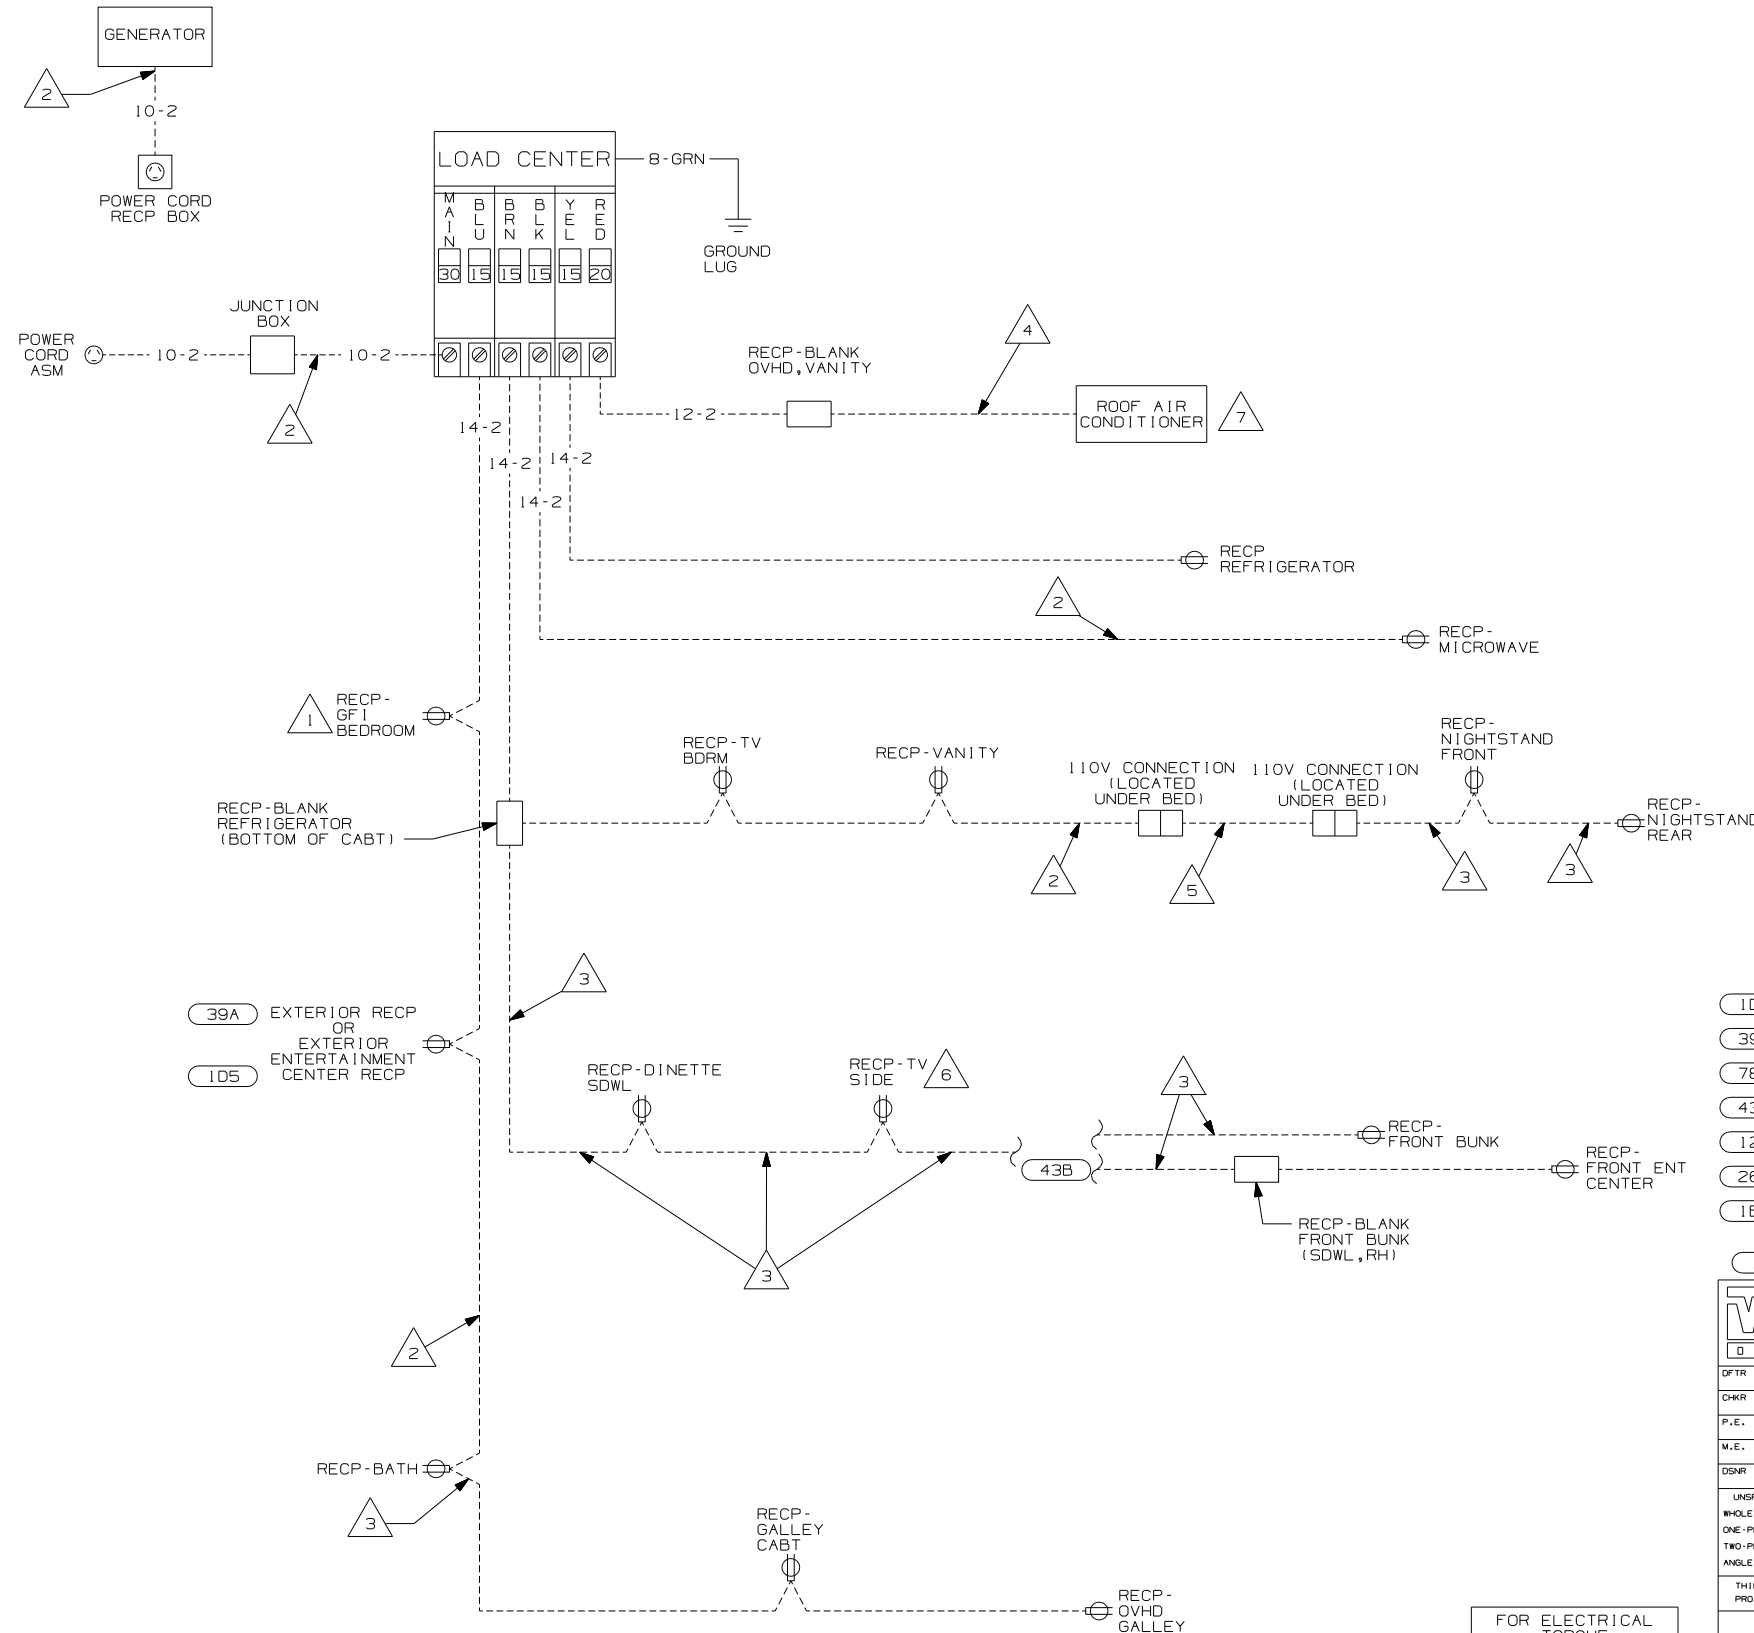
- 39A EXTERIOR RECP OR EXTERIOR ENTERTAINMENT CENTER RECP
- 1D5 ENTERTAINMENT CENTR/EXT W/CD

- 1D5 ENTERTAINMENT CENTR/EXT W/CD
- 39A EXT RECEPTACLE DPLX 120VAC
- 78A TV-13" W/VCP-12V
- 43B TV-25"STEREO/VIDEO SEL SYS
- 12D ELECTRICAL SYSTEM 30 AMP
- 265 CODES/STANDARDS-CSA/CMVSS
- 1B1 CODES/STANDARDS USA
