WINNEBAGO		COPYRIGHT 2002 WINNEBAGO INDUSTRIES, INC.	
DFT	ORIG. DATE		
CHKR	P.E.	ALL DIMENSIONS ARE IN MILLIMETERS	
M.E.	FIRST USED	04 331C/T	
DSNR			
UNSPECIFIED TOLERANCES ARE:		MATERIAL:	
WHOLE DIM (X)	:		
ONE-PLACE (X.X)	:		
TWO-PLACE (X.XX)	:		
ANGLE	:		
THIRD ANGLE PROJECTION		DO NOT SCALE DRAWING	
TITLE: WIRING DIAGRAM-BODY, 110V			
SHEET 1 of 1	PART NO	145099

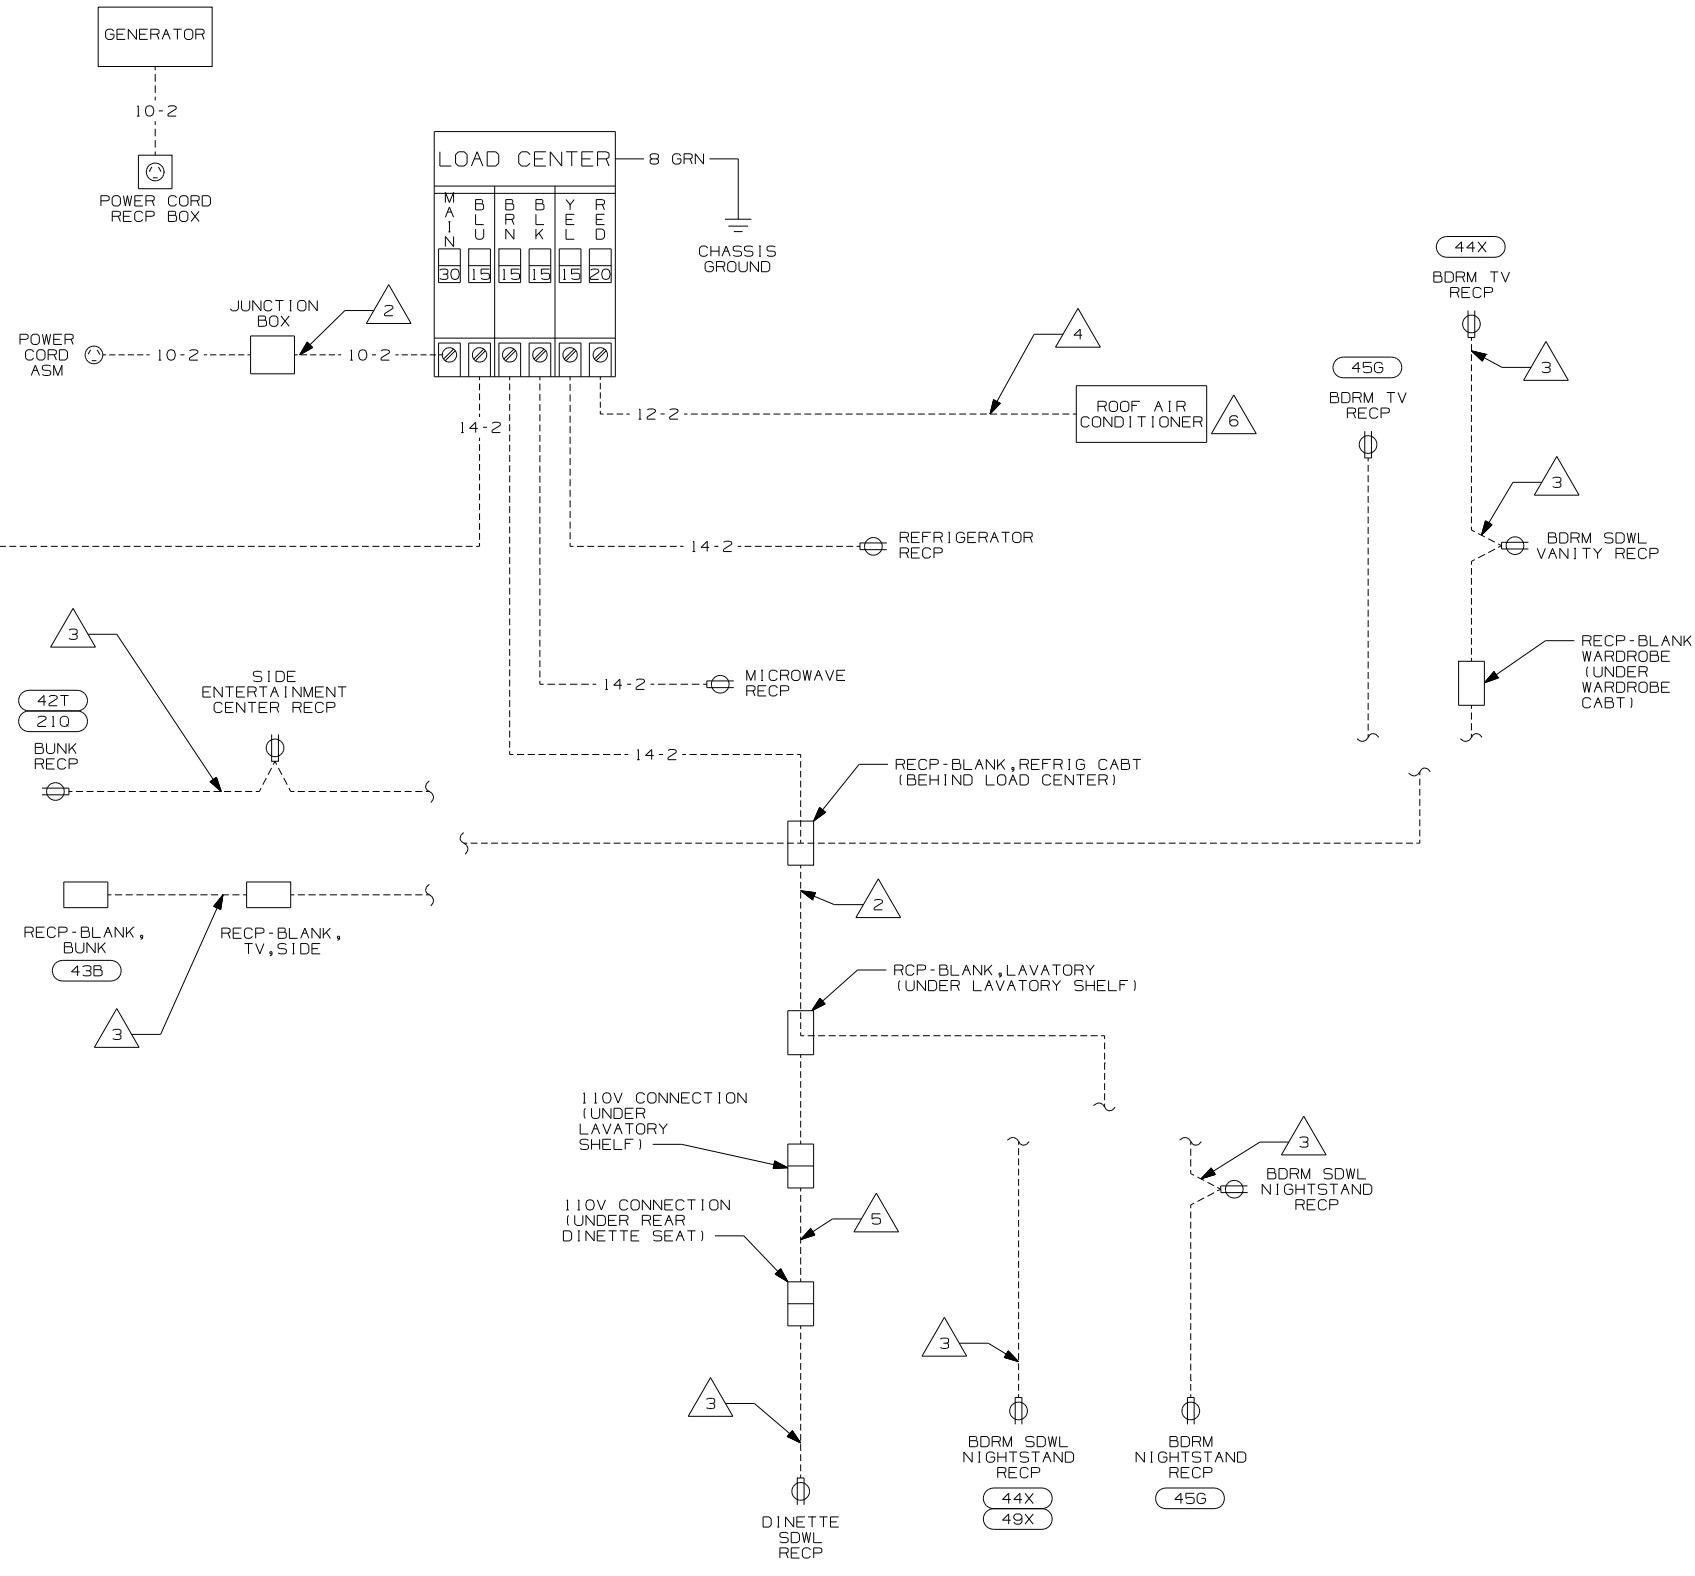
- (39A) EXT RECEPTACLE DPLX 120VAC
- (1D5) ENTERTAINMENT CENTR/EXT W/CD
- (42T) TV-19" FRONT W/VIDEO SEL
- (210) TV-19" W/VCR/VIDEO SELECTION
- (43B) TV-25"STEREO/VIDEO SEL SYS
- (49X) BED-QUEEN BACKWALL
- (44X) BED-QUEEN SIDEWALL
- (45G) BED-TWINS
- (12D) ELECTRICAL SYSTEM 30 AMP
- (265) CODES/STANDARDS-CSA/CMVSS
- (1B1) CODES/STANDARDS USA
