| TITLE: WIRING DIAGRAM-BODY, 110V | | | |
| SHEET 1 of 1 | PART NO | 146852 | |

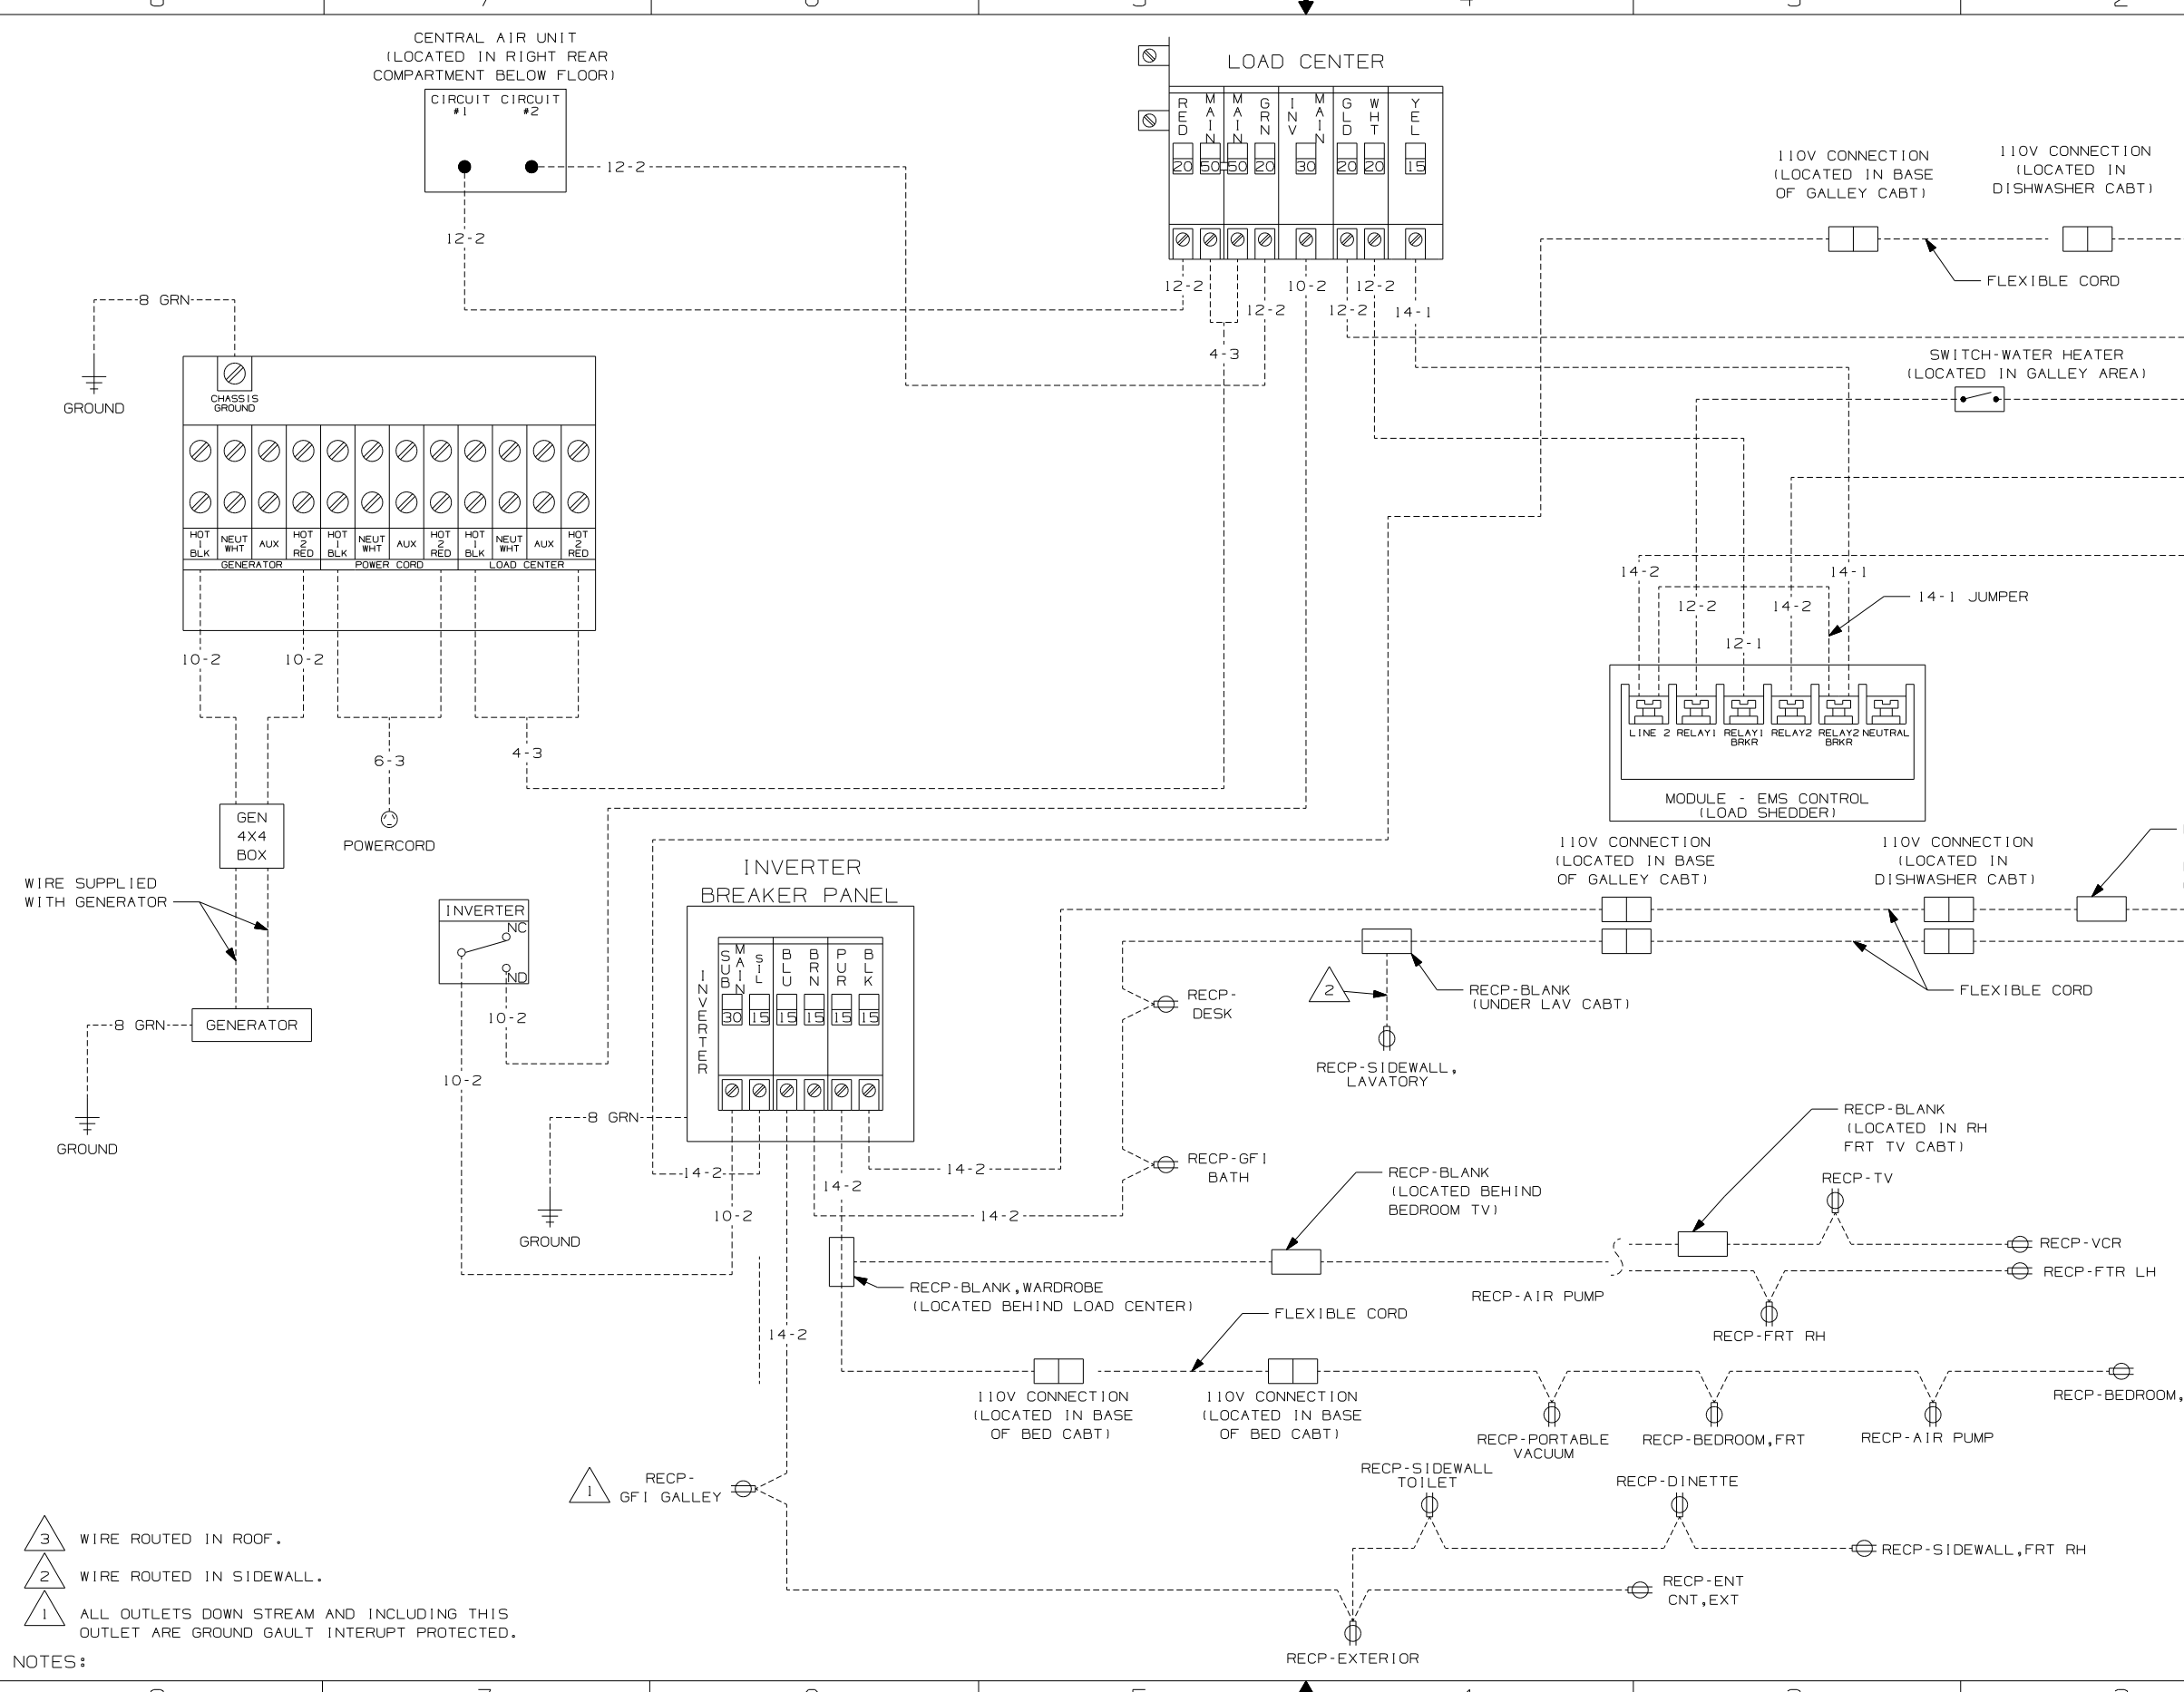
- NOTES:
- 3 WIRE ROUTED IN ROOF.
 - 2 WIRE ROUTED IN SIDEWALL.
 - 1 ALL OUTLETS DOWN STREAM AND INCLUDING THIS OUTLET ARE GROUND GAULT INTERRUPT PROTECTED.

- 13X INVERTER/CHARGER 2.0 KW
- 265 CODES/STANDARDS - CSA/CMVSS
- 21N DISHWASHER/BUILT-IN
- 1B1 CODES/STANDARDS - USA
