74J REARVIEW MONITOR SYSTEM

74J		COPYRIGHT 2003 WINNEBAGO INDUSTRIES, INC.	
UNSPECIFIED TOLERANCES ARE:		MATERIAL:	
WHOLE DIM (X)	:		
ONE-PLACE (X.X)	:		
TWO-PLACE (X.XX)	:		
ANGLE	:		
THIRD ANGLE PROJECTION	⊕		
DO NOT SCALE DRAWING			
TITLE: MONITOR INSTL			
SHEET 1 OF 1	PART NO	146109	
REF: 141331-C1 09/01/03

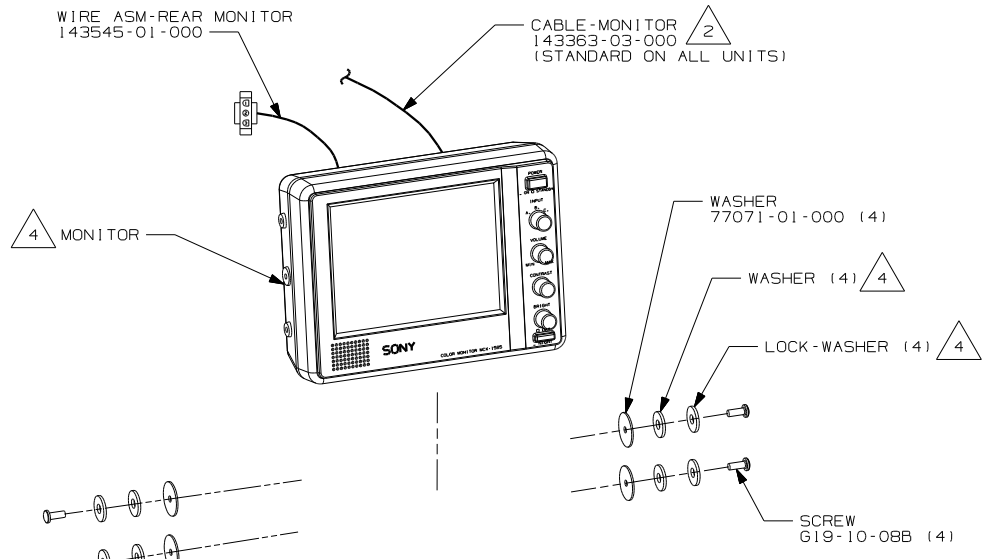
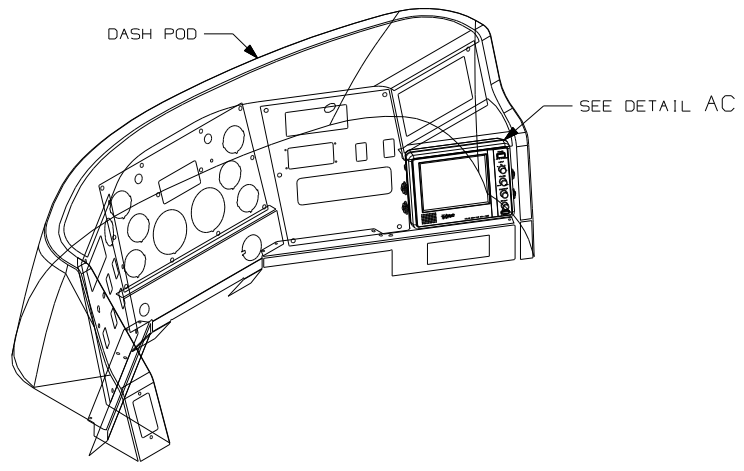
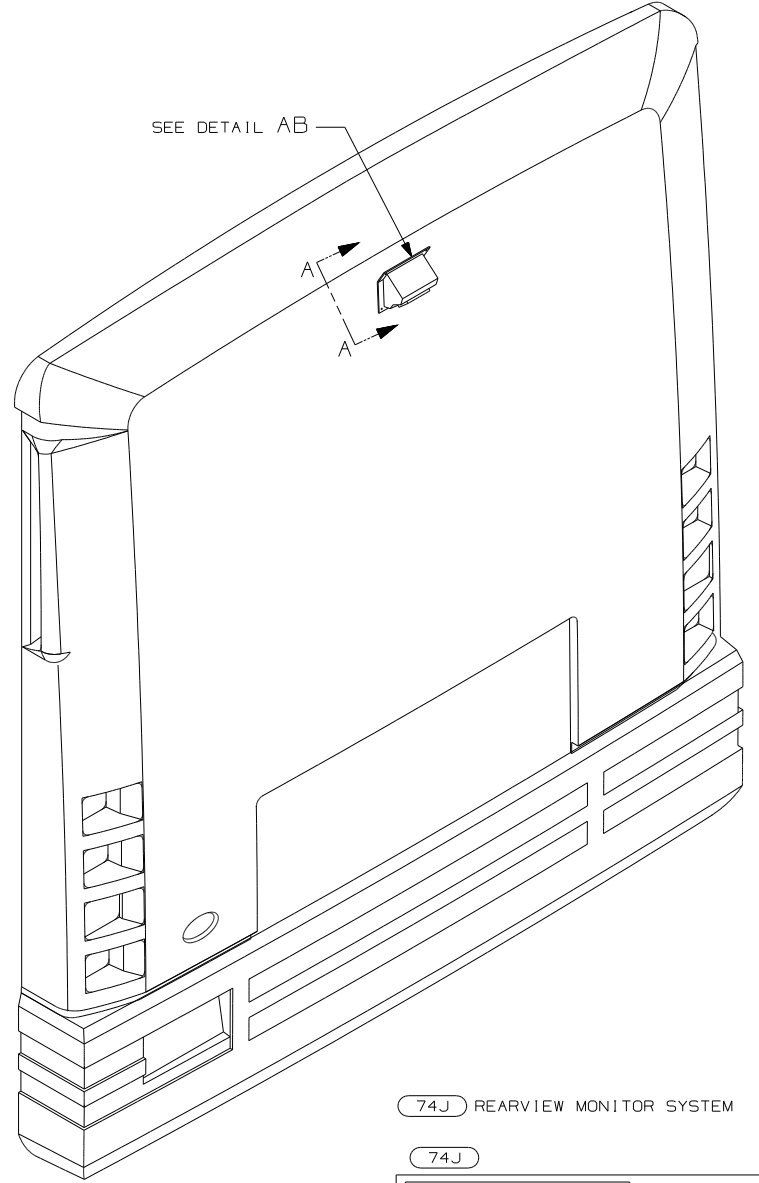
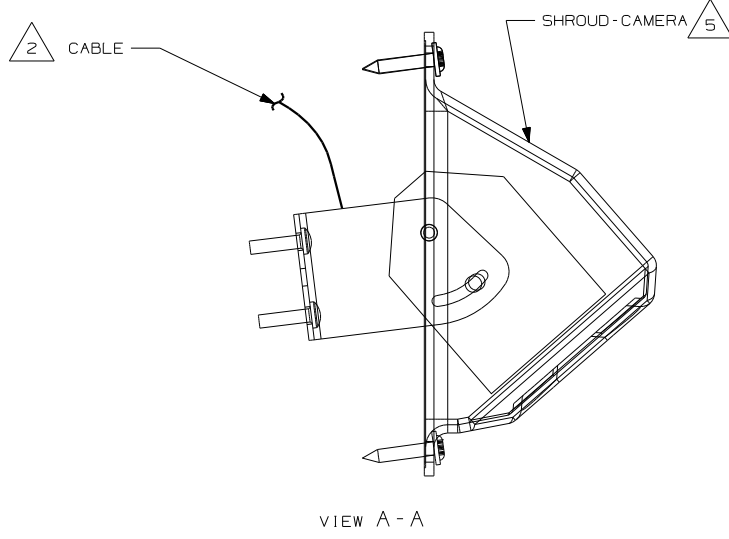
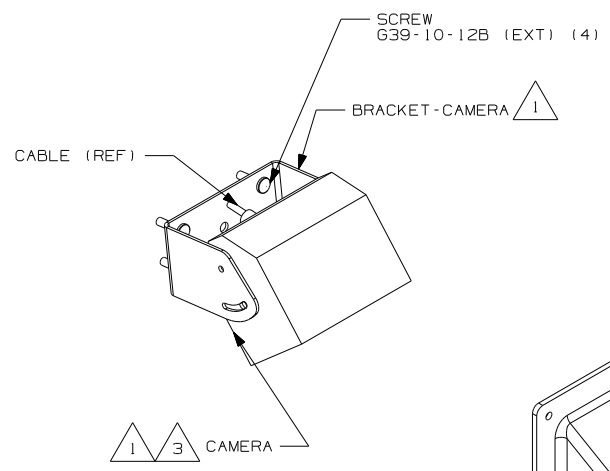
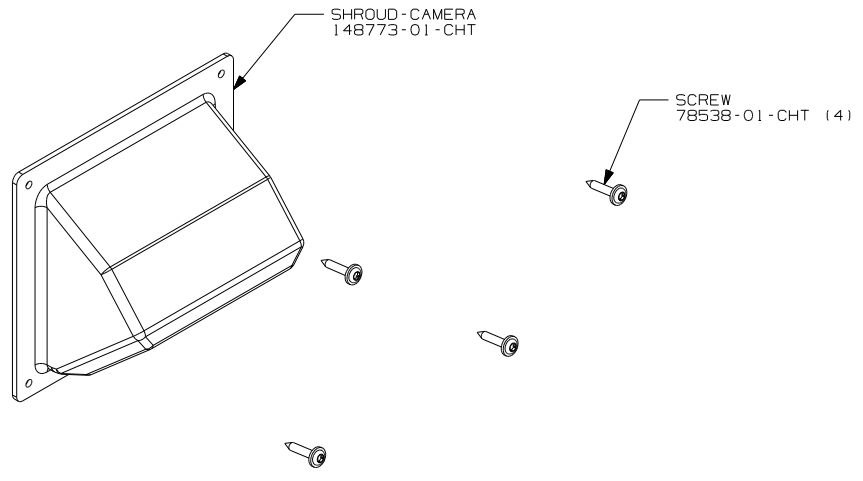
- NOTES:
- 5 SEE PANEL-REAR CAP FOR LOCATION.
 - 4 PARTS SUPPLIED WITH MONITOR P/N 143363-01-000.
 - 3 ALIGN TV SYSTEM CENTER OF SHROUD OPENING.
 - 2 RUN CABLE THRU LEFT HAND COVE TO FRONT OF UNIT AND DOWN LEFT A-PILLAR TO MONITOR.
 - 1 PARTS SUPPLIED WITH REAR CAMERA P/N 143363-05-000.
