FIRST USED	04 Q40ED
DO NOT SCALE DRAWING	
TITLE	WIRING DIAGRAM-BODY, 110V
SHEET	PART NO 146405

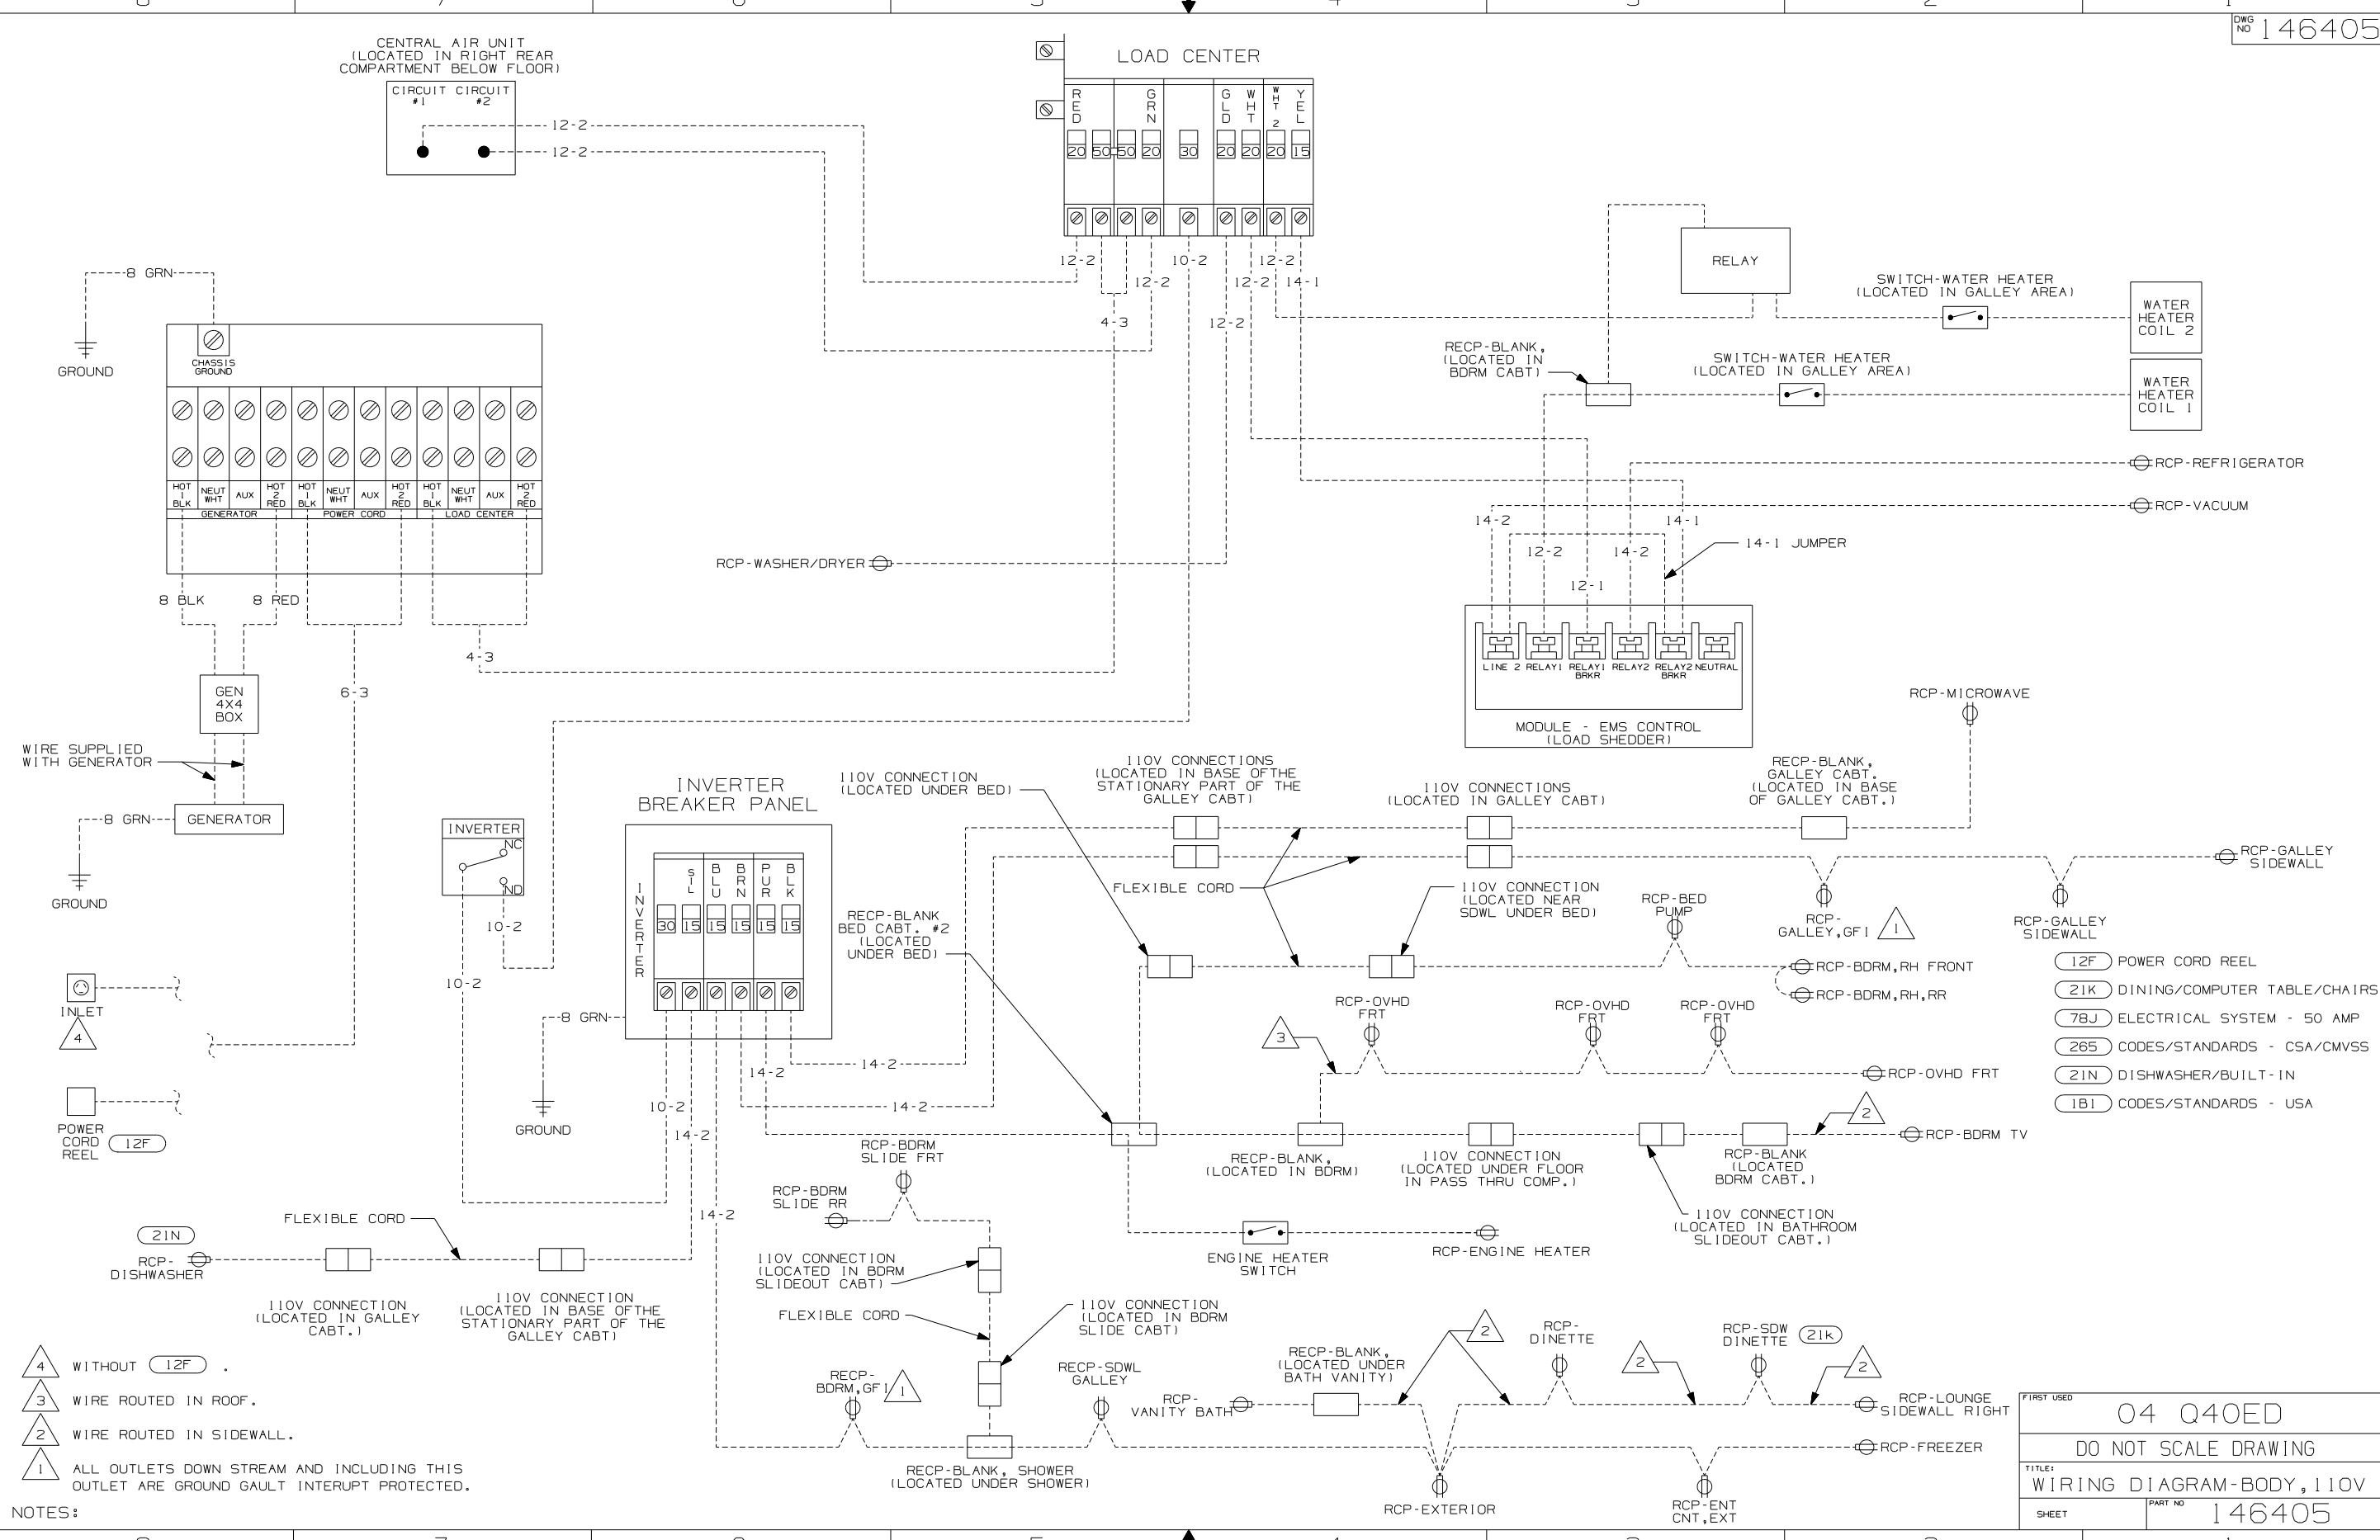
CENTRAL AIR UNIT
(LOCATED IN RIGHT REAR
COMPARTMENT BELOW FLOOR)

LOAD CENTER
