TITLE:  
**WIRING DIAGRAM-BODY, 110V**

SHEET 1 OF 1 PART NO 150945

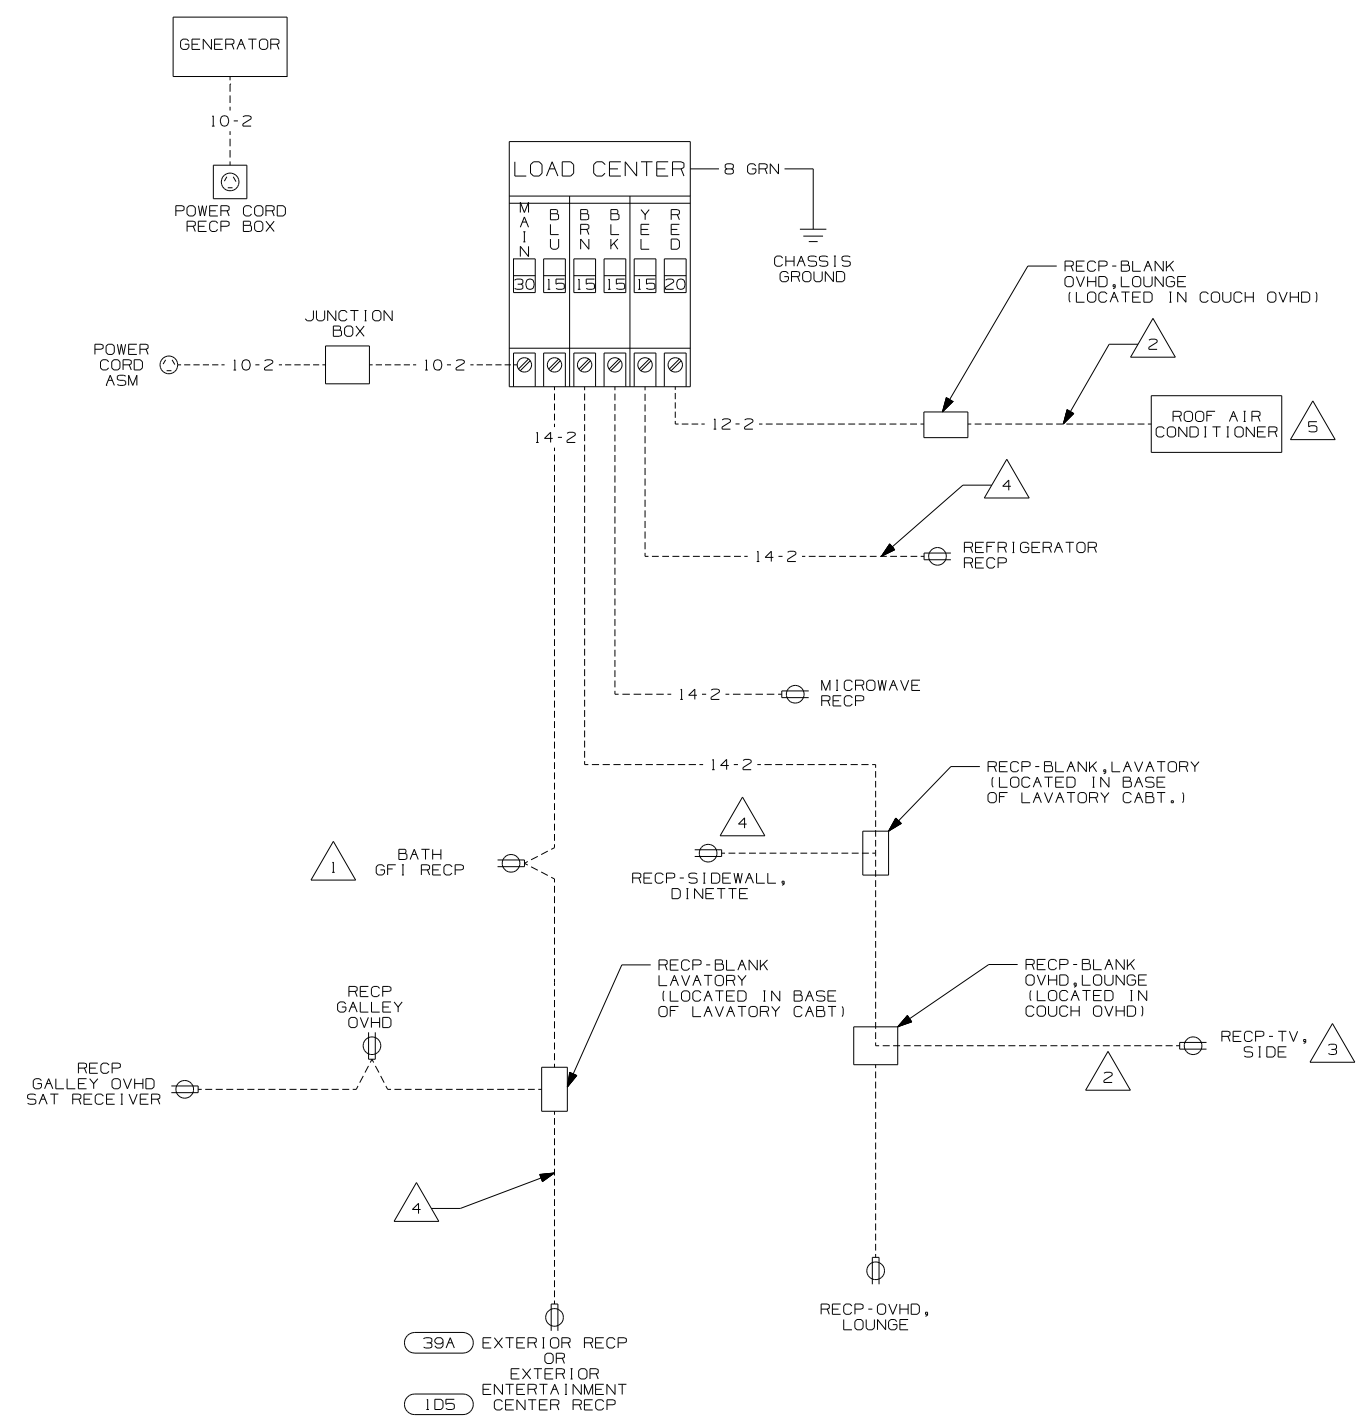
- 5 SEE MANUFACTURERS DIAGRAM.
- 4 WIRE ROUTED THRU FLOOR.
- 3 NOT USED WITH (1JR).
- 2 WIRE ROUTED IN ROOF.
- 1 ALL OUTLETS DOWN STREAM AND INCLUDING THIS OUTLET ARE GROUND FAULT CIRCUIT INTERRUPT PROTECTED.
