<b>WINNEBAGO</b>		COPYRIGHT 2004 WINNEBAGO INDUSTRIES, INC.	
DFTR	ORIG. DATE		
CHKR	ALL DIMENSIONS ARE IN MILLIMETERS		
P.E.	FIRST USED	05 327L	
M.E.			
DSNR			
UNSPECIFIED TOLERANCES ARE:		MATERIAL:	
WHOLE DIM (X)	:		.
ONE-PLACE (X.X)	:		.
TWO-PLACE (X.XX)	:		.
ANGLE	:		.
THIRD ANGLE PROJECTION			
DO NOT SCALE DRAWING			
TITLE: WIRING DIAGRAM-BODY, 110V			
SHEET 1 OF 1	PART NO	151146

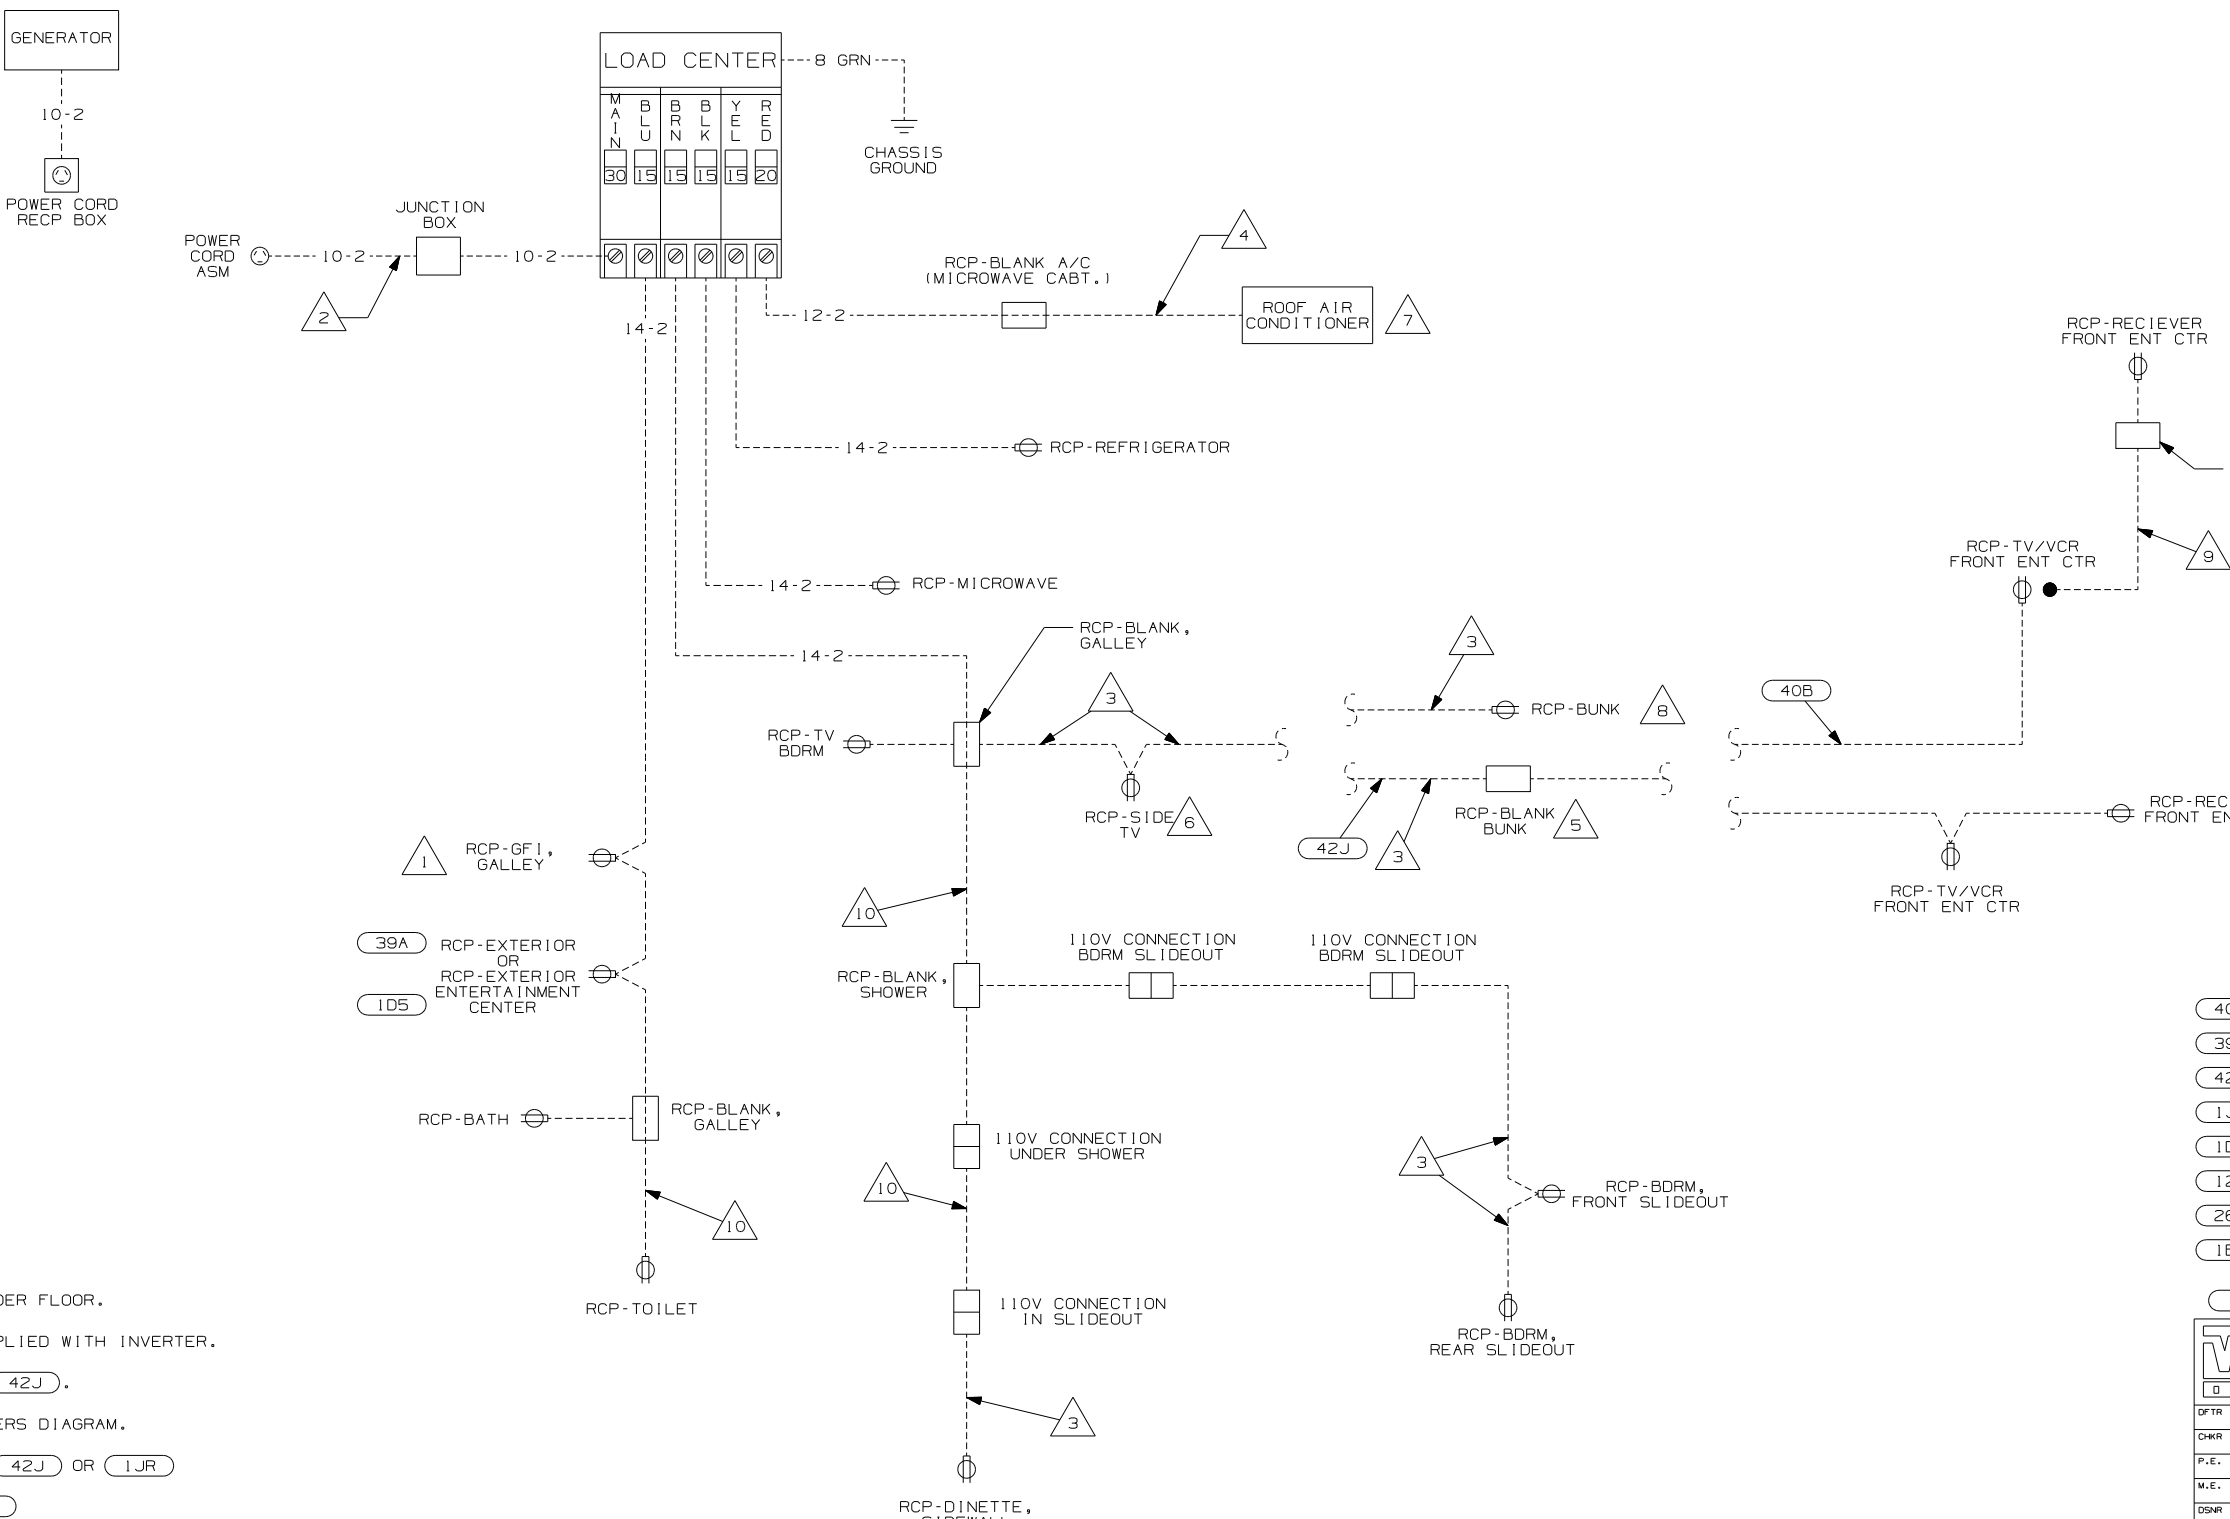
- 10 WIRE ROUTED UNDER FLOOR.
- 9 POWER CORD SUPPLIED WITH INVERTER.
- 8 NOT USED WITH (42J).
- 7 SEE MANUFACTURERS DIAGRAM.
- 6 NOT USED WITH (42J) OR (1JR)
- 5 ONLY WITH (42J)
- 4 WIRE ROUTED THRU ROOF.
- 3 WIRE ROUTED THRU SIDEWALL.
- 2 WIRE ROUTED THRU FLOOR.
- 1 ALL OUTLETS DOWN STREAM AND INCLUDING THIS OUTLET ARE GROUND FAULT CIRCUIT INTERRUPT PROTECTED.
