<b>WINNEBAGO</b>		COPYRIGHT 2004 WINNEBAGO INDUSTRIES, INC.	
DFTR	ORIG. DATE	ALL DIMENSIONS ARE IN MILLIMETERS	
CHKR		FIRST USED	
P.E.		05 S40KD	
M.E.		UNSPECIFIED TOLERANCES ARE:	
DSNR		MATERIAL:	
		WHOLE DIM (X)	:
		ONE-PLACE (X.X)	:
		TWO-PLACE (X.XX)	:
		ANGLE	:
		THIRD ANGLE PROJECTION	
<b>DO NOT SCALE DRAWING</b>			
TITLE: WIRING DIAGRAM-BODY,110V			
SHEET 1 OF 1	PART NO	150113	
REF: 147321-E 1 11/17/2004

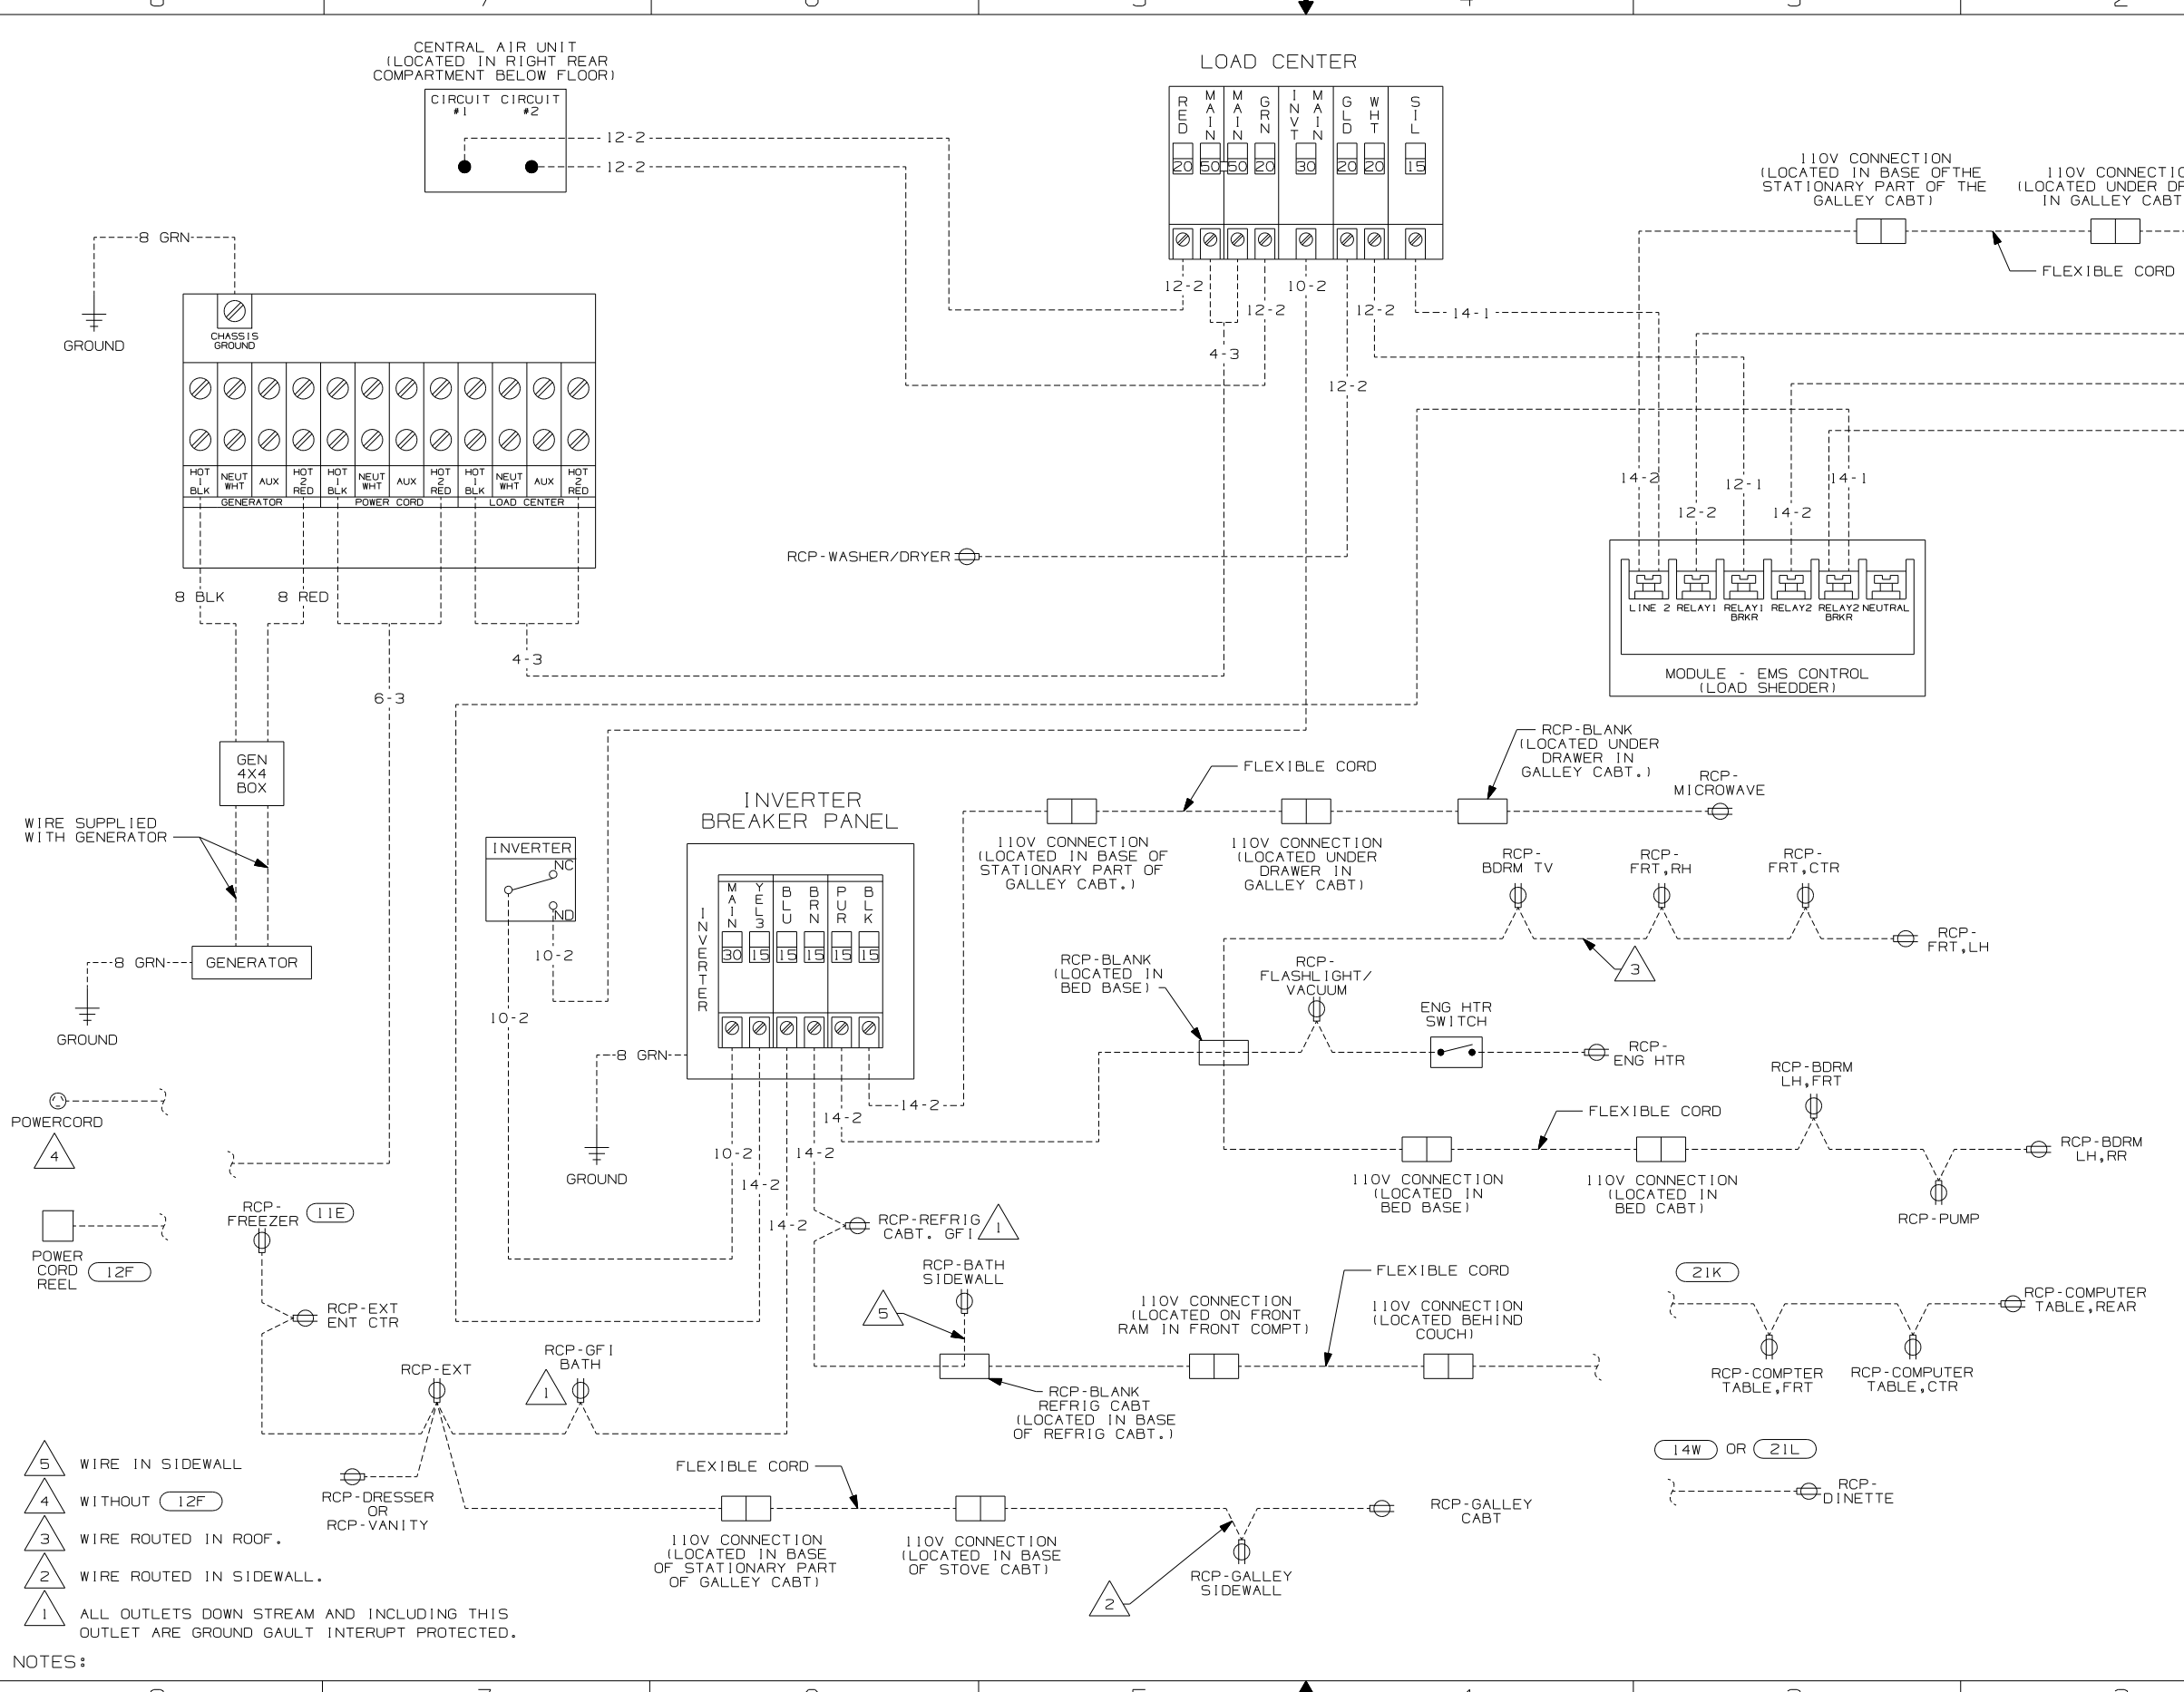
- 5 WIRE IN SIDEWALL
- 4 WITHOUT (12F)
- 3 WIRE ROUTED IN ROOF.
- 2 WIRE ROUTED IN SIDEWALL.
- 1 ALL OUTLETS DOWN STREAM AND INCLUDING THIS OUTLET ARE GROUND GAULT INTERRUPT PROTECTED.

- (11E) REFRIGERATOR/FREEZER PORTABL
- (21N) DISHWASHER/BUILT-IN
- (21L) DINING TABLE/CHAIRS
- (21K) DINING/COMPUTER TABLE/CHAIRS
- (14W) DINETTE
- (12F) POWER CORD REEL
- (265) CODES/STANDARDS - CSA/CMVSS
- (1B1) CODES/STANDARDS - USA
