WINNEBAGO		COPYRIGHT 2006 WINNEBAGO INDUSTRIES, INC.	
DFTR	ORIG. DATE		
CHKR		ALL DIMENSIONS ARE IN MILLIMETERS	
P.E.			
M.E.	FIRST USED	07 G35L	
DSNR			
UNSPECIFIED TOLERANCES ARE:		MATERIAL:	
WHOLE DIM (X)	:	1	
ONE-PLACE (X.X)	:		
TWO-PLACE (X.XX)	:		
ANGLE	:		
THIRD ANGLE PROJECTION			
DO NOT SCALE DRAWING			
TITLE: WIRING DIAGRAM-BODY, 110V			
SHEET 1 of 1	PART NO	159396	REV
REF:	1 6/16/2006

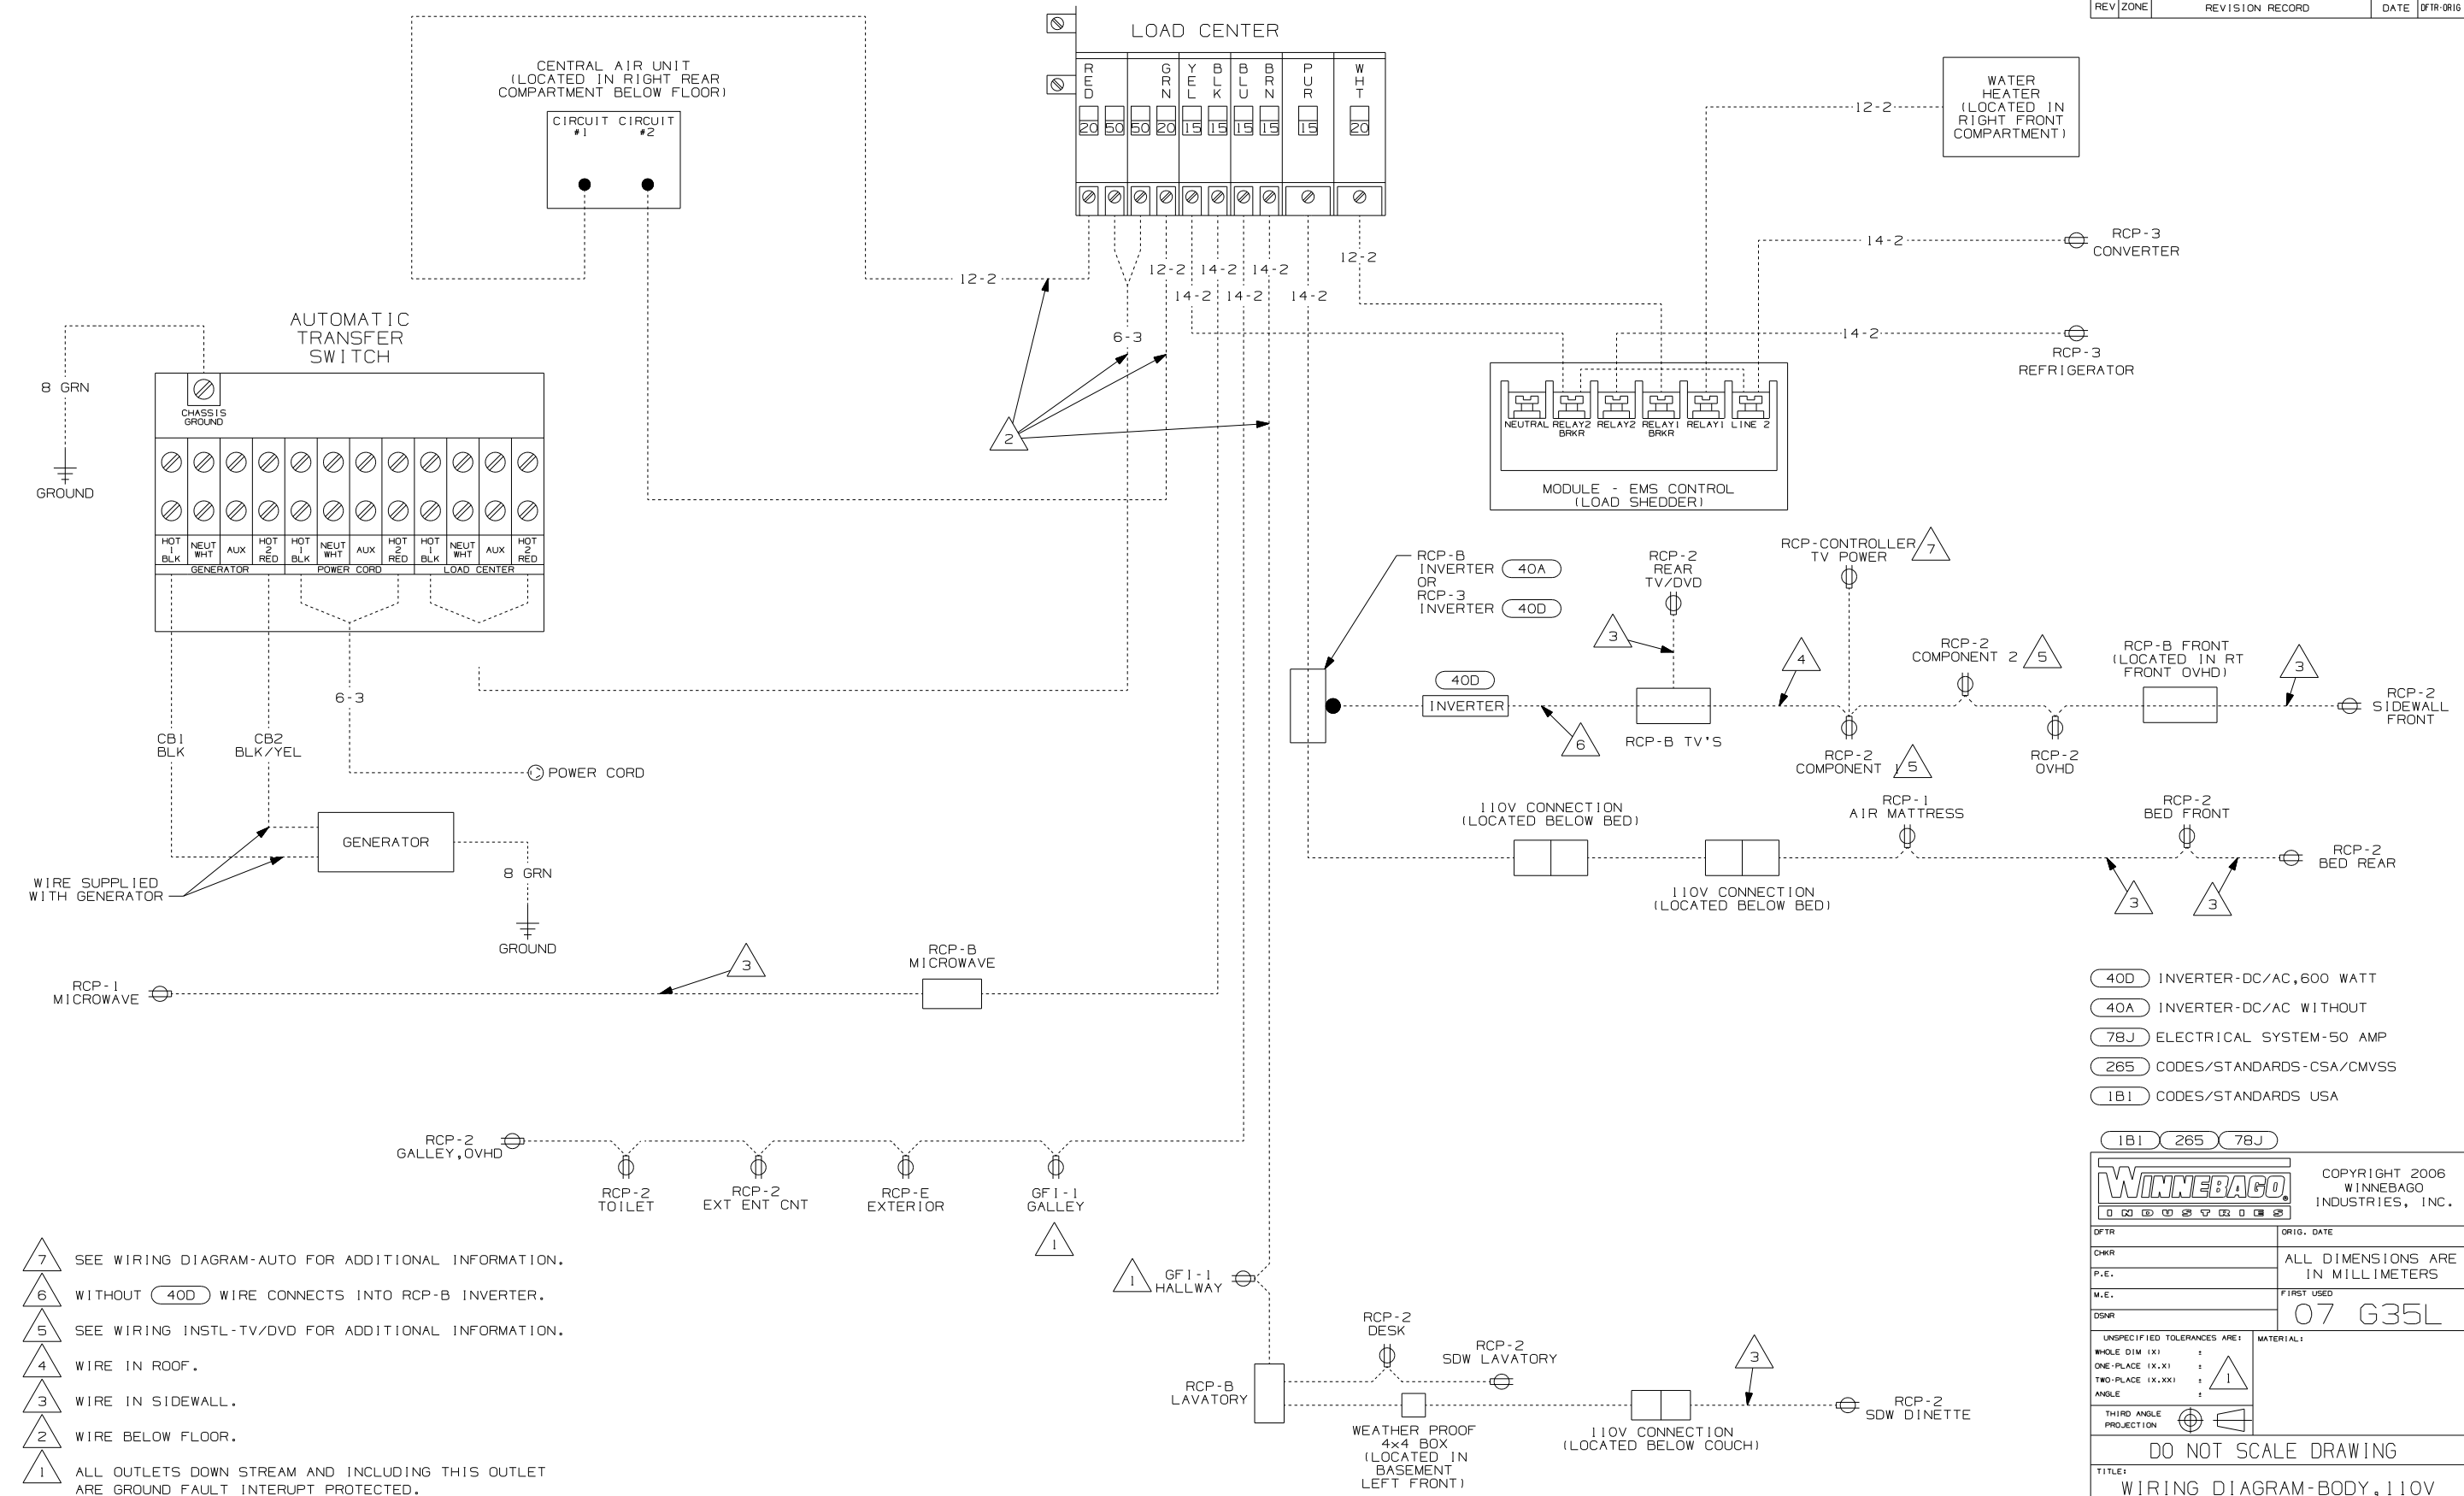
- NOTES:
- 7 SEE WIRING DIAGRAM-AUTO FOR ADDITIONAL INFORMATION.
 - 6 WITHOUT (40D) WIRE CONNECTS INTO RCP-B INVERTER.
 - 5 SEE WIRING INSTL-TV/DVD FOR ADDITIONAL INFORMATION.
 - 4 WIRE IN ROOF.
 - 3 WIRE IN SIDEWALL.
 - 2 WIRE BELOW FLOOR.
 - 1 ALL OUTLETS DOWN STREAM AND INCLUDING THIS OUTLET ARE GROUND FAULT INTERRUPT PROTECTED.
