| WINNEBAGO | | COPYRIGHT 2006 WINNEBAGO INDUSTRIES, INC. | |
| TITLE: WIRING DIAGRAM-BODY, 110V | | | |
| SHEET 1 of 1 | PART NO | 163768 | REV |

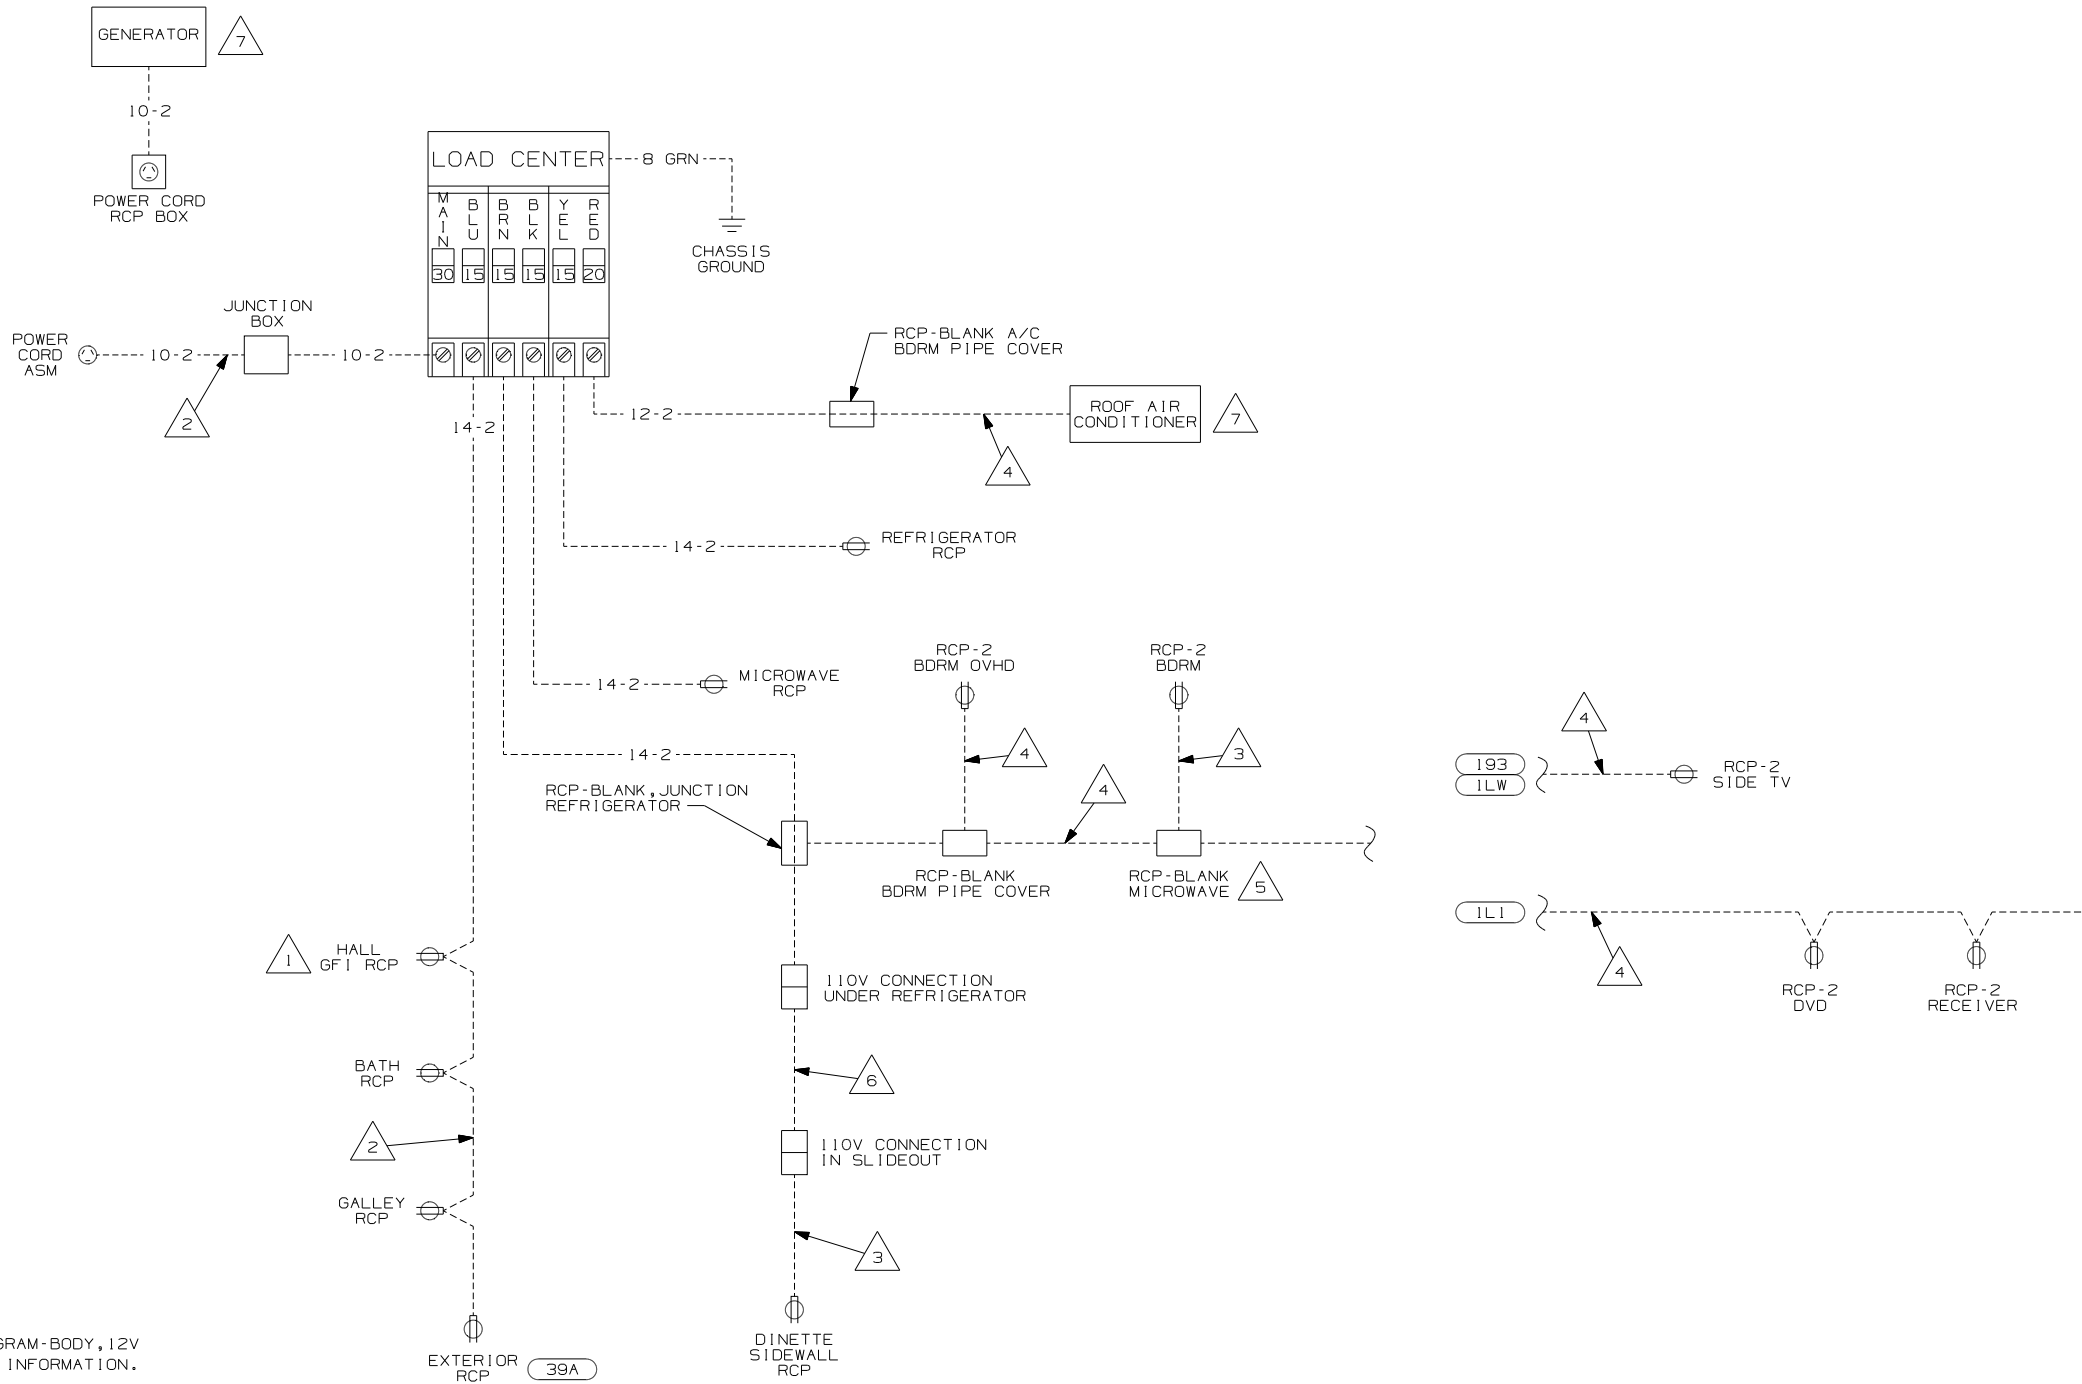
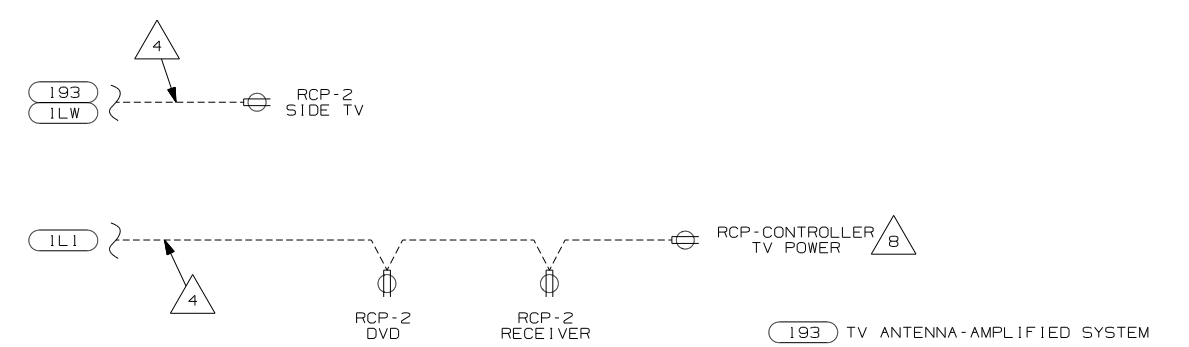
- 193 TV ANTENNA-AMPLIFIED SYSTEM
- 39A EXT RECEPTACLE DPLX 120VAC
- 1L1 TV-27\"/>
