<b>WINNEBAGO</b>		COPYRIGHT 2006 WINNEBAGO INDUSTRIES, INC.	
DFT	ORIG. DATE		
CHKR	ALL DIMENSIONS ARE IN MILLIMETERS		
P.E.	FIRST USED		
M.E.	08 R40TD		
DSNR			
UNSPECIFIED TOLERANCES ARE:		MATERIAL:	
WHOLE DIM (X)	:		
ONE-PLACE (X.X)	:		
TWO-PLACE (X.XX)	:		
ANGLE	:		
THIRD ANGLE PROJECTION			
<b>DO NOT SCALE DRAWING</b>			
TITLE: WIRING DIAGRAM-BODY, 110V			
SHEET 1 OF 1	PART NO	163821	REV
REF:	1 10/16/2007

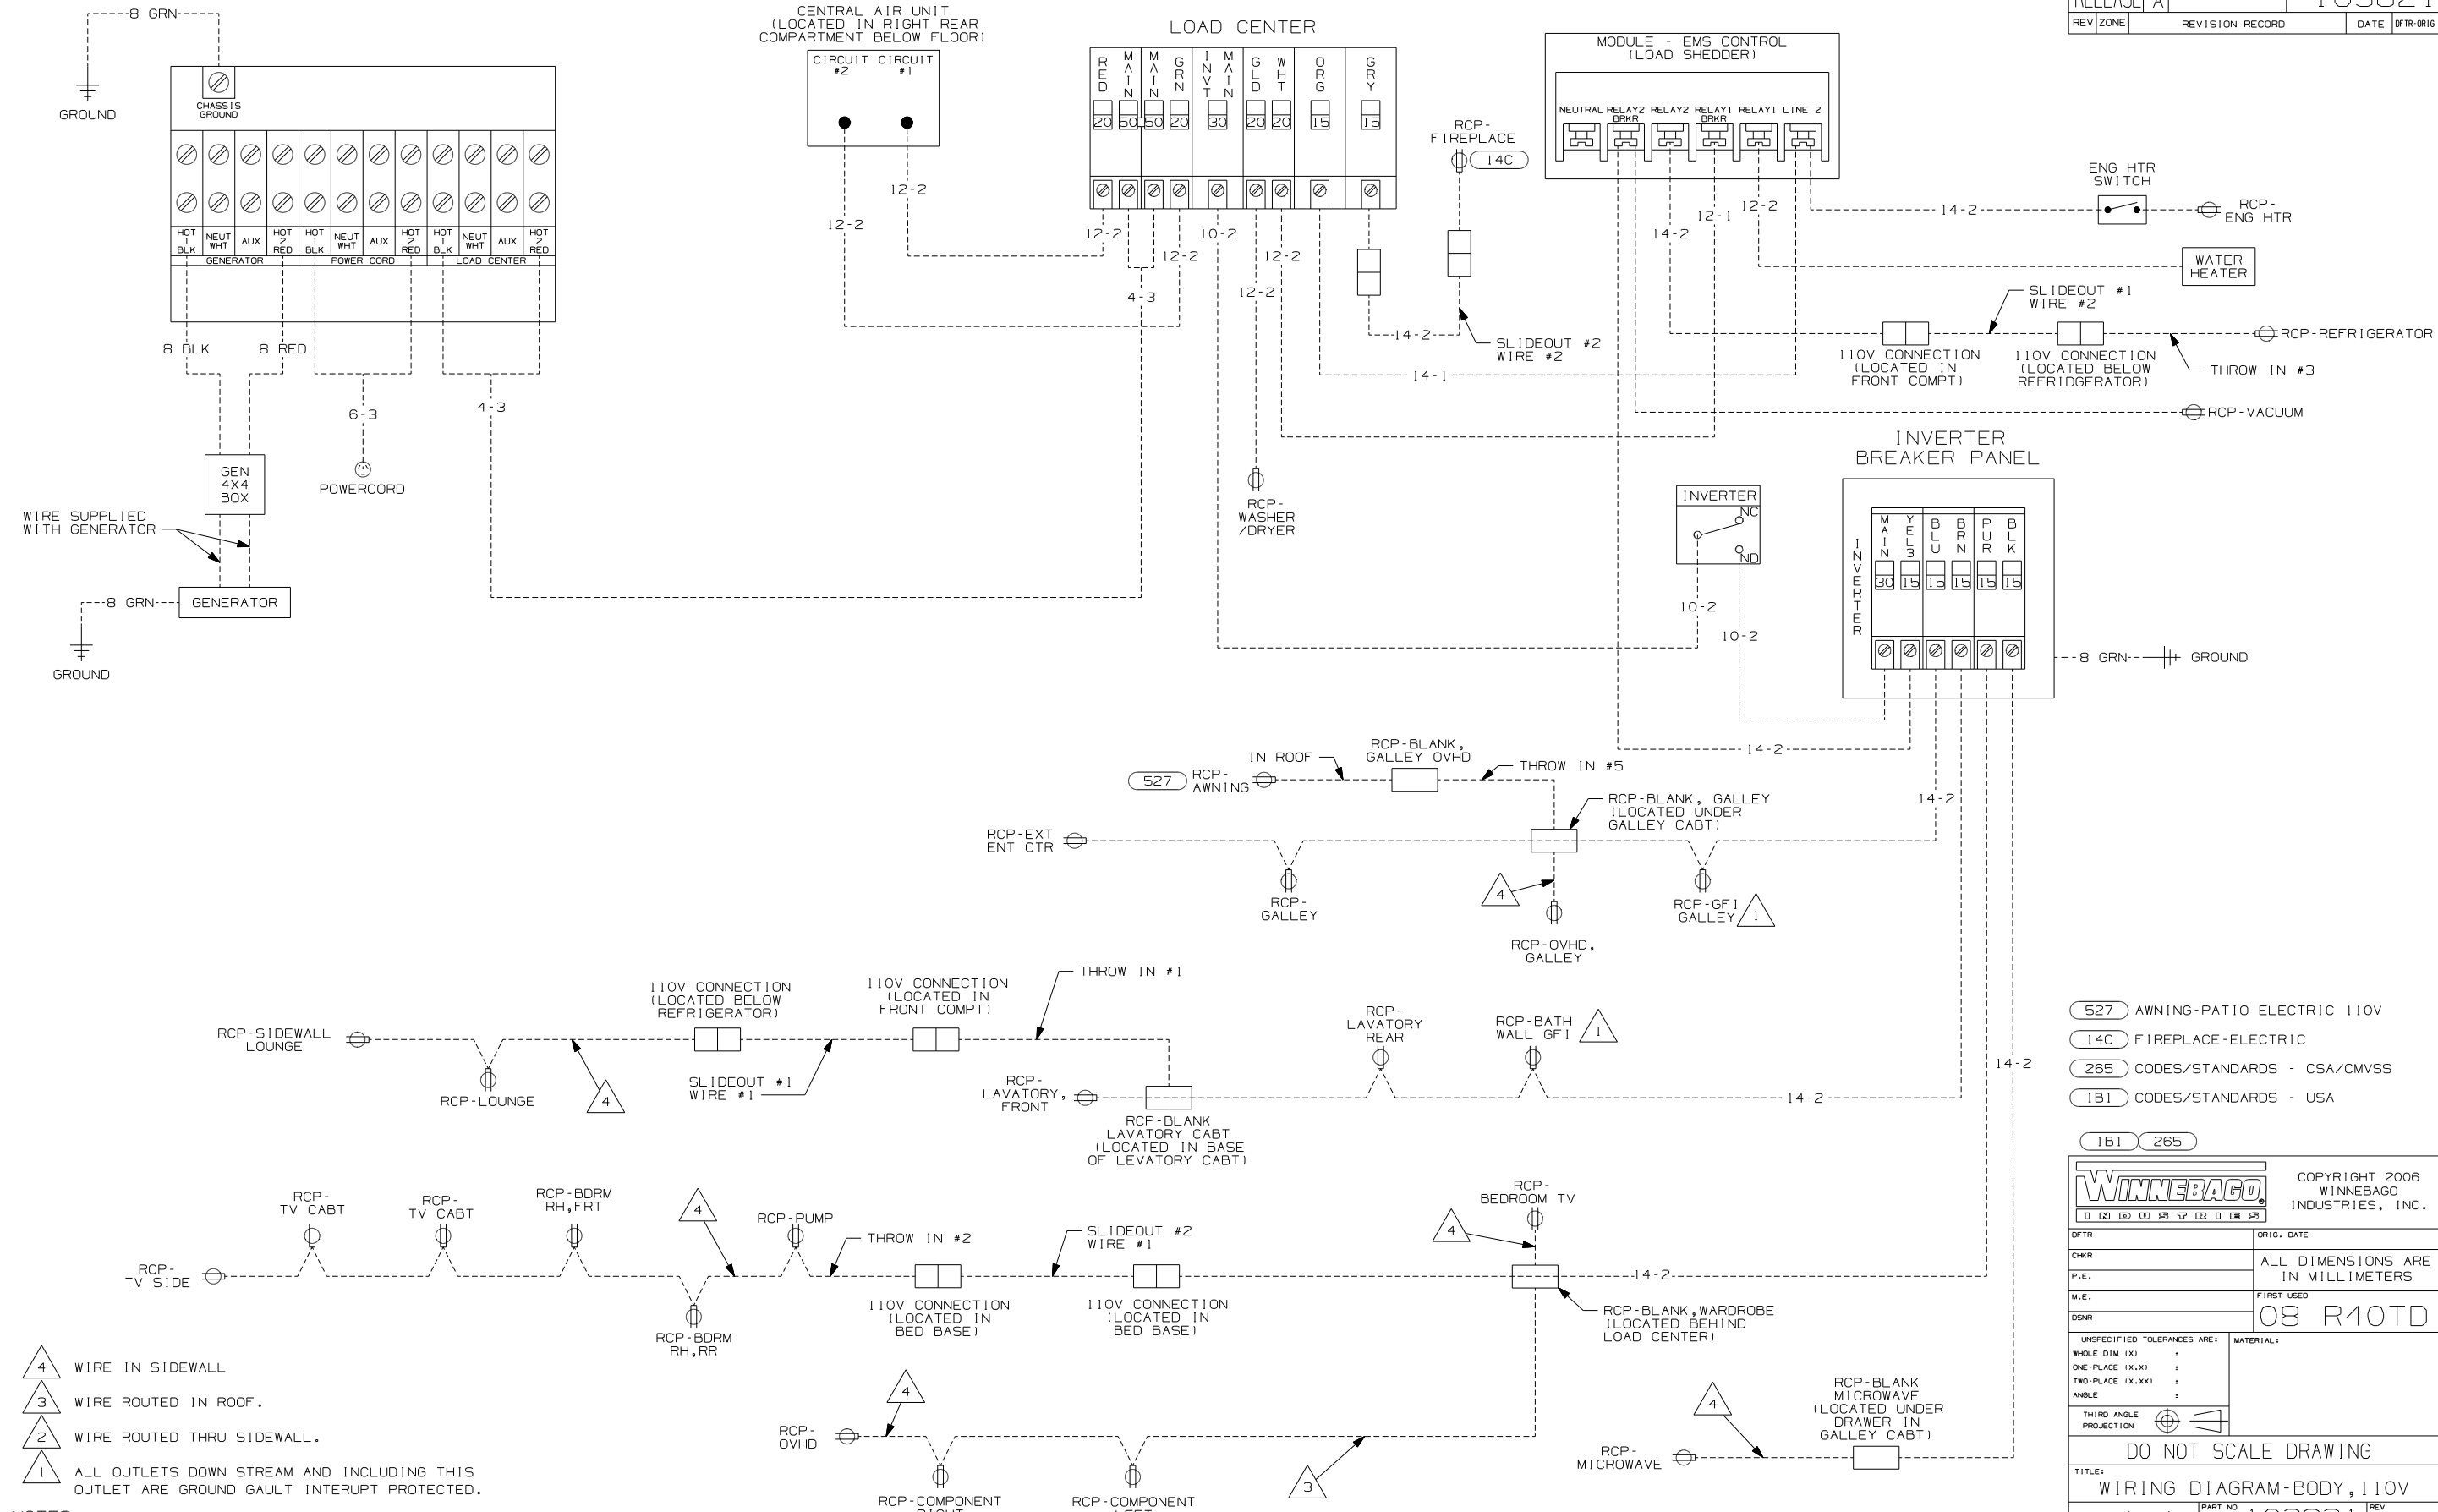
- NOTES:
- 4 WIRE IN SIDEWALL
  - 3 WIRE ROUTED IN ROOF.
  - 2 WIRE ROUTED THRU SIDEWALL.
  - 1 ALL OUTLETS DOWN STREAM AND INCLUDING THIS OUTLET ARE GROUND GAULT INTERRUPT PROTECTED.

- 527 AWNING-PATIO ELECTRIC 110V
- 14C FIREPLACE-ELECTRIC
- 265 CODES/STANDARDS - CSA/CMVSS
- 1B1 CODES/STANDARDS - USA
