WINNEBAGO		COPYRIGHT 2006 WINNEBAGO INDUSTRIES, INC.	
DFTR	ORIG. DATE	ALL DIMENSIONS ARE IN MILLIMETERS	
CHKR		FIRST USED	
P.E.		08 S40KD	
M.E.		UNSPECIFIED TOLERANCES ARE:	
DSNR		MATERIAL:	
		WHOLE DIM (X)	:
		ONE-PLACE (X.X)	:
		TWO-PLACE (X.XX)	:
		ANGLE	:
		THIRD ANGLE PROJECTION	
DO NOT SCALE DRAWING			
TITLE: WIRING DIAGRAM-BODY, 110V			
SHEET 1 OF 1	PART NO	163517	REV
REF:	1 7/23/2007

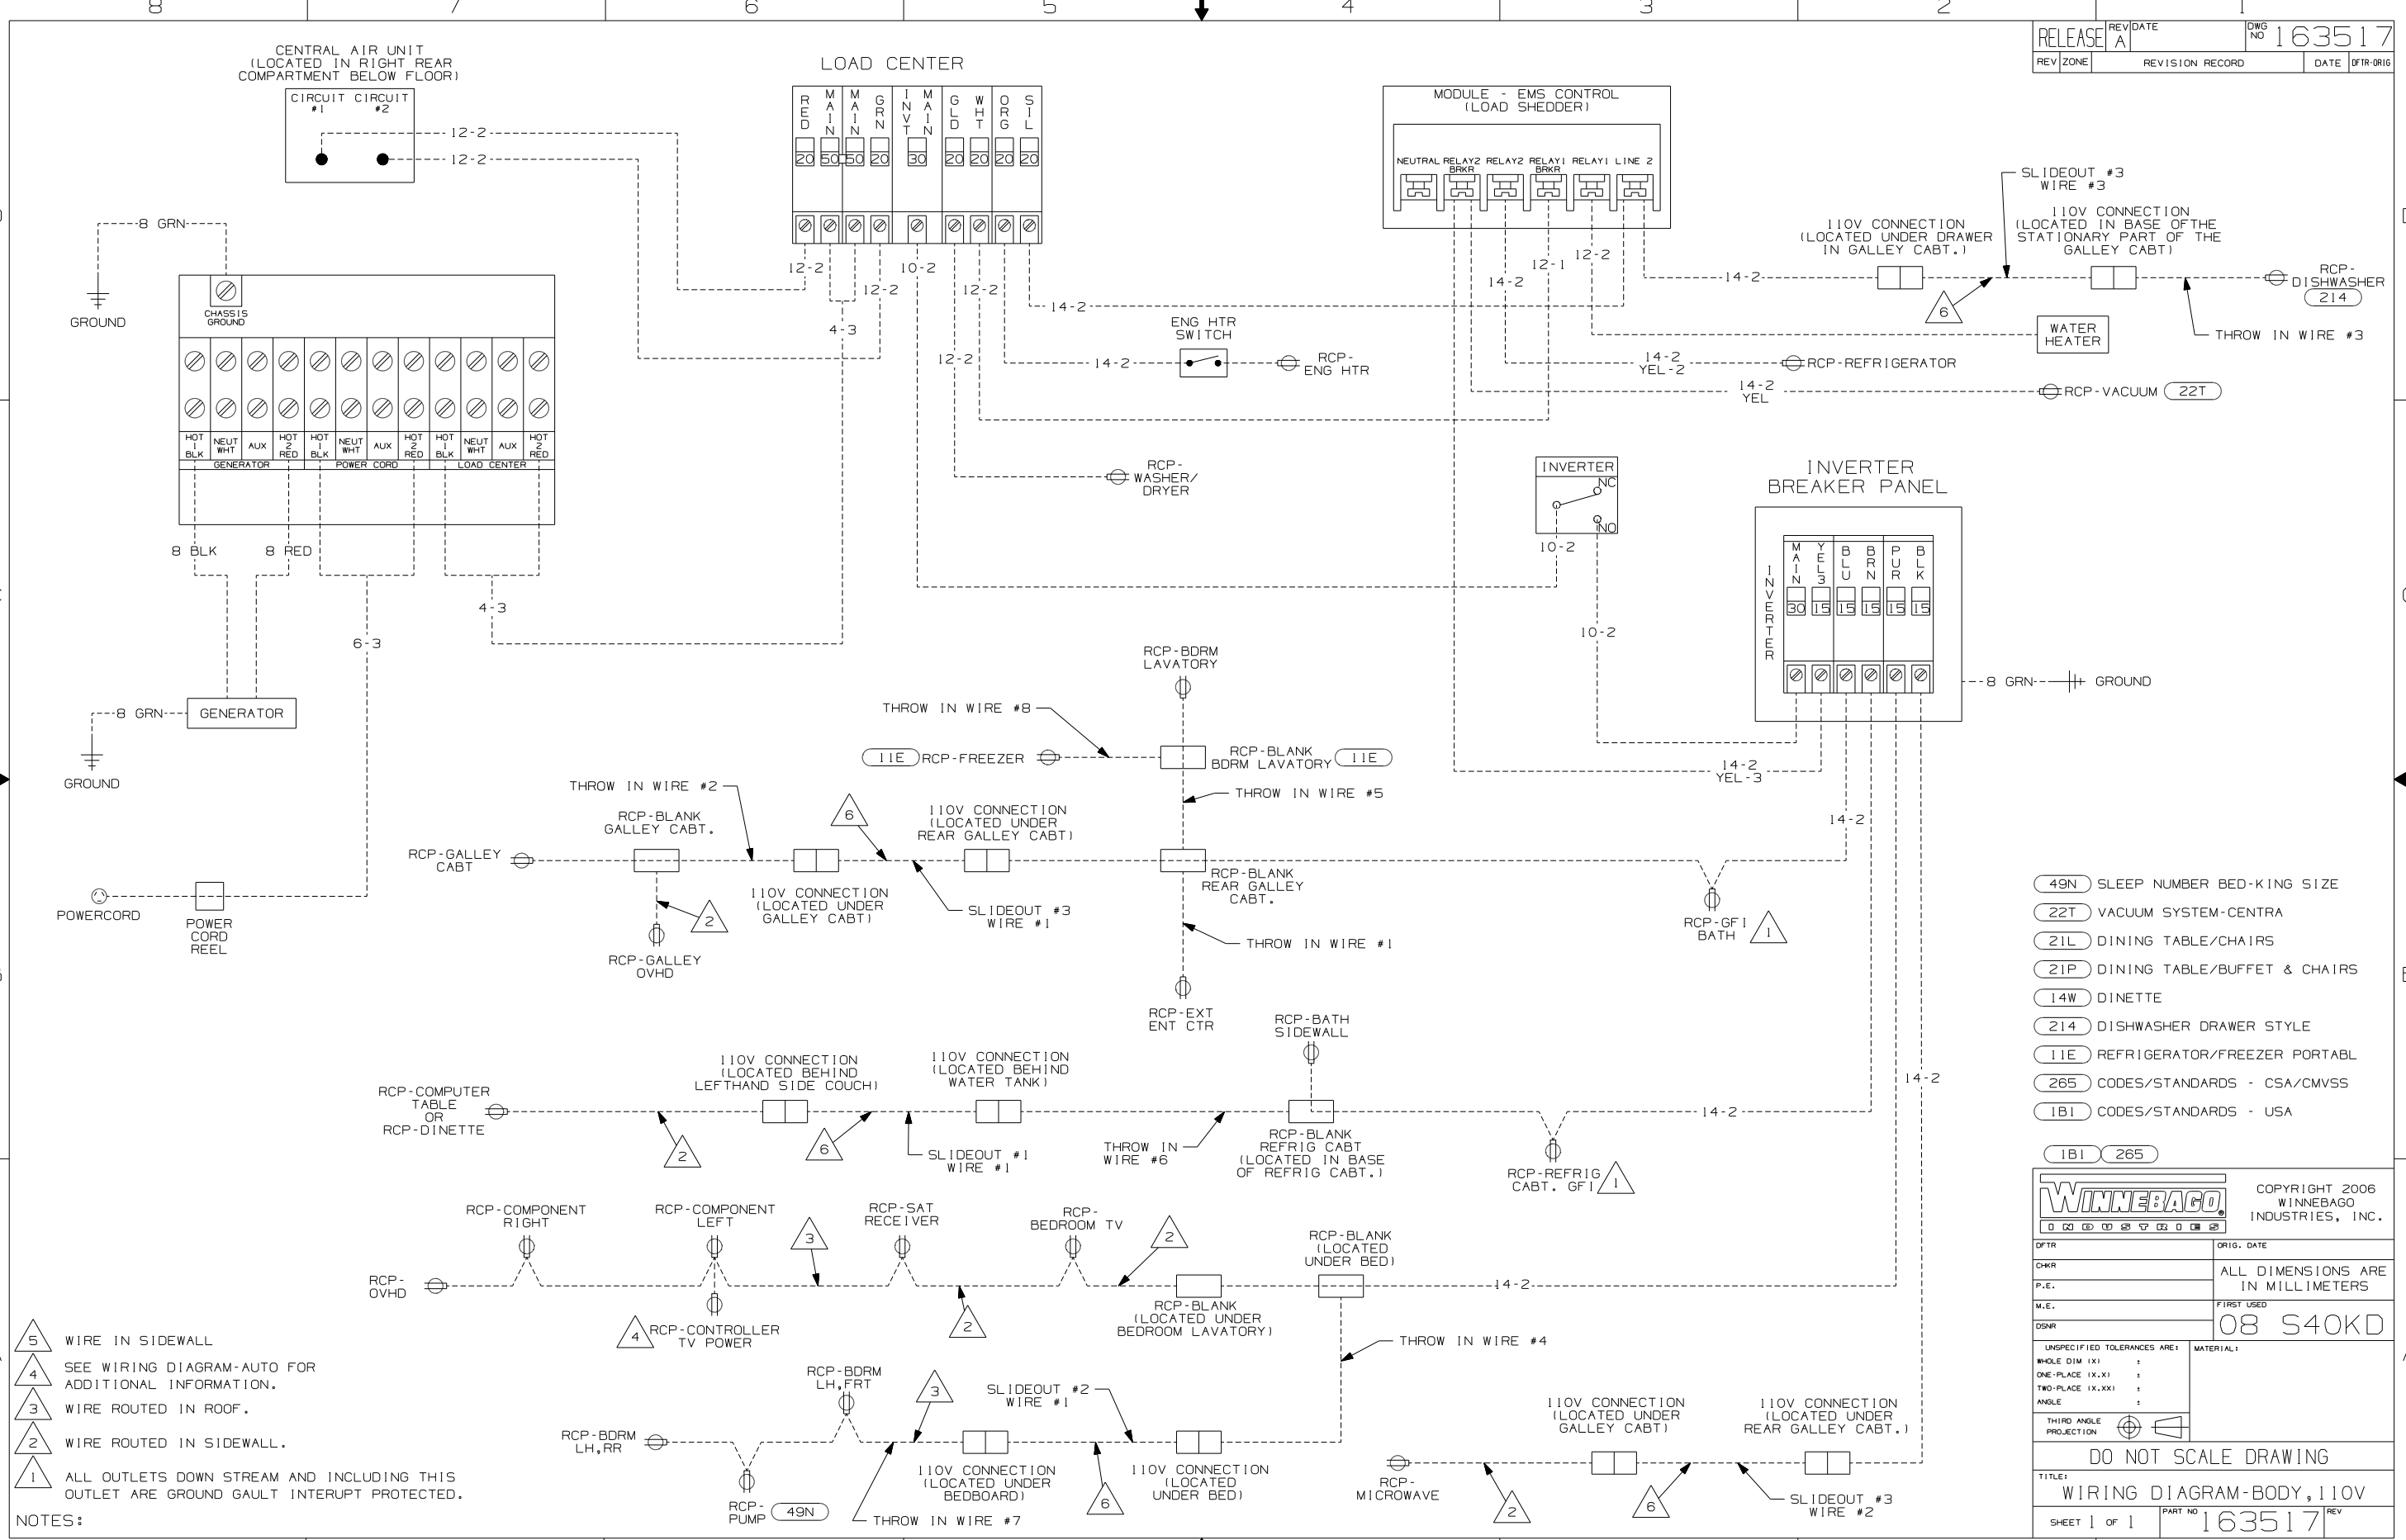
- NOTES:
- 5 WIRE IN SIDEWALL
 - 4 SEE WIRING DIAGRAM-AUTO FOR ADDITIONAL INFORMATION.
 - 3 WIRE ROUTED IN ROOF.
 - 2 WIRE ROUTED IN SIDEWALL.
 - 1 ALL OUTLETS DOWN STREAM AND INCLUDING THIS OUTLET ARE GROUND GAULT INTERRUPT PROTECTED.
