TITLE: WIRING DIAGRAM-BODY, 110V

SHEET 1 OF 1 PART NO. 167661 REV

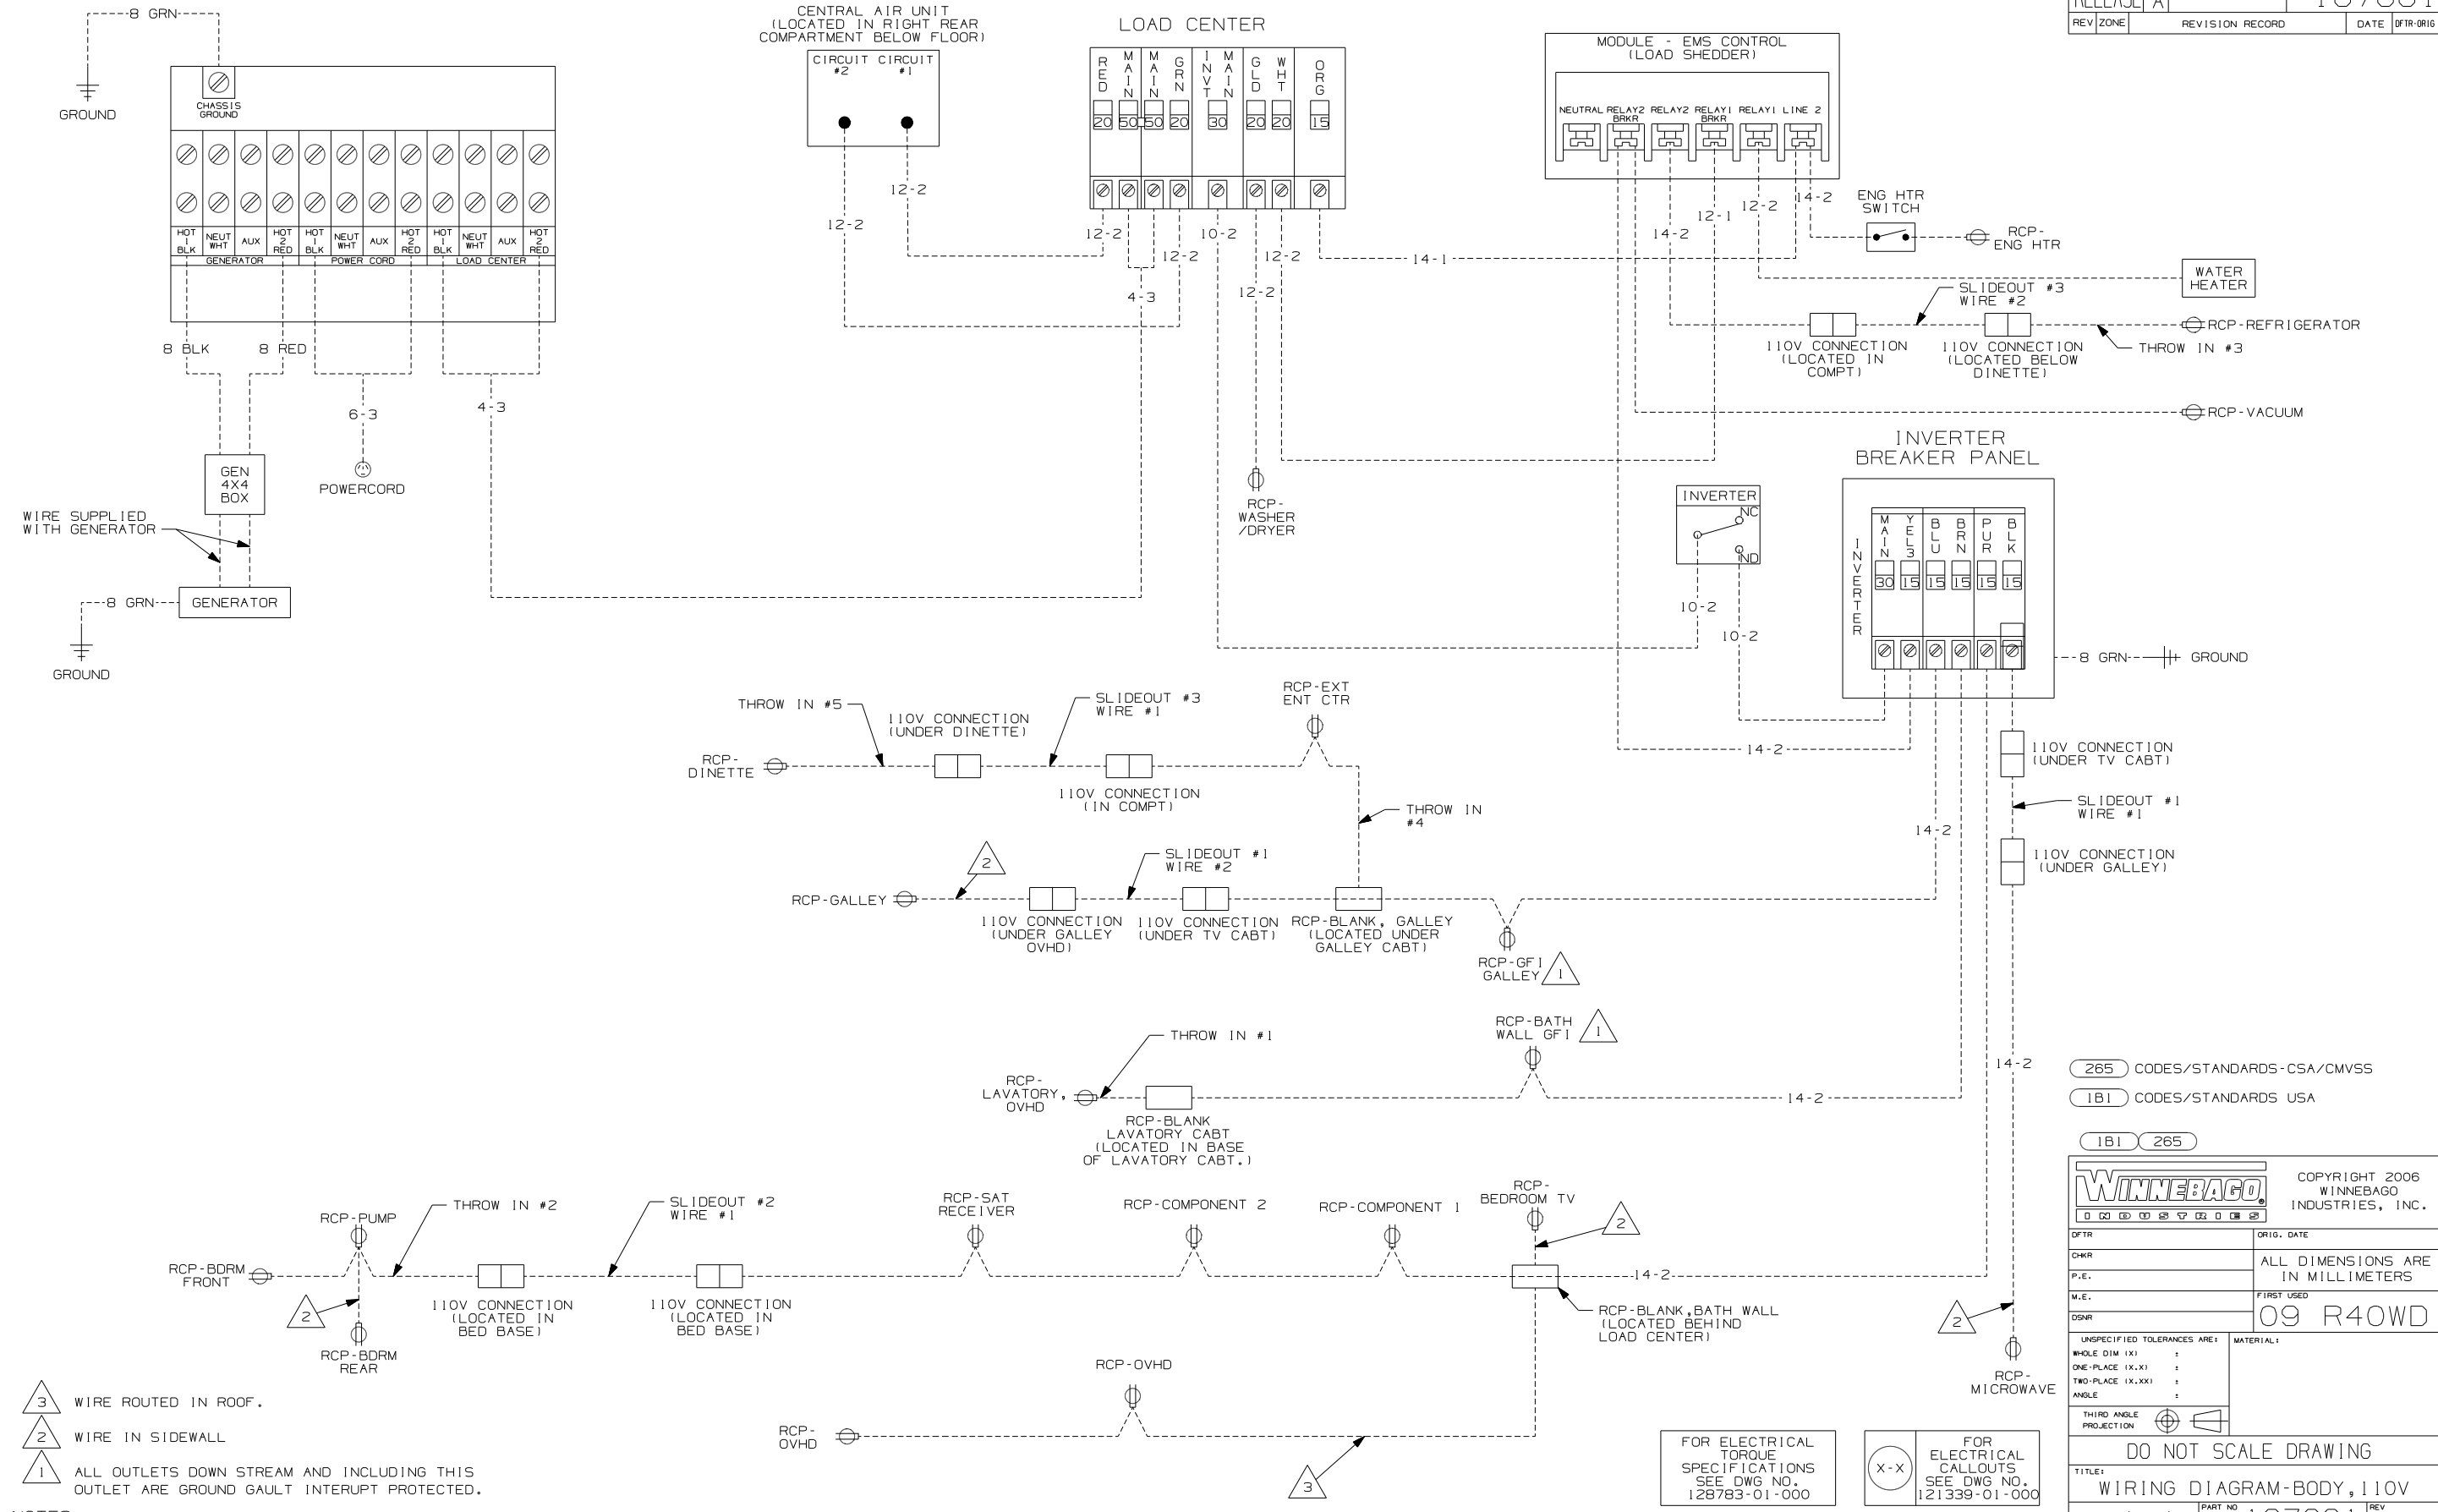
- 3 WIRE ROUTED IN ROOF.
- 2 WIRE IN SIDEWALL
- 1 ALL OUTLETS DOWN STREAM AND INCLUDING THIS OUTLET ARE GROUND GAULT INTERRUPT PROTECTED.
