<b>WINNEBAGO</b>		COPYRIGHT 2008 WINNEBAGO INDUSTRIES, INC.	
DFTR	ORIG. DATE		
CHKR	ALL DIMENSIONS ARE IN MILLIMETERS		
P.E.			
M.E.	FIRST USED		
DSNR	10 231J		
UNSPECIFIED TOLERANCES ARE:		MATERIAL:	
WHOLE DIM (X)	:		
ONE-PLACE (X.X)	:		
TWO-PLACE (X.XX)	:		
ANGLE	:		
THIRD ANGLE PROJECTION			
DO NOT SCALE DRAWING			
TITLE: WIRING DIAGRAM-BODY, 110V			
SHEET 1 OF 1	PART NO	170014	REV
REF:		1 8/27/2008

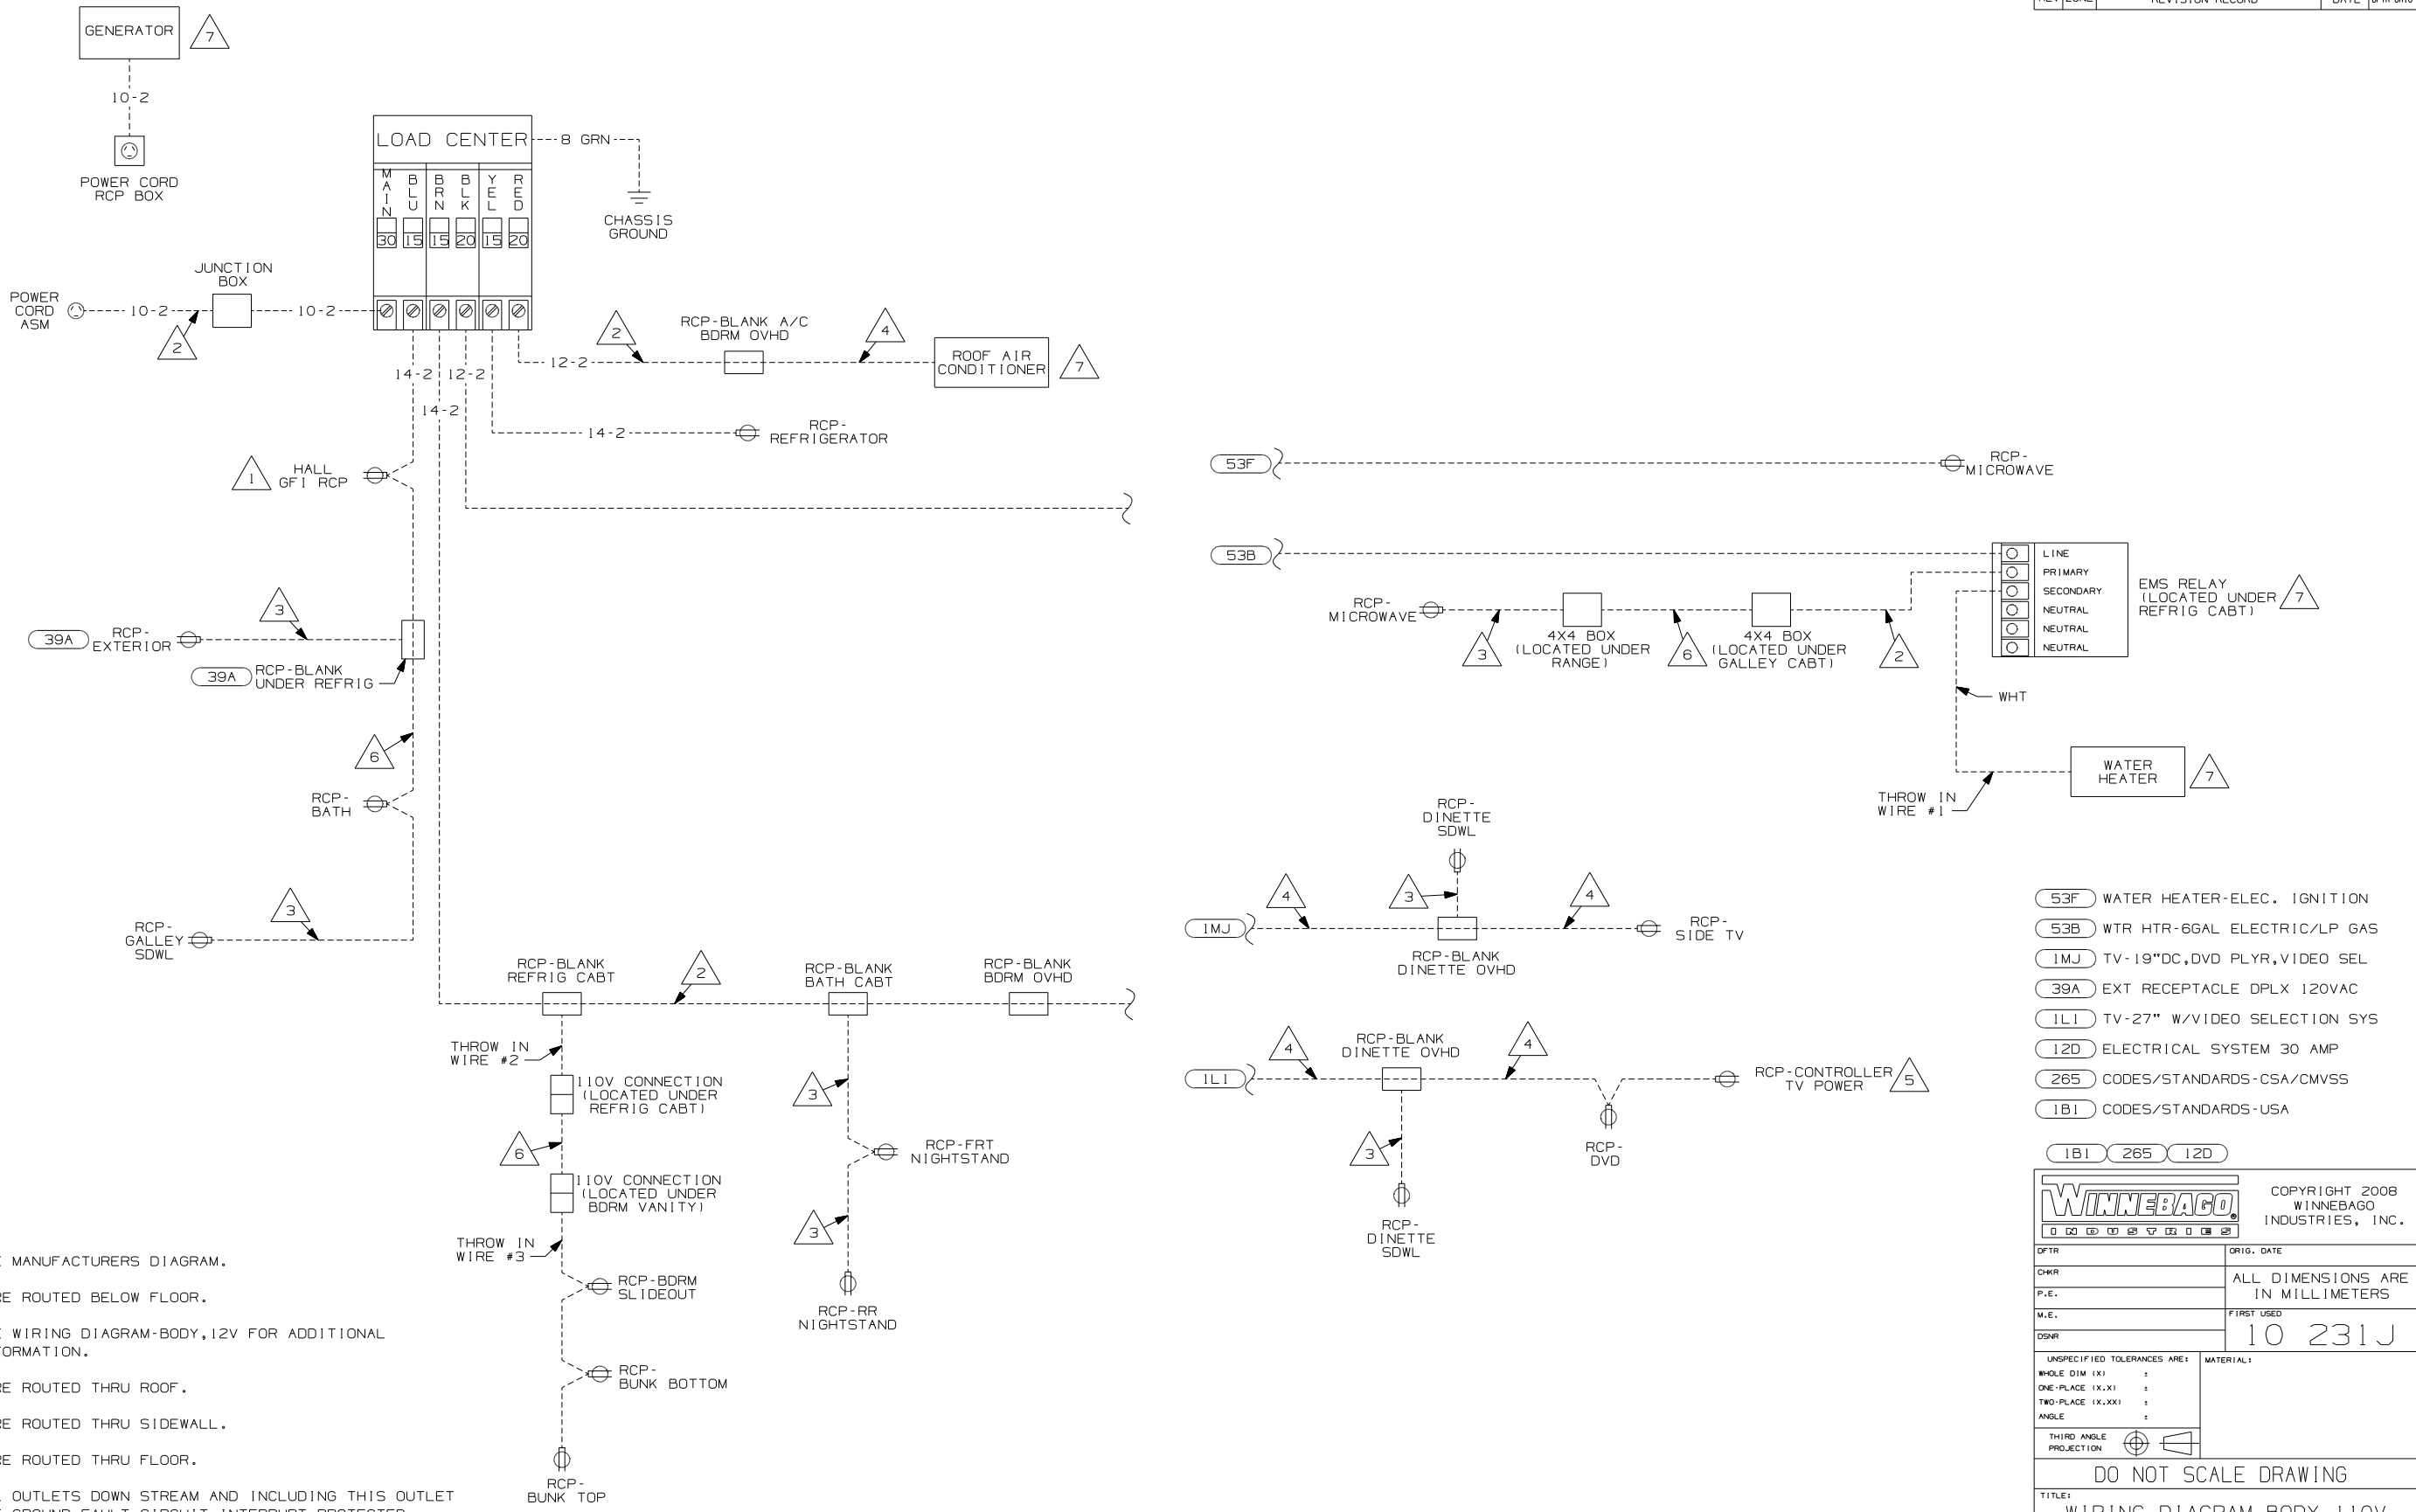
- 7 SEE MANUFACTURERS DIAGRAM.
- 6 WIRE ROUTED BELOW FLOOR.
- 5 SEE WIRING DIAGRAM-BODY,12V FOR ADDITIONAL INFORMATION.
- 4 WIRE ROUTED THRU ROOF.
- 3 WIRE ROUTED THRU SIDEWALL.
- 2 WIRE ROUTED THRU FLOOR.
- 1 ALL OUTLETS DOWN STREAM AND INCLUDING THIS OUTLET ARE GROUND FAULT CIRCUIT INTERRUPT PROTECTED.
