WINNEBAGO		COPYRIGHT 2009 WINNEBAGO INDUSTRIES, INC.	
DFTR	ORIG. DATE		
CHKR	ALL DIMENSIONS ARE IN MILLIMETERS		
P.E.			
M.E.	FIRST USED	10 P34Y	
DSNR			
UNSPECIFIED TOLERANCES ARE:		MATERIAL:	
WHOLE DIM (X)	:	X	
ONE-PLACE (X.X)	:	X	
TWO-PLACE (X.XX)	:	X	
ANGLE	:	X	
THIRD ANGLE PROJECTION	:	X	
DO NOT SCALE DRAWING			
TITLE: WIRING DIAGRAM-BODY, 110V			
SHEET 1 OF 1	PART NO	173541	REV
REF:	1 10/28/2009

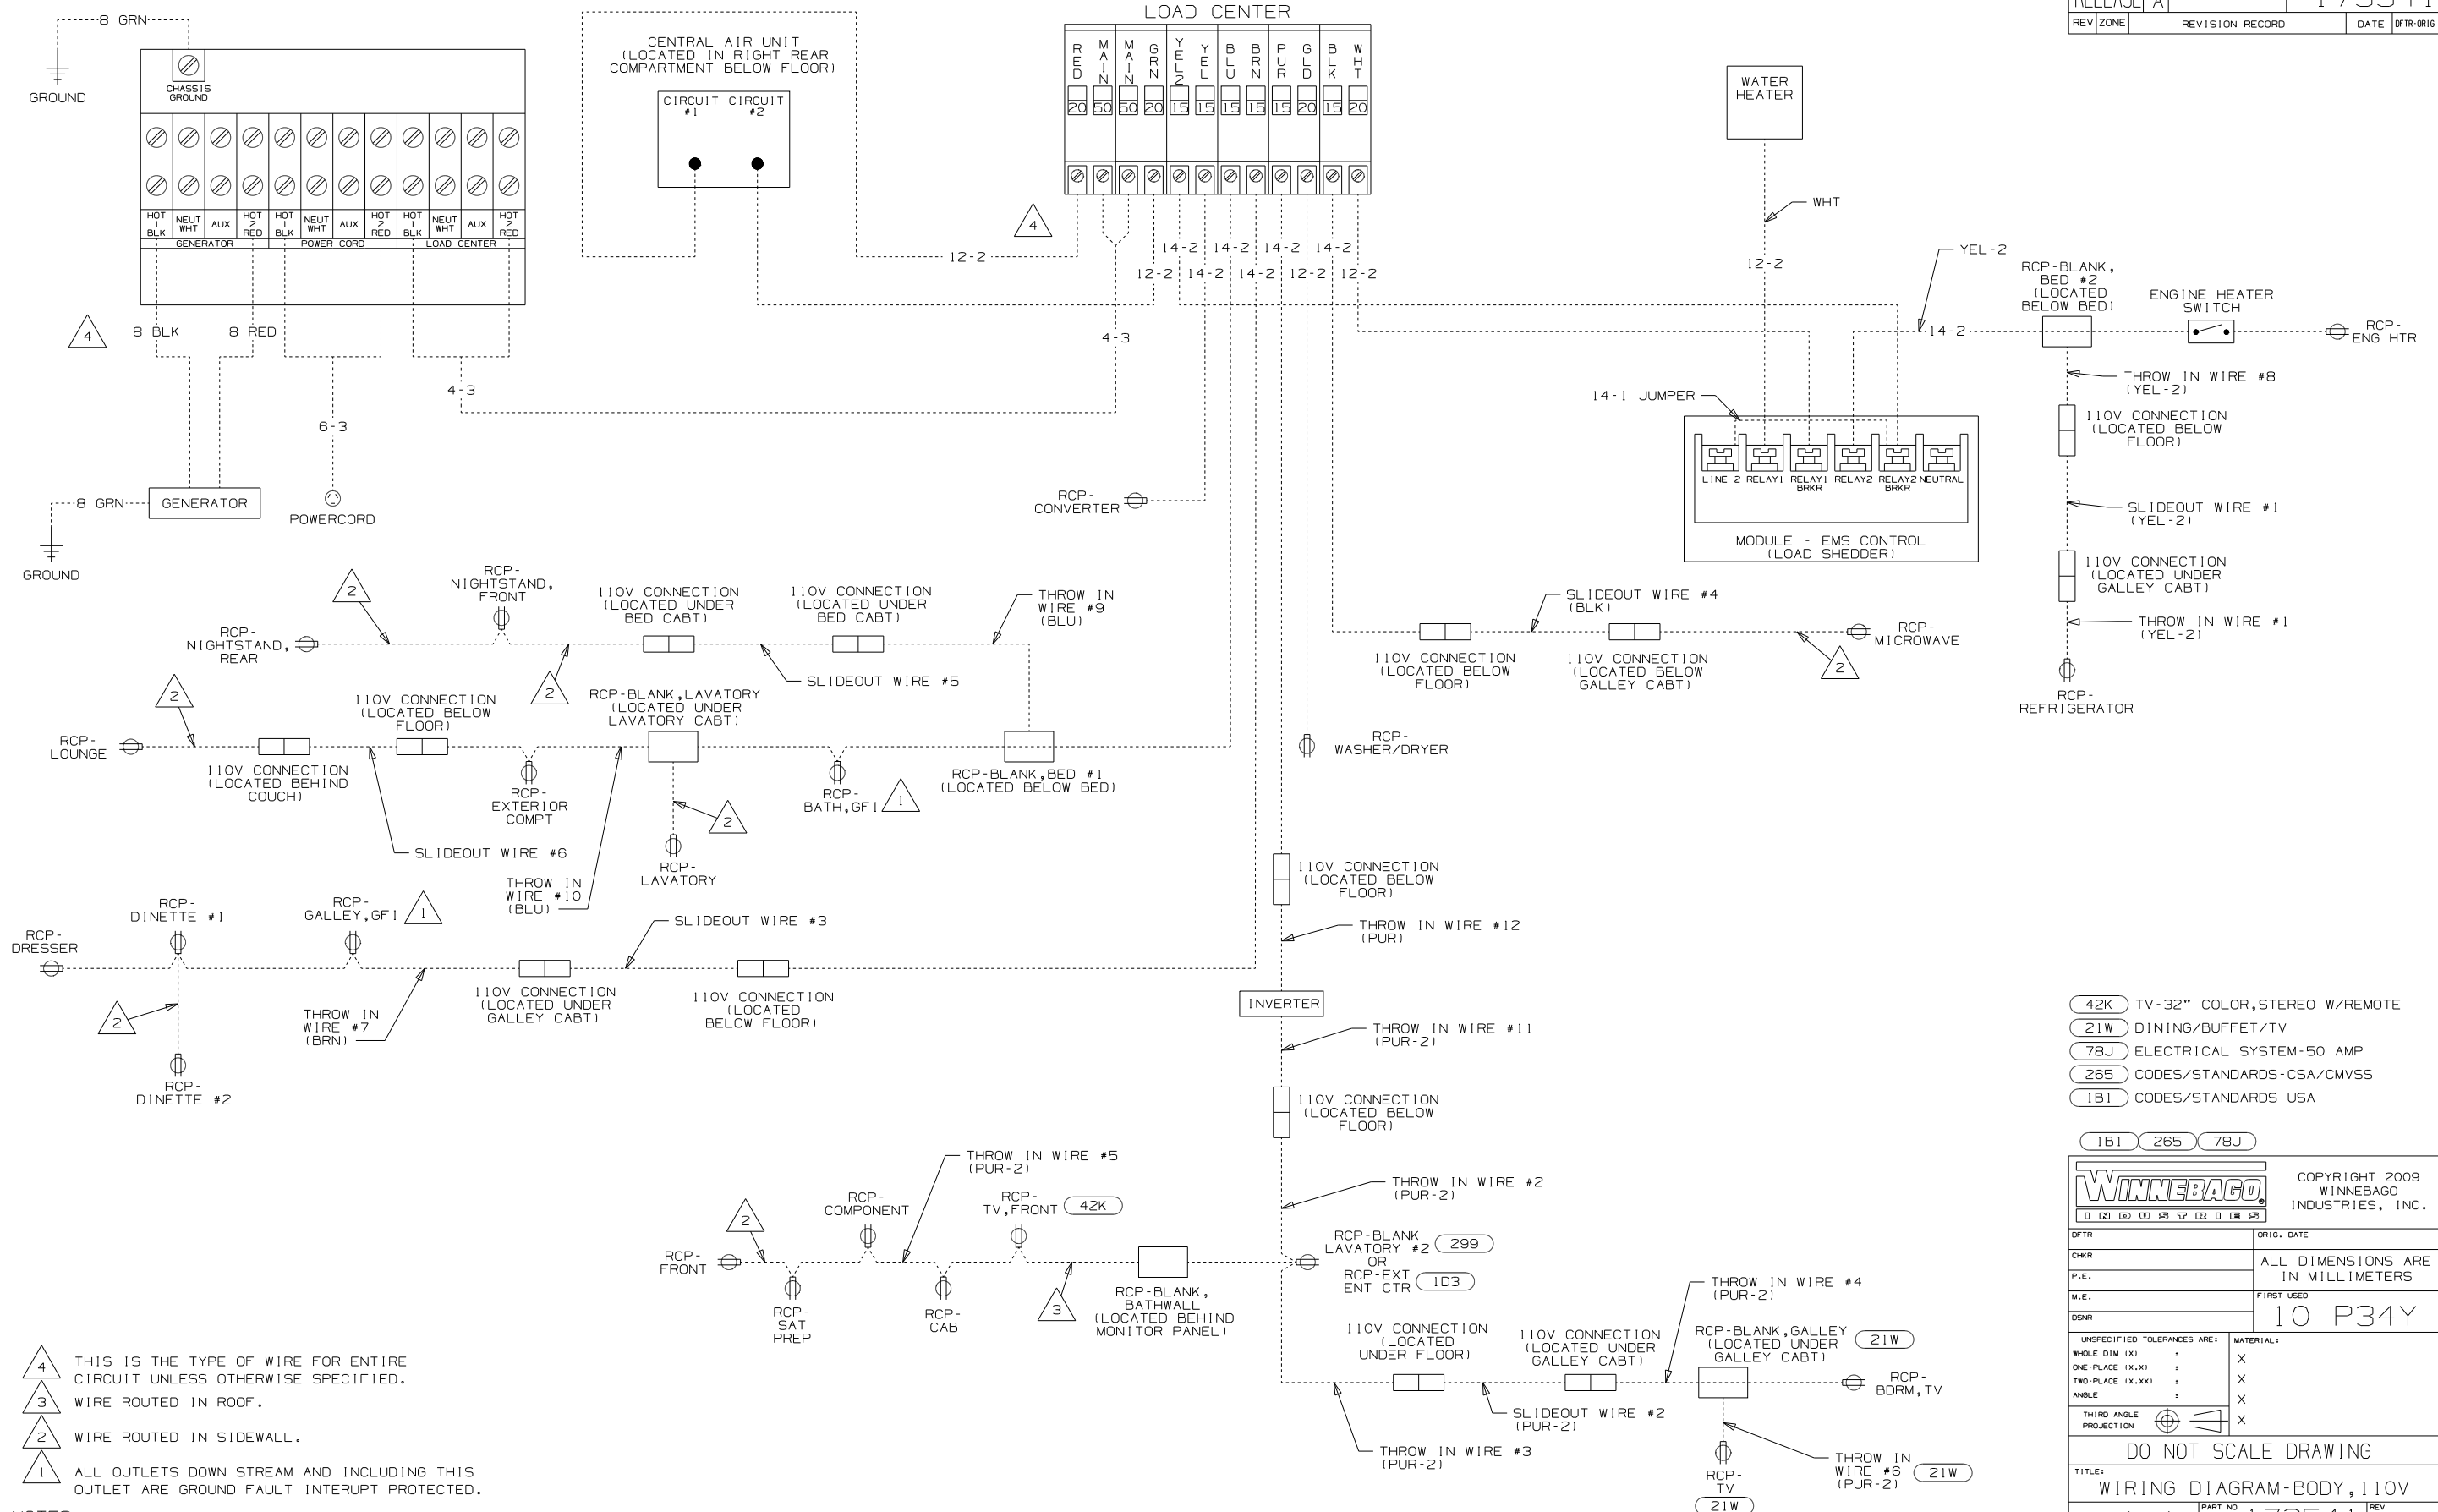
- 4 THIS IS THE TYPE OF WIRE FOR ENTIRE CIRCUIT UNLESS OTHERWISE SPECIFIED.
- 3 WIRE ROUTED IN ROOF.
- 2 WIRE ROUTED IN SIDEWALL.
- 1 ALL OUTLETS DOWN STREAM AND INCLUDING THIS OUTLET ARE GROUND FAULT INTERRUPT PROTECTED.
